Some Observations of Geotechnical Aspects of the February 28,
2001,
Nisqually Earthquake in Olympia, South Seattle, and Tacoma,
Washington

Performance of Earth Structures

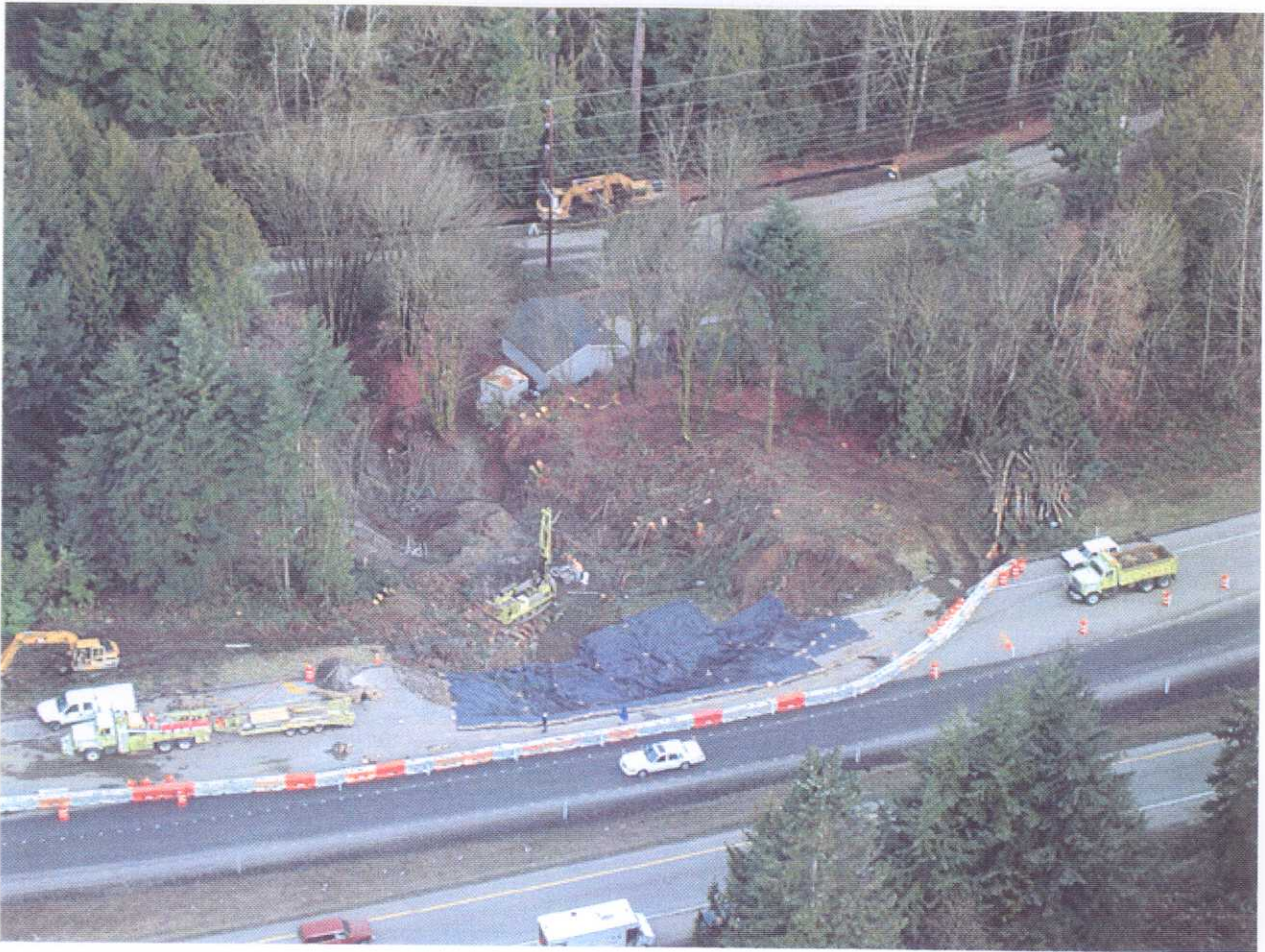
Slide in Highway 101 road embankment near State Road 8 junction. The earth embankment crosses a ravine that was carrying water at the time of the earthquake. The embankment is about 15 to 20 m high, has a crest width of 30 m, and has side slopes of approximately 1.5H:1V. A 1 m diameter corrugated metal culvert through the base of the embankment provides drainage across it. The failed material flowed downslope approximately 150 m and partially covered the road that parallels Highway 101 to the north. Pavement sections and culvert materials were found about 50 m and 70 m, respectively, north of the edge of the original road embankment (GPS N47.05834 W123.01365; 03/03/01).

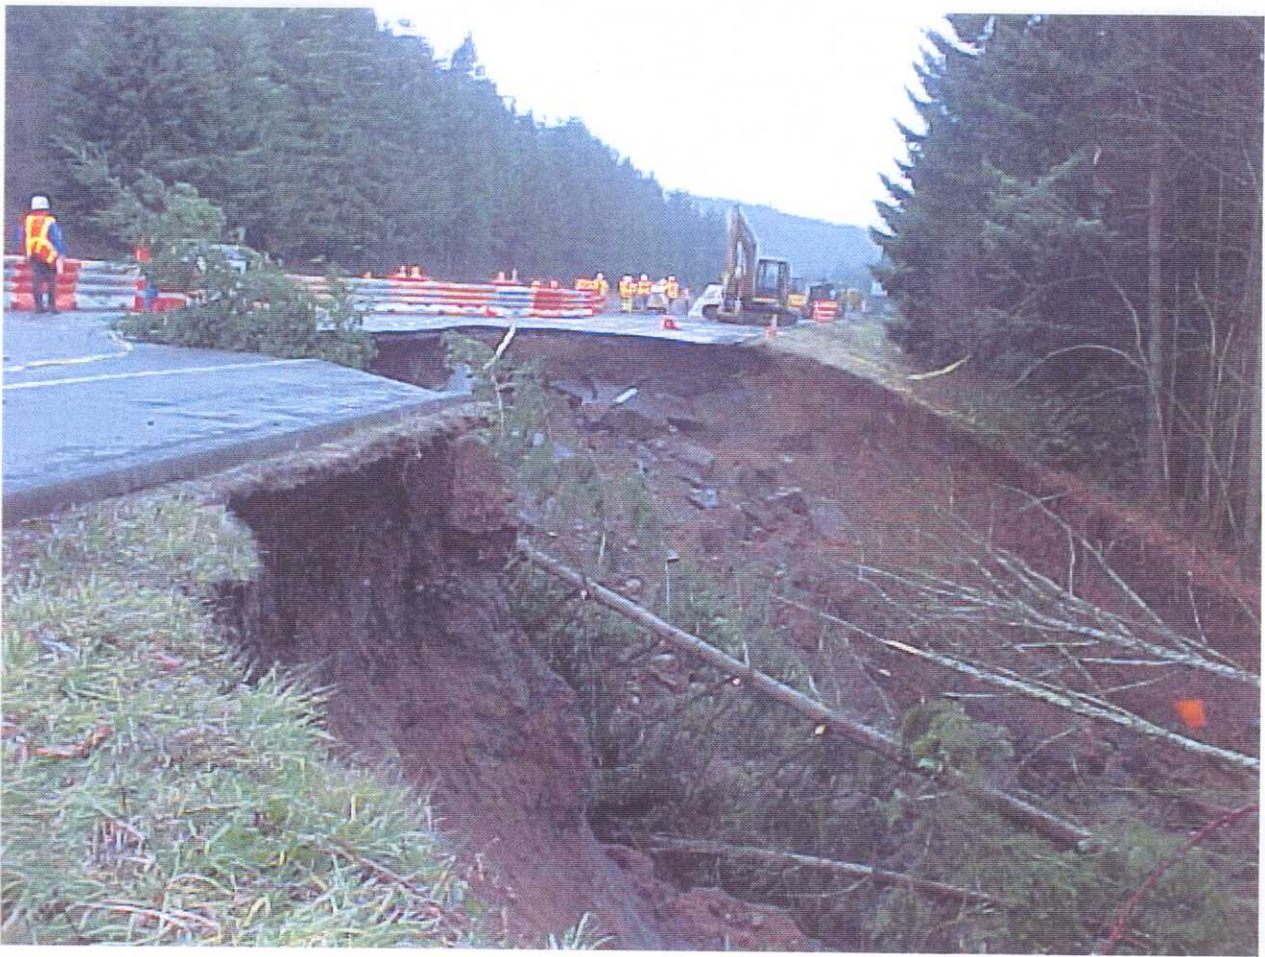
The curved headscarp of the slide is 24 m wide, and the total width of the slide at the edge of the road is 35 m. The landslide has undermined the outside lane of the two northbound lanes, so that it reaches back around 7 m from the outside edge of the emergency lane on the north shoulder of the highway (GPS N47.05834 W123.01365; 1030 03/01/01).

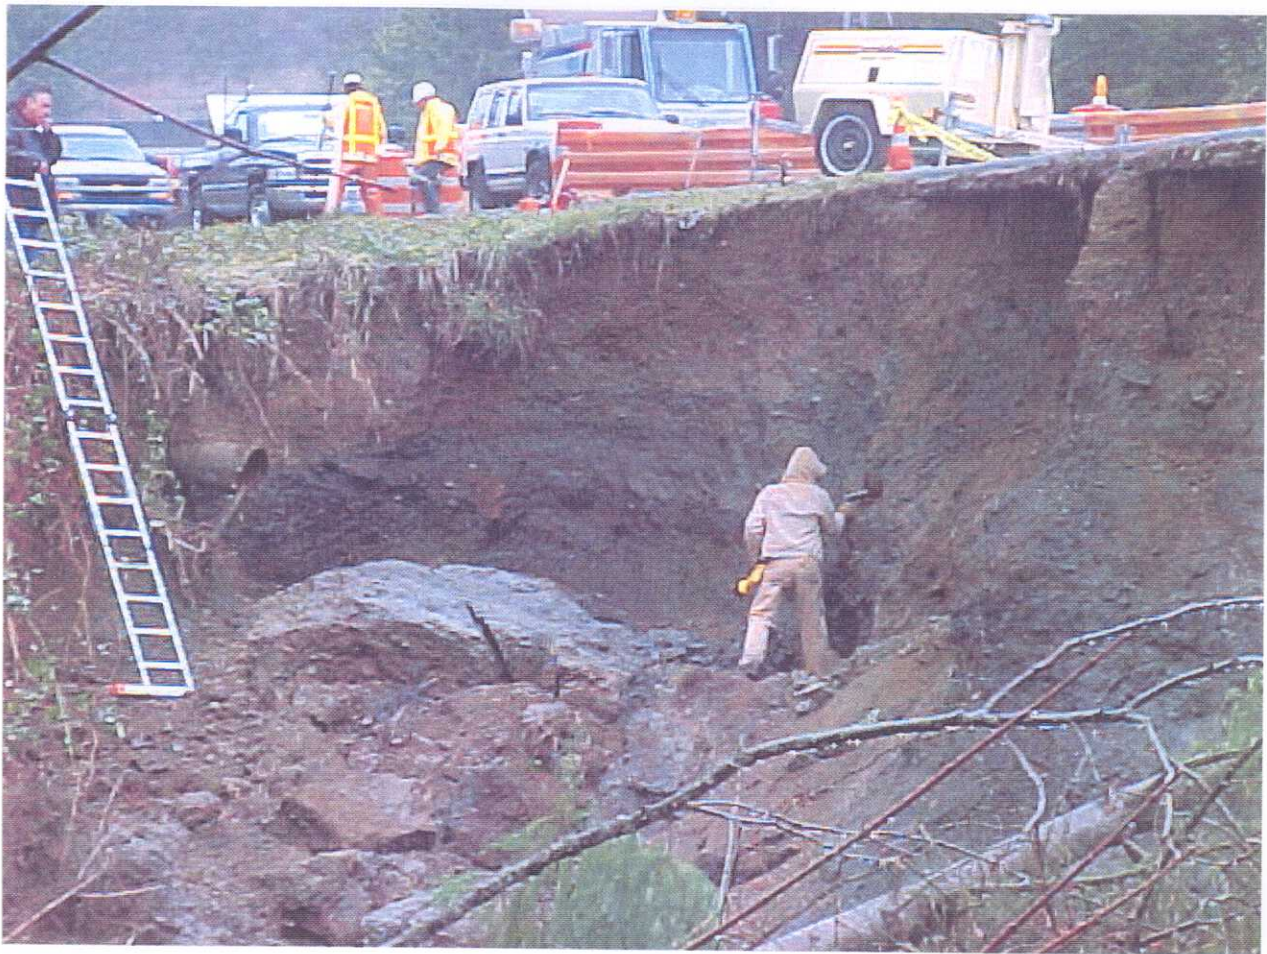
View of eastern end of the headscarp at the Highway 101 road embankment slide shown in the previous photograph. In this area the headscarp is approximately 6 m high (GPS N47.05834 W123.01365; 1050 03/01/01).

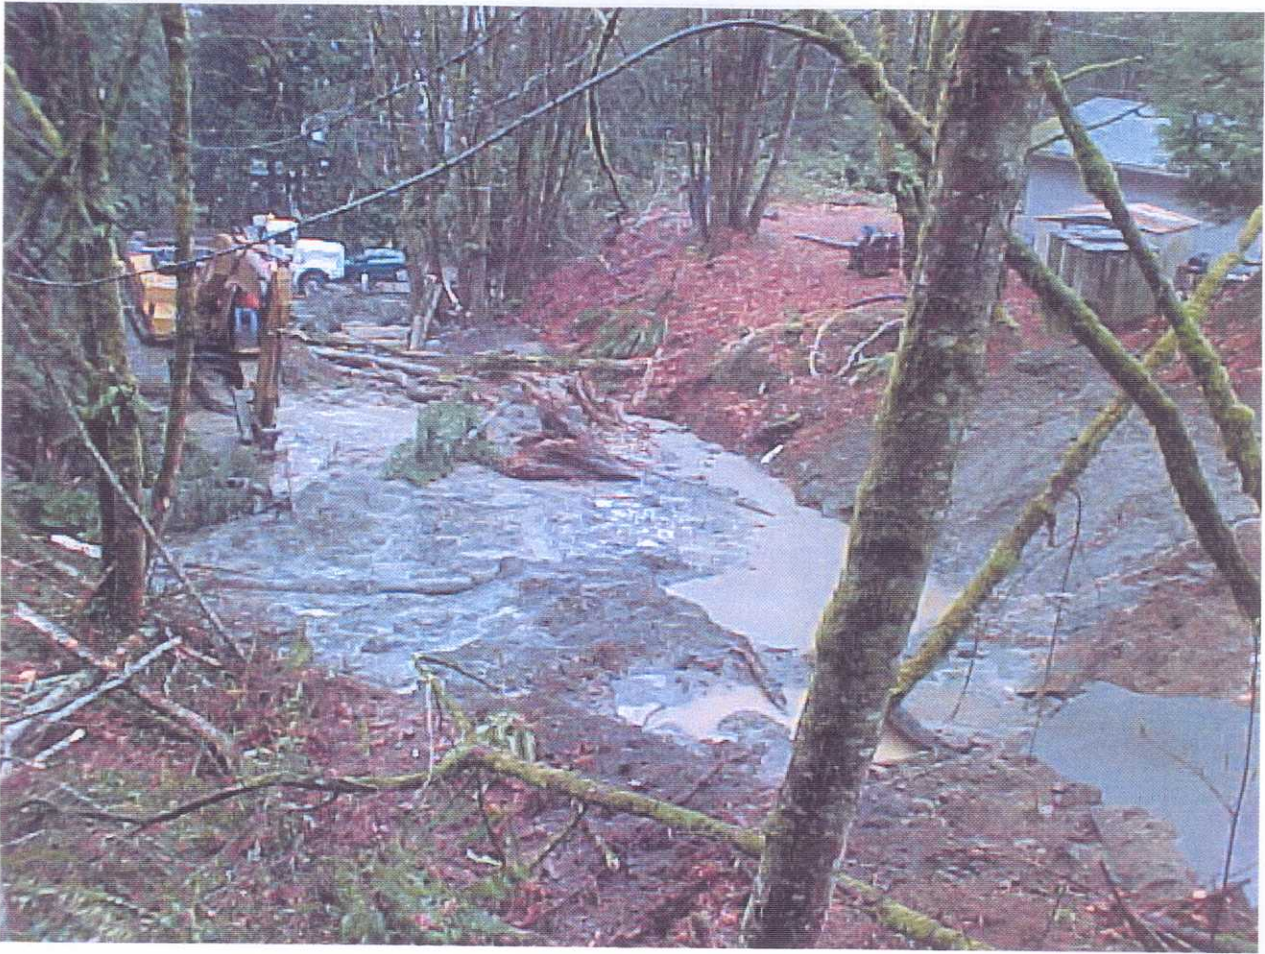
View of run-out of slide material downslope from the Highway 101 earth embankment slide.(GPS N47.05834 W123.01365; 1100 03/01/01).

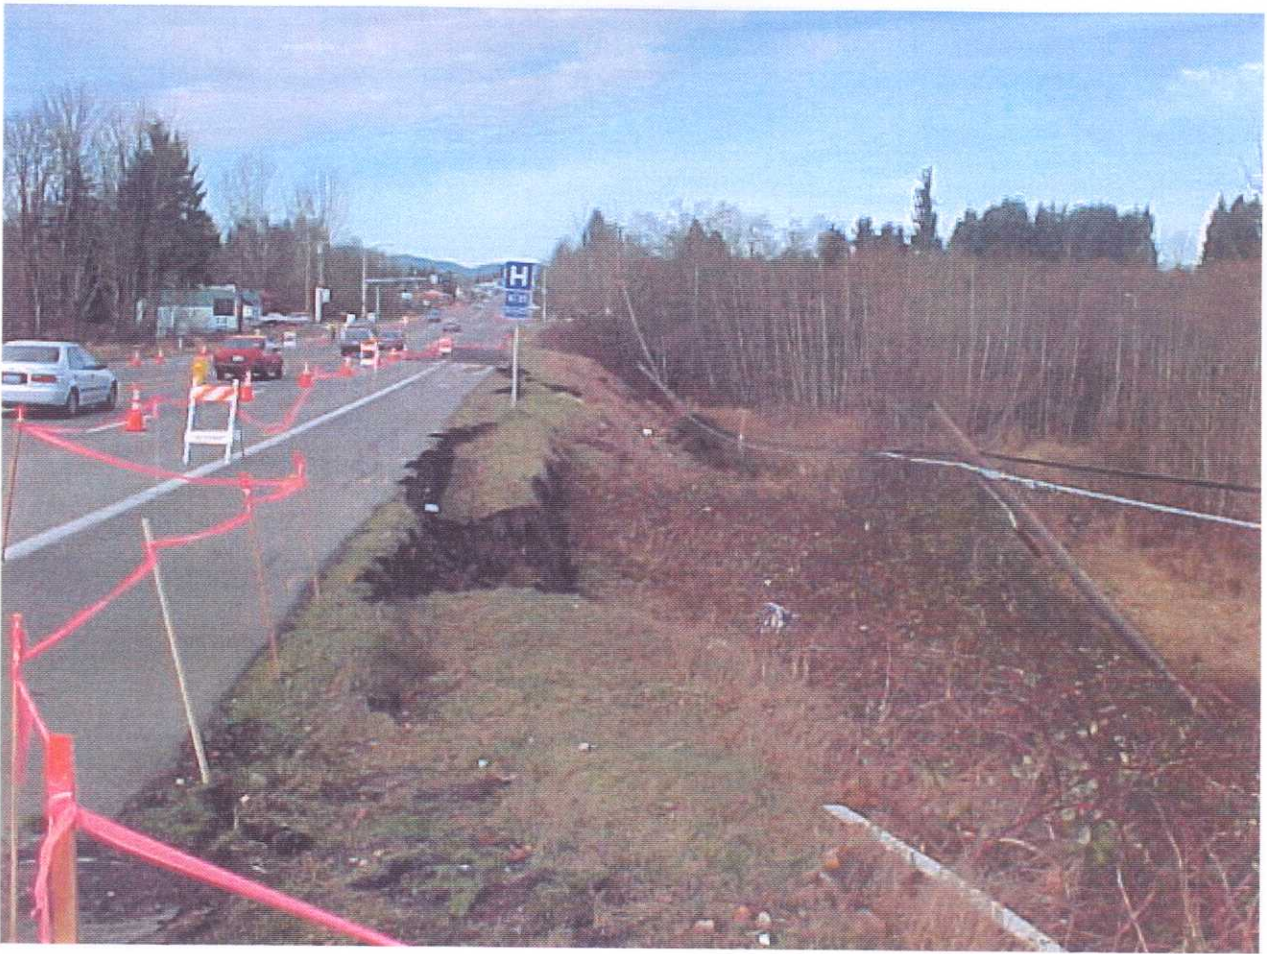
The earth embankment, which is composed of compacted uniform sand in its upper section, crosses a peat bog. The embankment is about 6.5 to 7 m high, has a crest width of 24 m, and has side slopes of approximately 1.5H:1V. The slide along the northern edge is about 120 m long, and there is a 27 m long slide along the southern edge of the embankment that reaches back 4 to 5 m from the original southern edge of the embankment (GPS N47.04693 W122.85092; 0950 03/04/01).

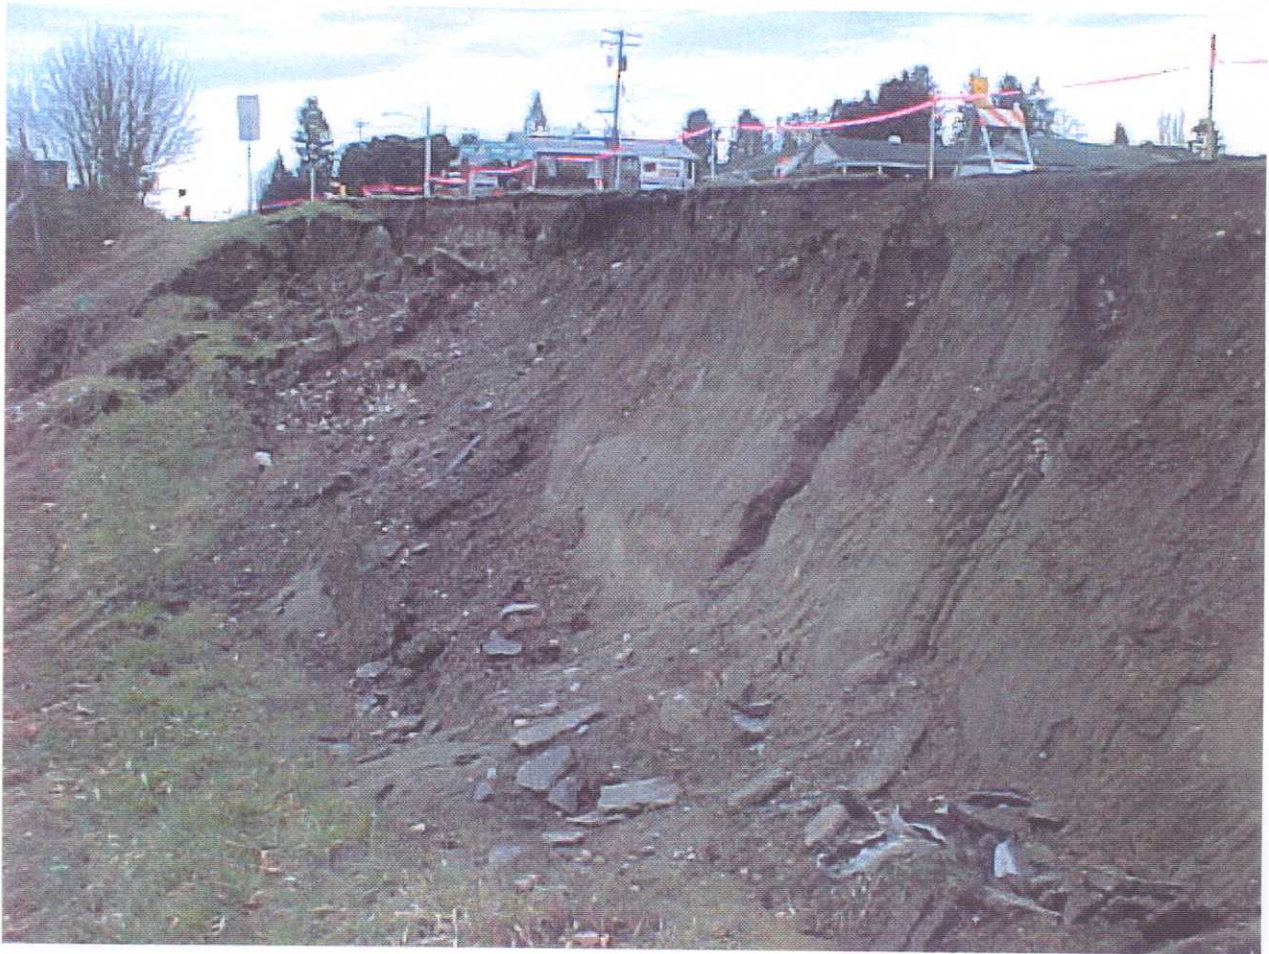
View to east showing slide along the northern edge of the Martin Way earth embankment slide. The maximum vertical offset of the headscarp at this area was 3.3 m (GPS N47.04693 W122.85092; 1000 03/04/01).

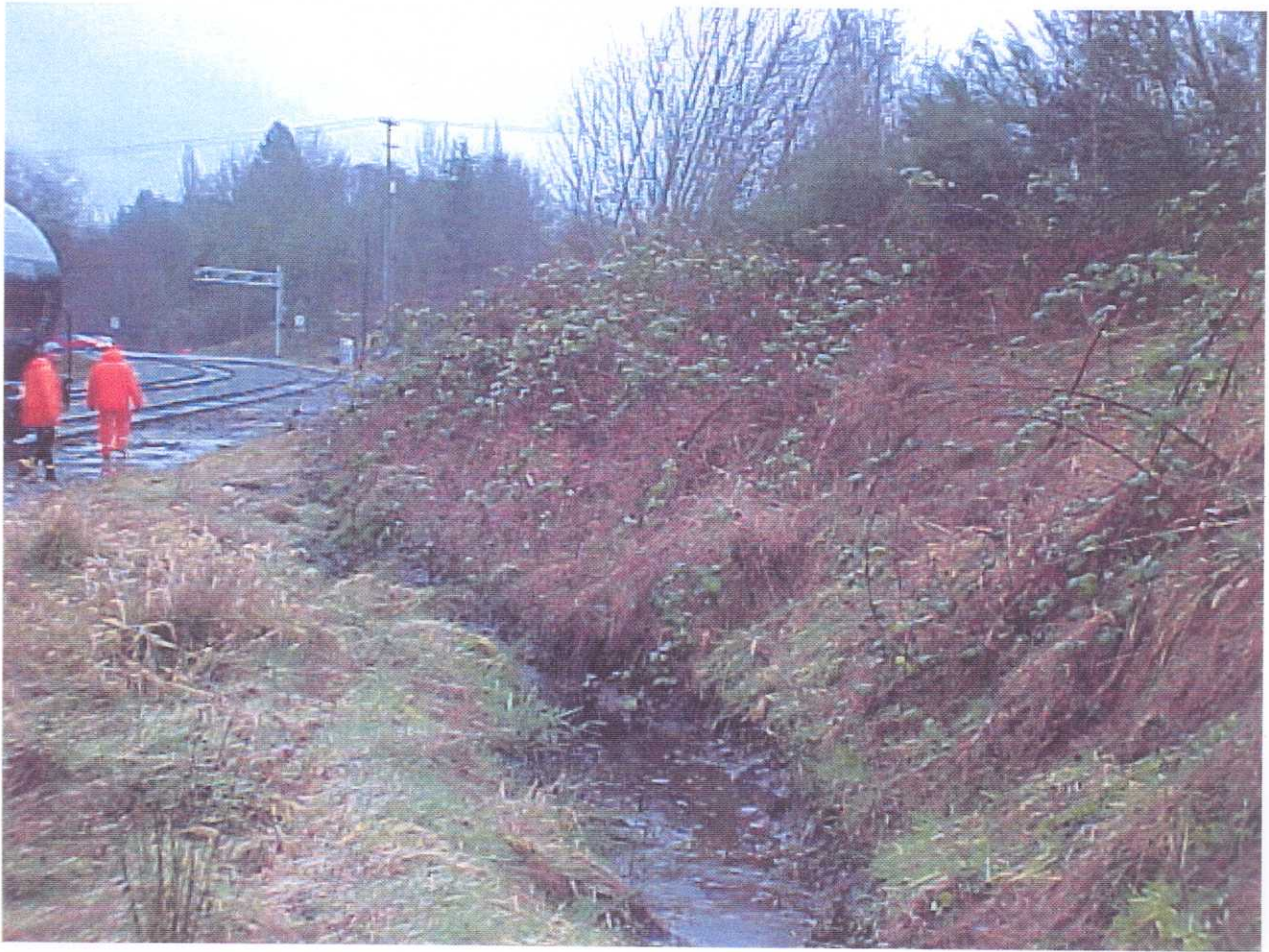
Slumping of earth embankment into ditch that parallels an active rail line between Union and Cherry Streets in Olympia. The embankment is about 5 m high. The length of the failed section of the embankment was about 50 m, although lateral displacement was observed along a total length of 120 m. The cracks in the crest of the embankment had vertical offsets of between 15 and 45 cm (GPS N47.0402 W122.8939; 1630 03/01/01).

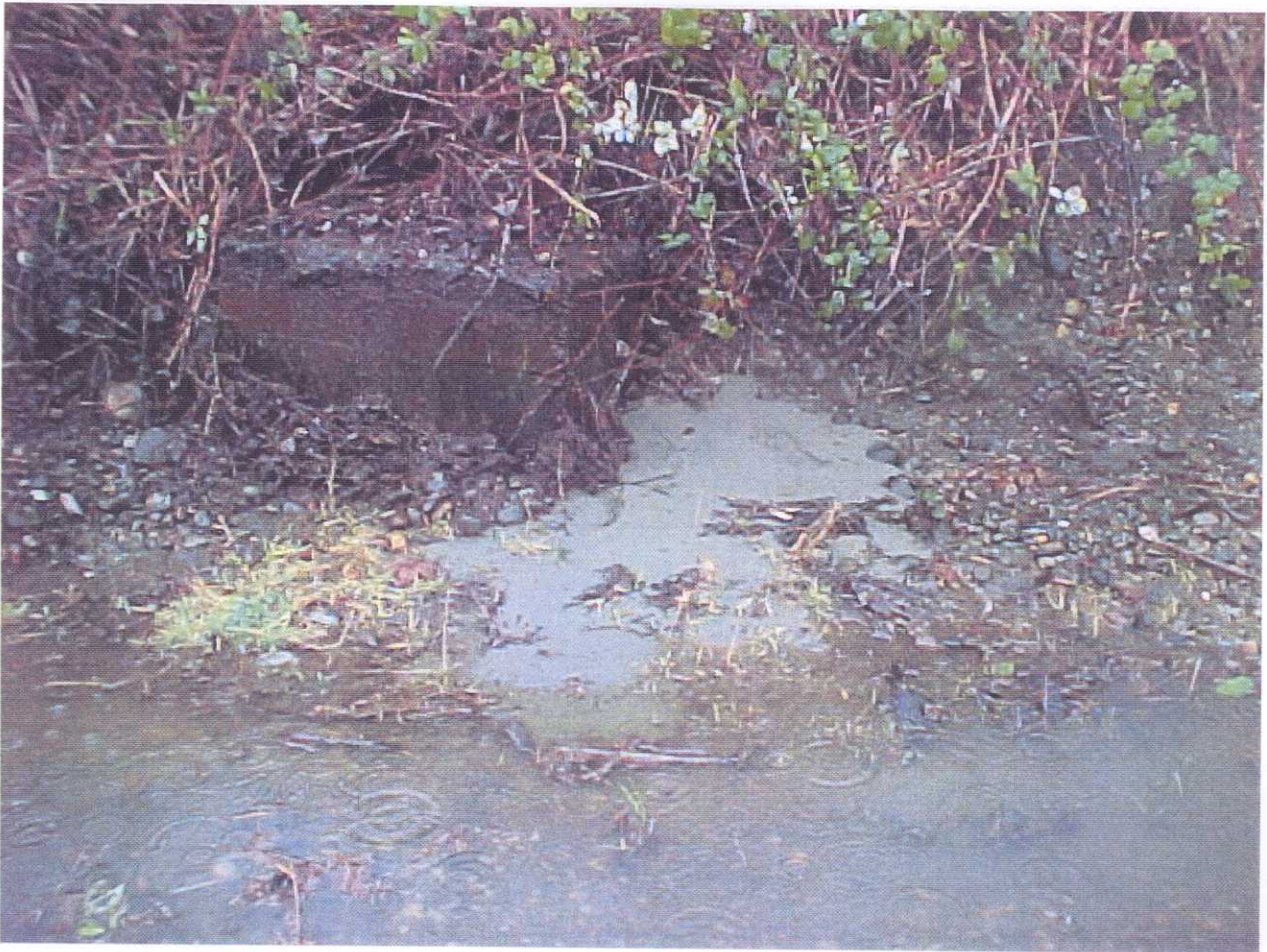
Sediment ejecta at base of embankment shown previously indicating liquefaction (GPS N47.0402 W122.8939; 1630 03/01/01)

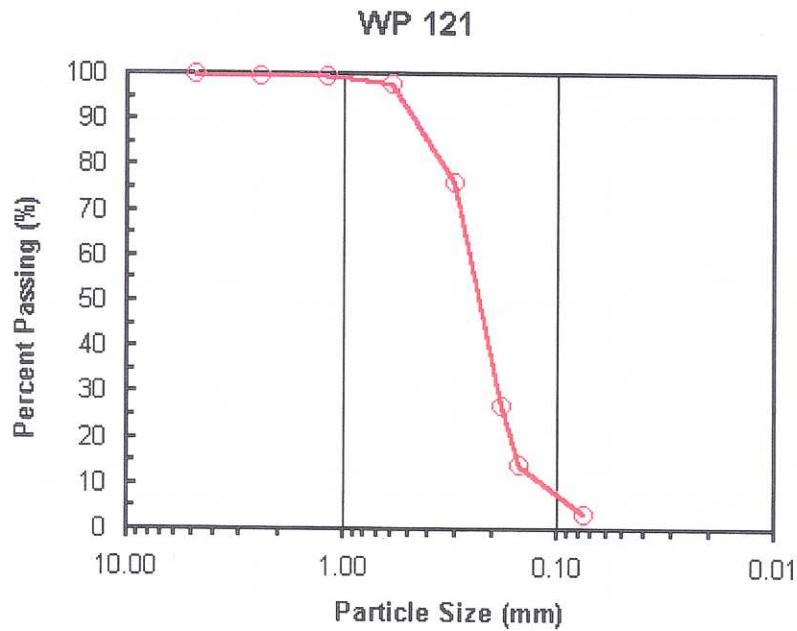
Grain size distribution of ejecta. The poorly graded clean sand classifies as an SP (USCS, $C_c = 1.7$, $C_u = 4.9$).

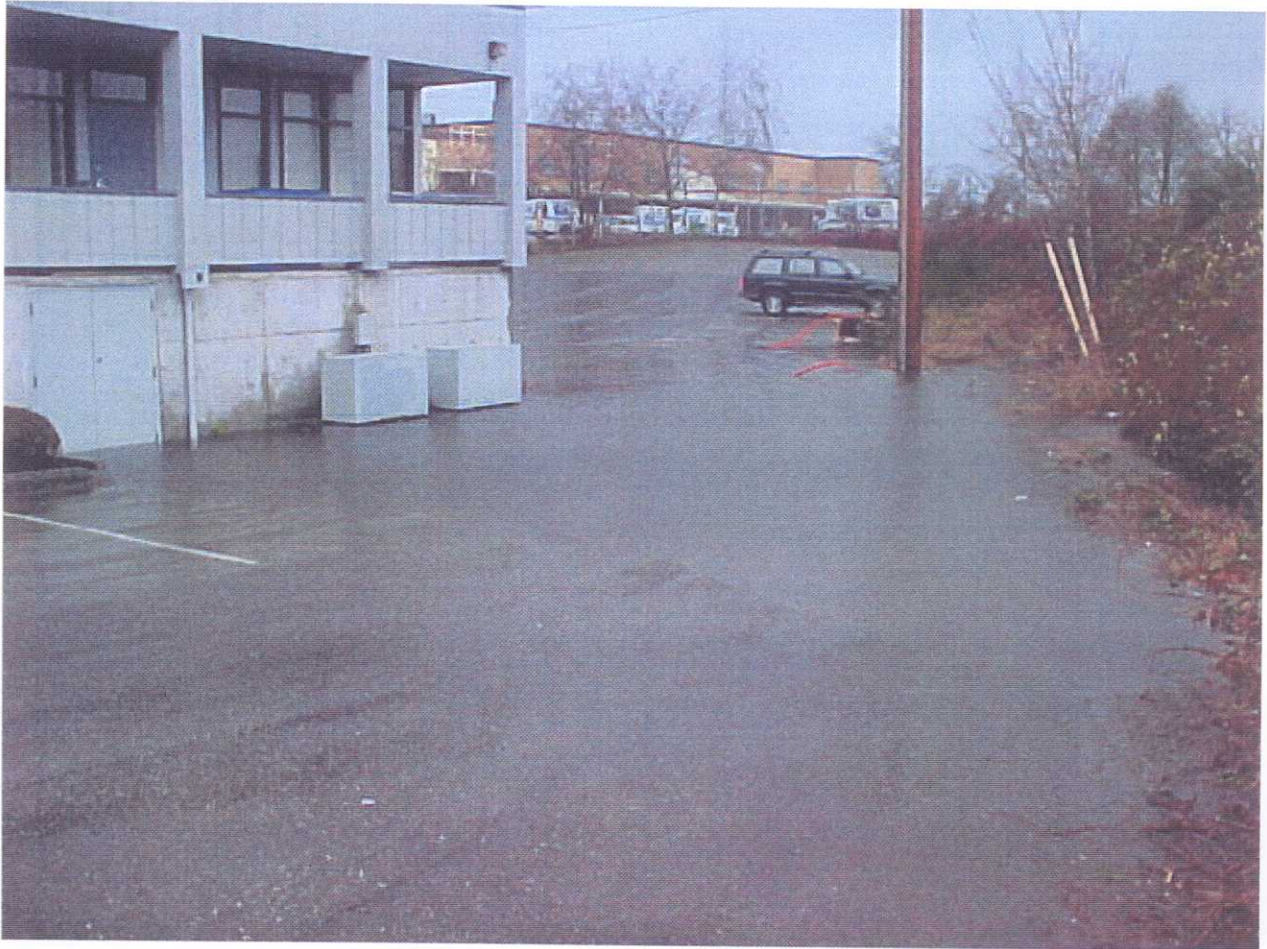
Flooding on the backside of the earth embankment shown previously due to the embankment slumping over the outlet drain and breaking the drain pipe through the embankment (GPS N47.0402 W122.8939; 1630 03/01/01)

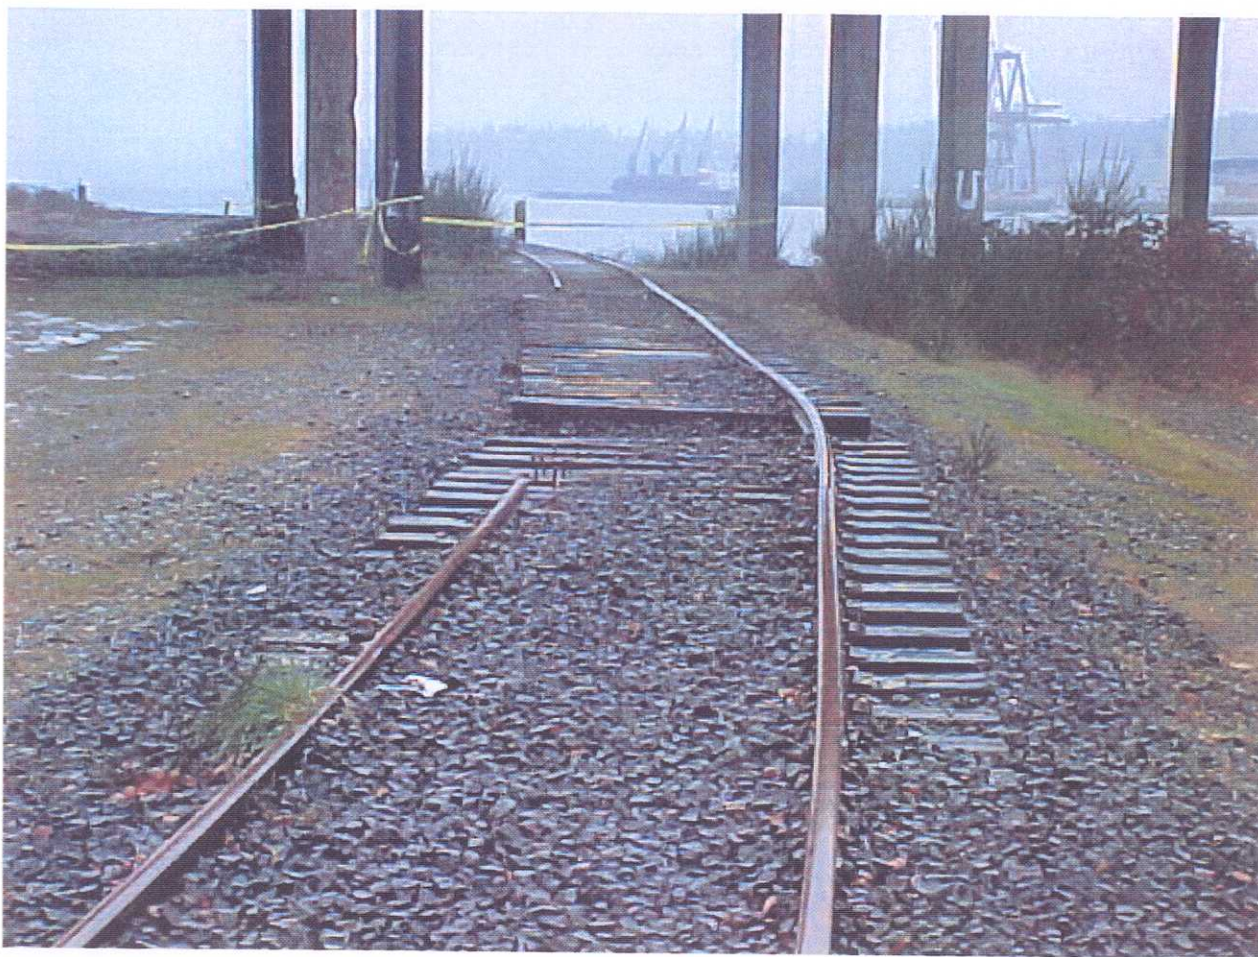
Broken rail line along the western shore of Capital Lake in Olympia (GPS N47.04401° W122.91071°; 1200 03/01/01).

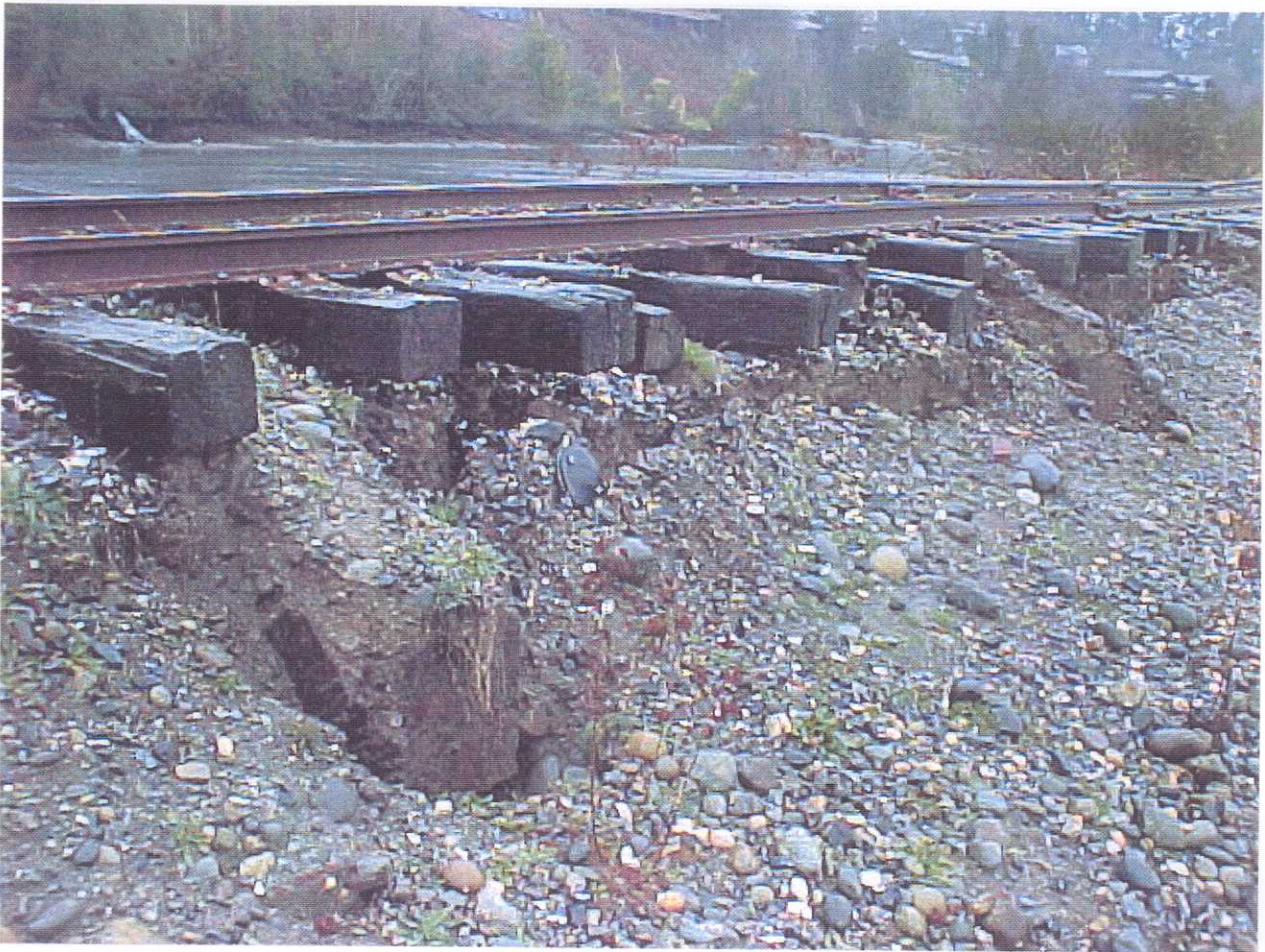
Slumping of railroad embankment in Olympia. Tracks are supported by a wooden trestle that underlies the embankment (GPS N47.04567 W122.91043; 1230 03/01/01).

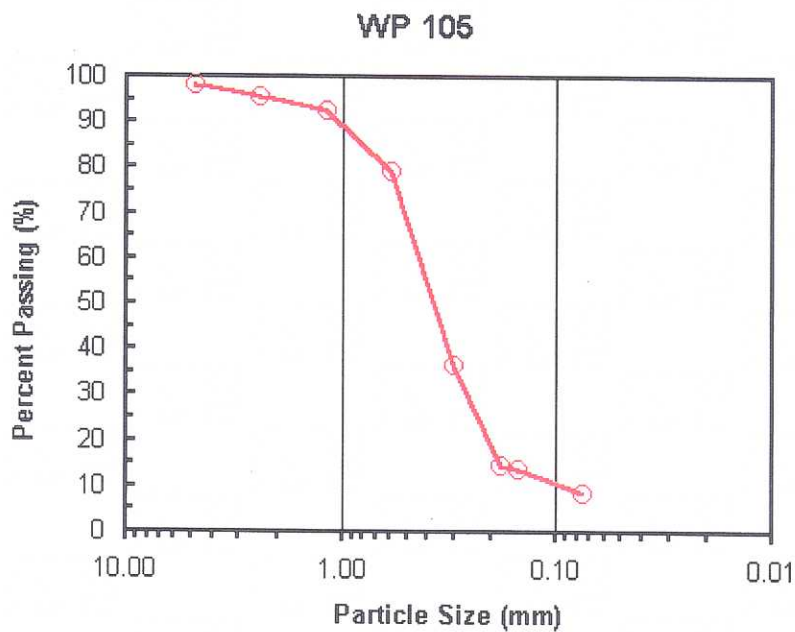
Grain size distribution of ejecta from sand boil. Sand boil was located at base of embankment on far side of tracks adjacent to the water. The poorly graded clean sand classifies as an SP (USCS, $C_c = 1.1$, $C_u = 0.4$).

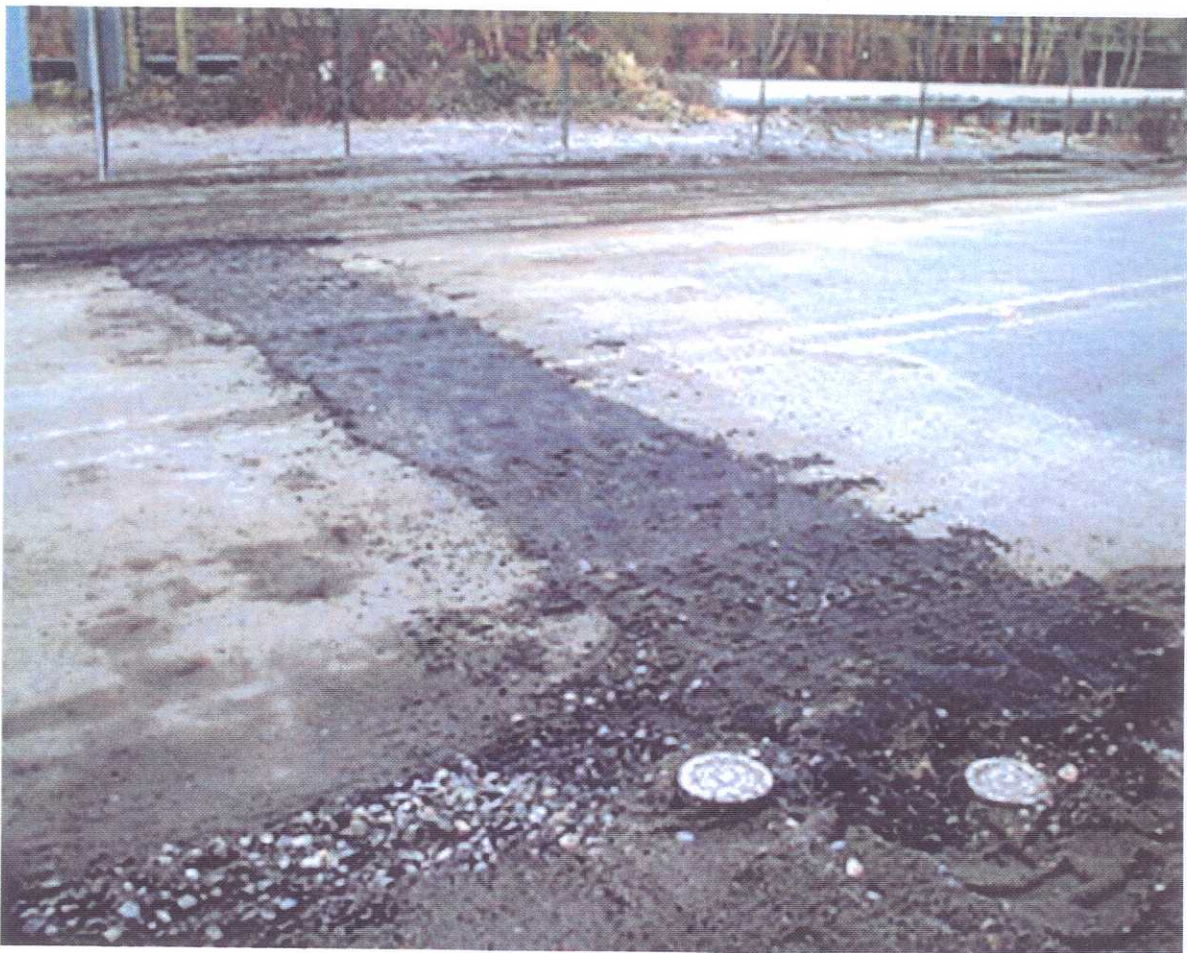
Figure 11. Sewer main repair at south abutment (GPS N47.1917° W122.5733°; 0737 03/04/01)

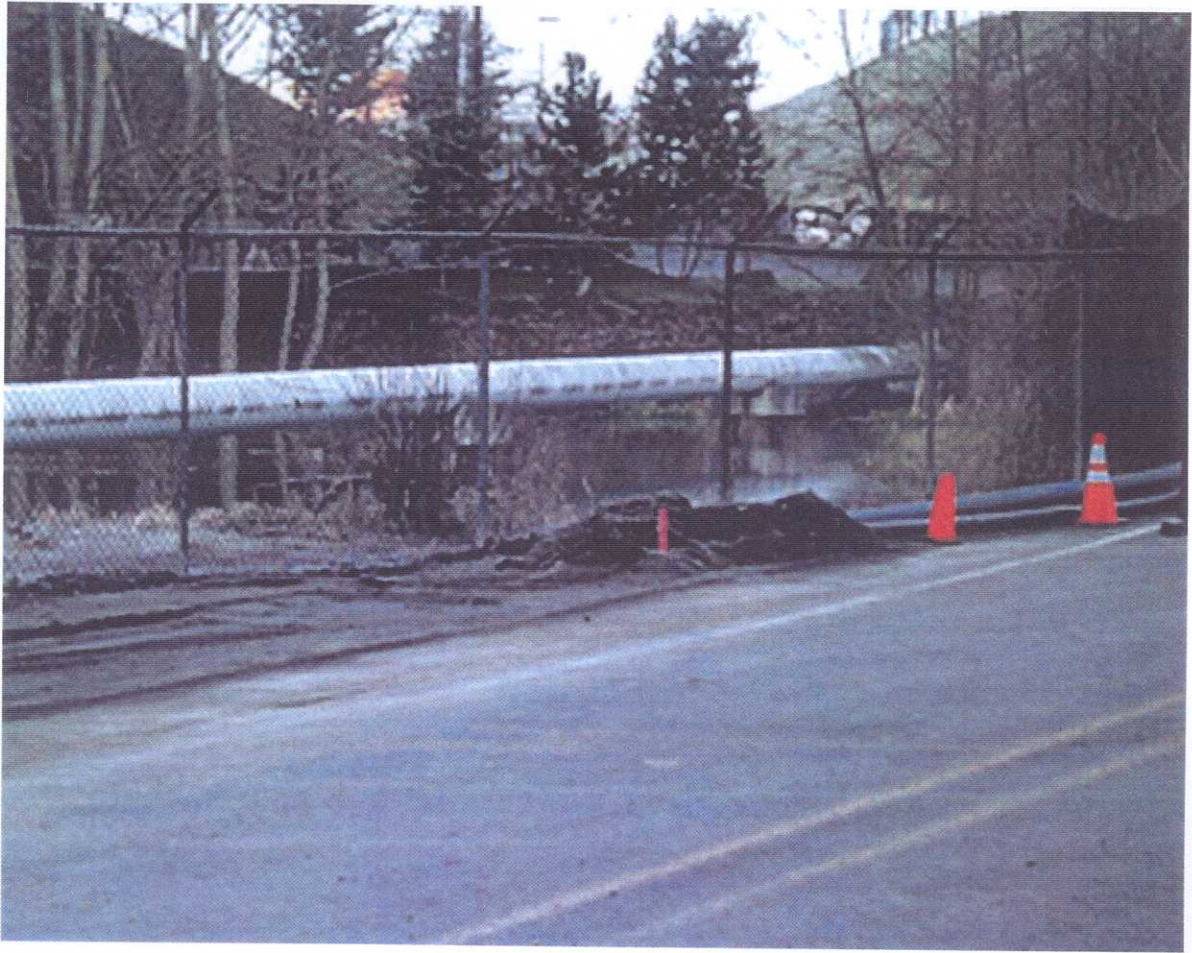
Sewer line repair using high density polyethylene. Water distribution line (undamaged) crosses adjacent to bridge. Behind water line on far bank is small landslide with several trees within sliding block. (GPS N47.1917° W122.5733°; 0737, 03/04/01)

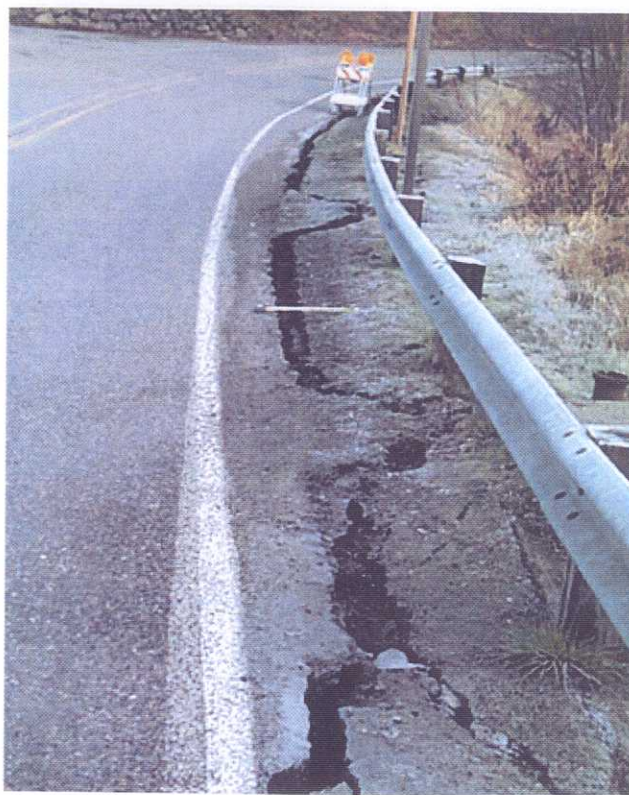
Ground cracking with outward movement of roadway edge and guard rail. Lateral offset is on the order of 18 cm. (GPS N47.1923° W122.5739°; 0745 03/04/01)

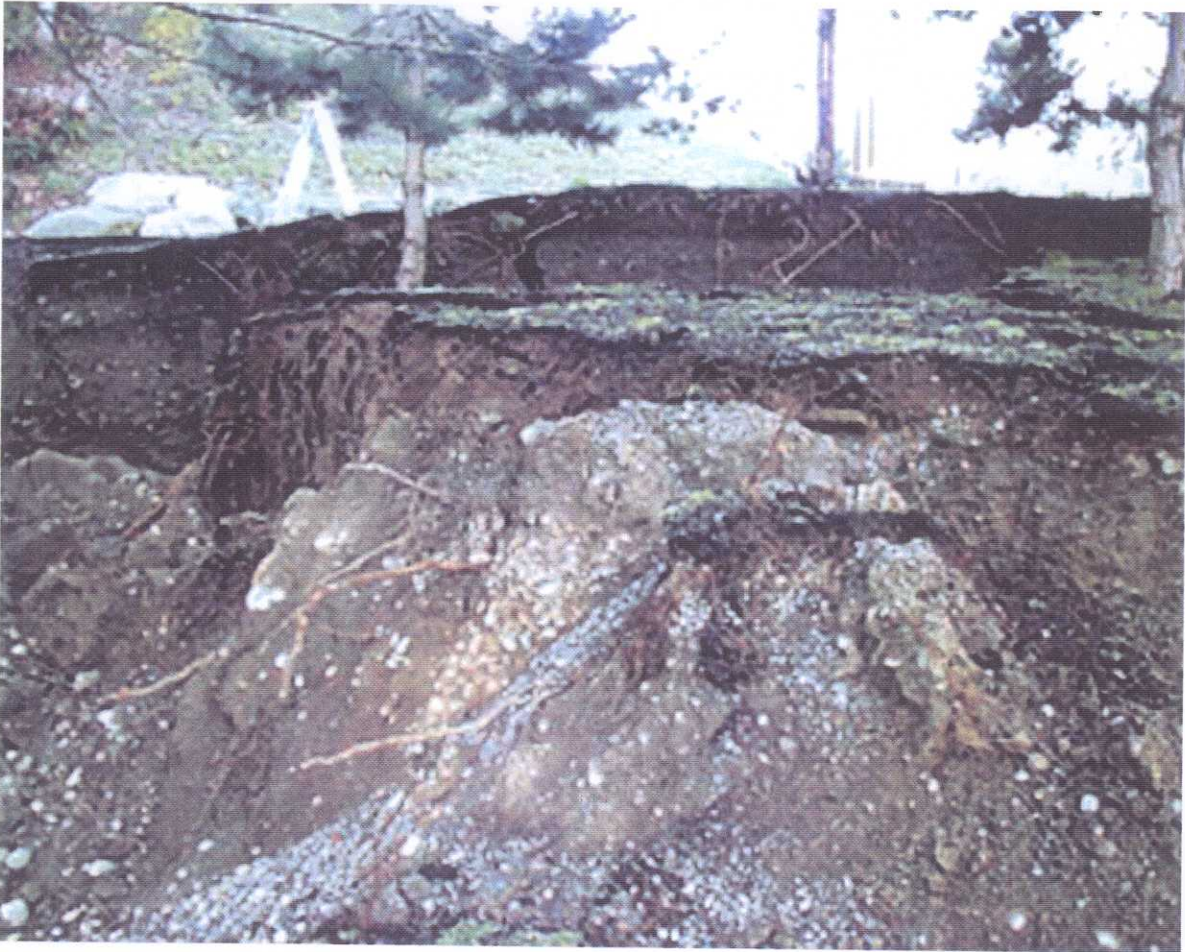
This small landslide is immediately west of the northern end of the water distribution pipe shown previously. This vertical head scarp is about 2 m high and parallels the edge of the roadway entrance to private property. This view, looking to the west, shows the larger of two blocks along the lower left hand side and the smaller block along the right hand side. The smaller of the two blocks is about 1 to 2 m wide about 4 m long. It translated downslope approximately 0.5 m horizontally and 0.5 m vertically. (GPS N47.1921° W122.5742°; 0754 03/04/01)

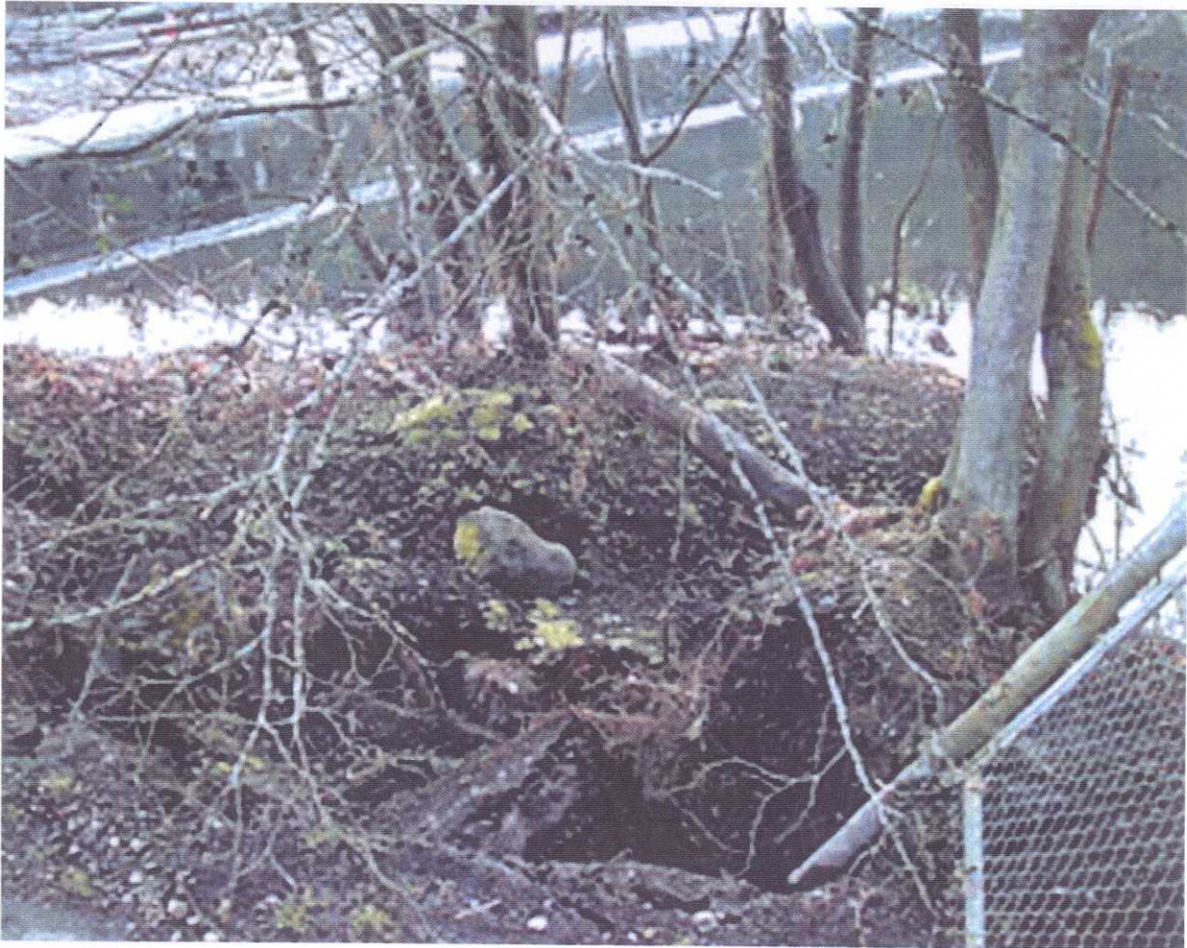
The larger of the two blocks is about 6 m wide about 6 m long. It translated downslope approximately 3 m horizontally and 2 m vertically. (GPS N47.19205° W122.57436°; 0756 03/04/01)

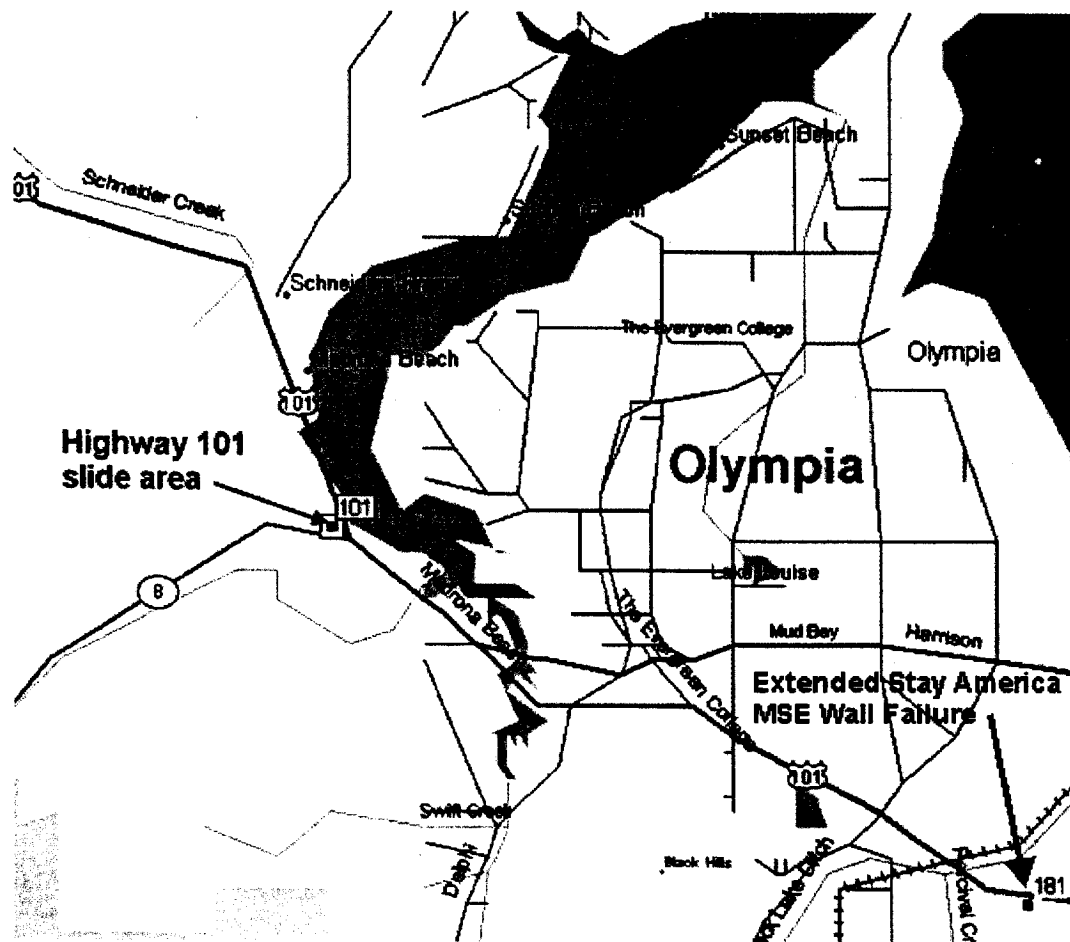
A failed MSE wall in front of the Extended Stay America in western Tumwater (lower right corner of location plan) was observed. A 2" irrigation water line was also observed near the top of the fill. However, the relative timing between the break of the water line and the failure of the wall is unknown.

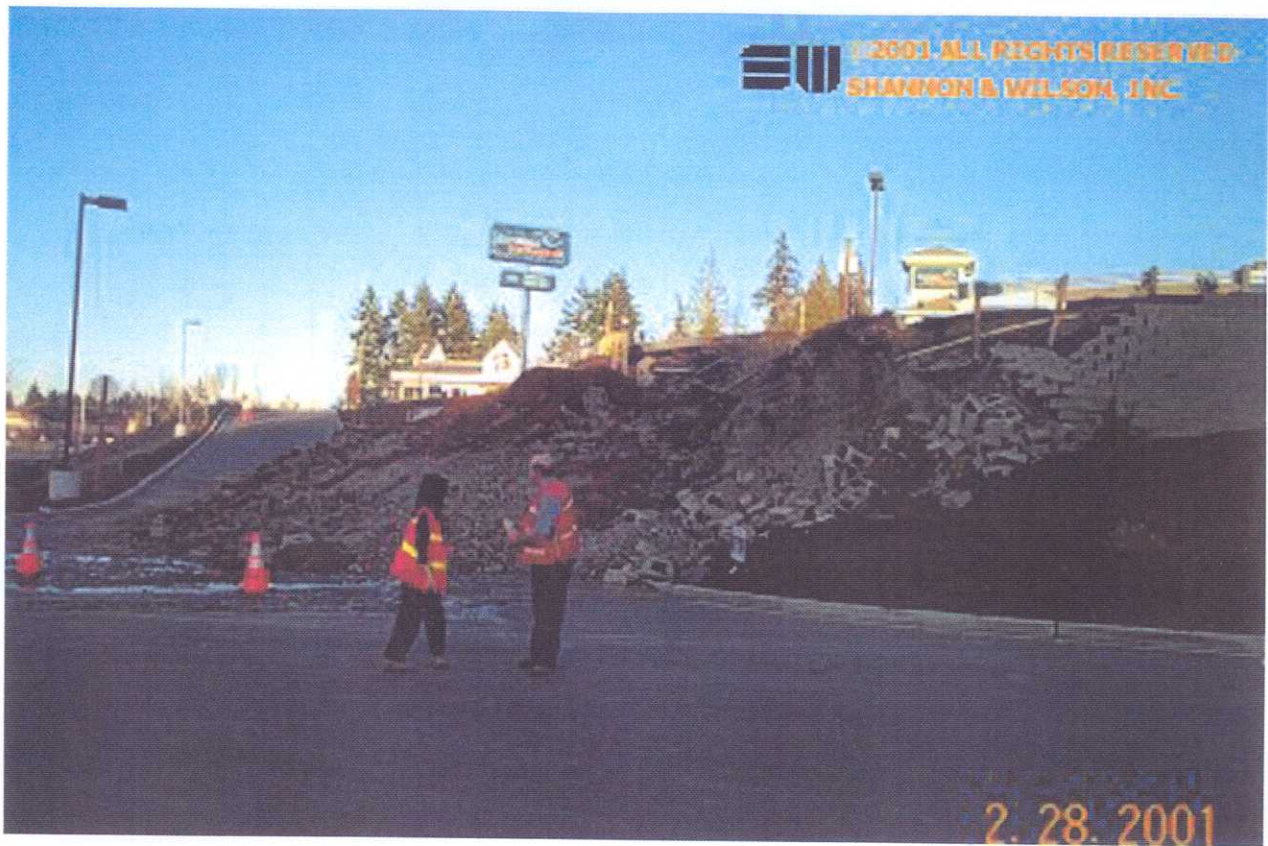
Along the right hand edge of the wall, the height of the wall was 15 20-cm high blocks for a total of 3 m (GPS N47.02479 W122.92230; 02/28/01).
