Some Observations of Geotechnical Aspects of the February 28,
2001,
Nisqually Earthquake in Olympia, South Seattle, and Tacoma,
Washington

Performance of Earth Structures

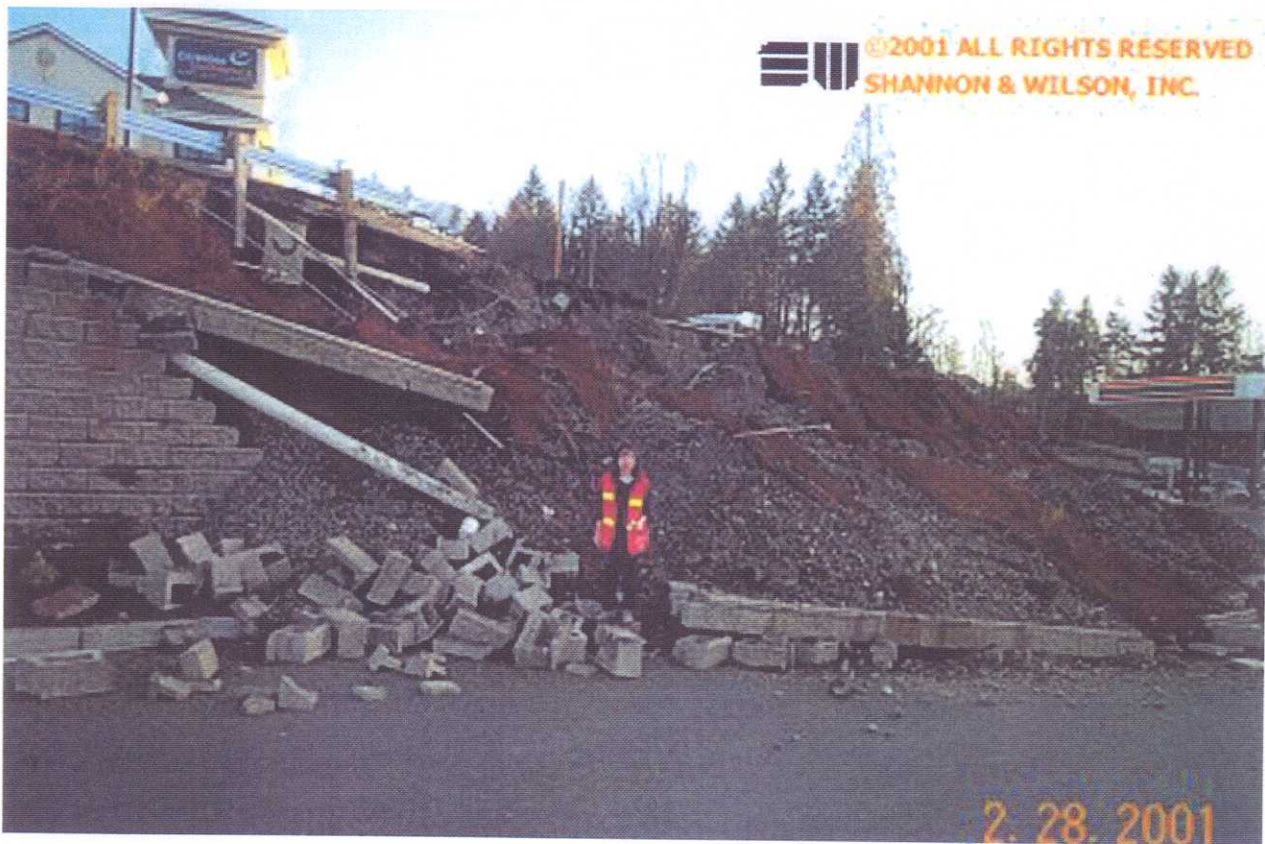
Note broken water pipe at the top of slope (GPS N47.02479 W122.92230; 02/28/01).

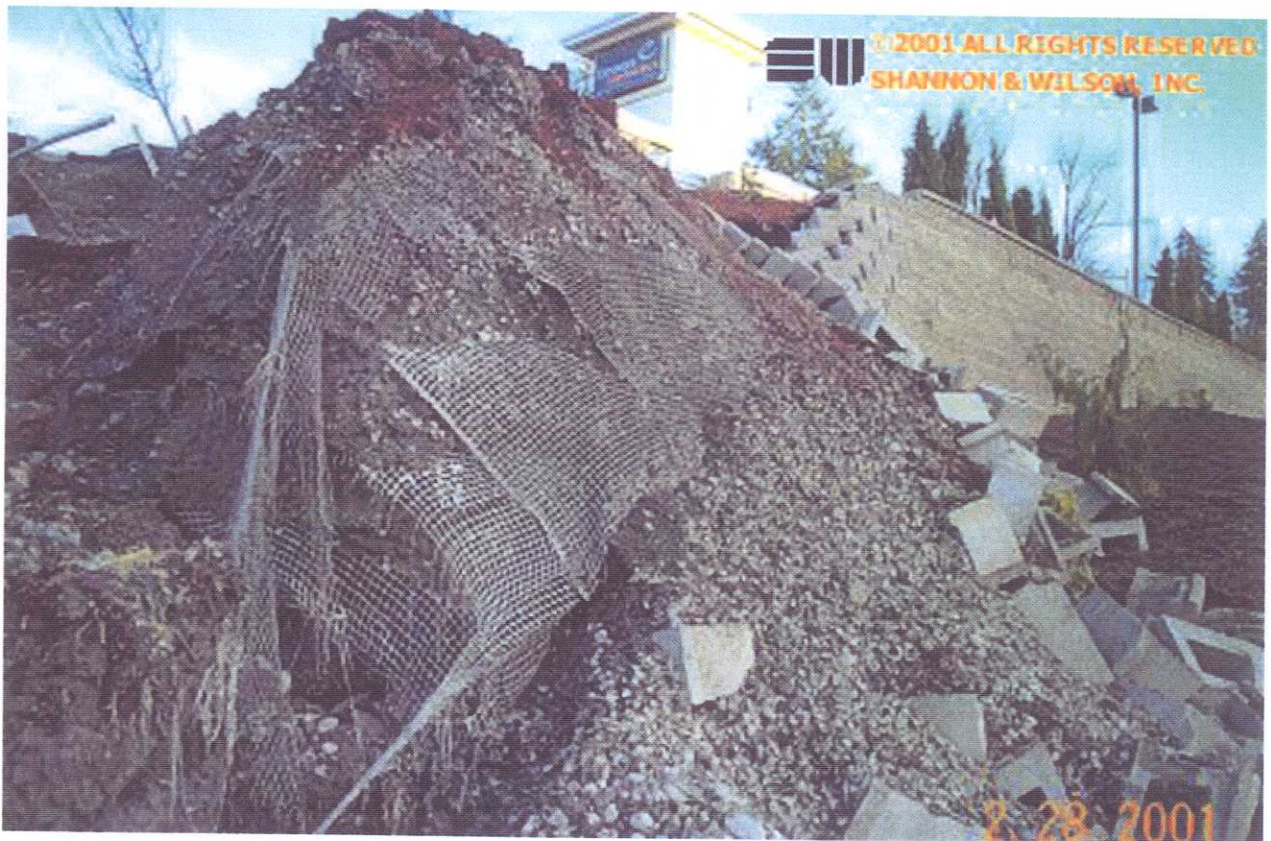
This wall had a segmental masonry facing and two types of geogrid reinforcement. The first is an asphalt-impregnated polyester biaxial geogrid with a 20 mm x 20 mm aperture. The second is a polypropylene biaxial geogrid with a 30 mm x 40 mm aperture (GPS N47.02479 W122.92230; 02/28/01).

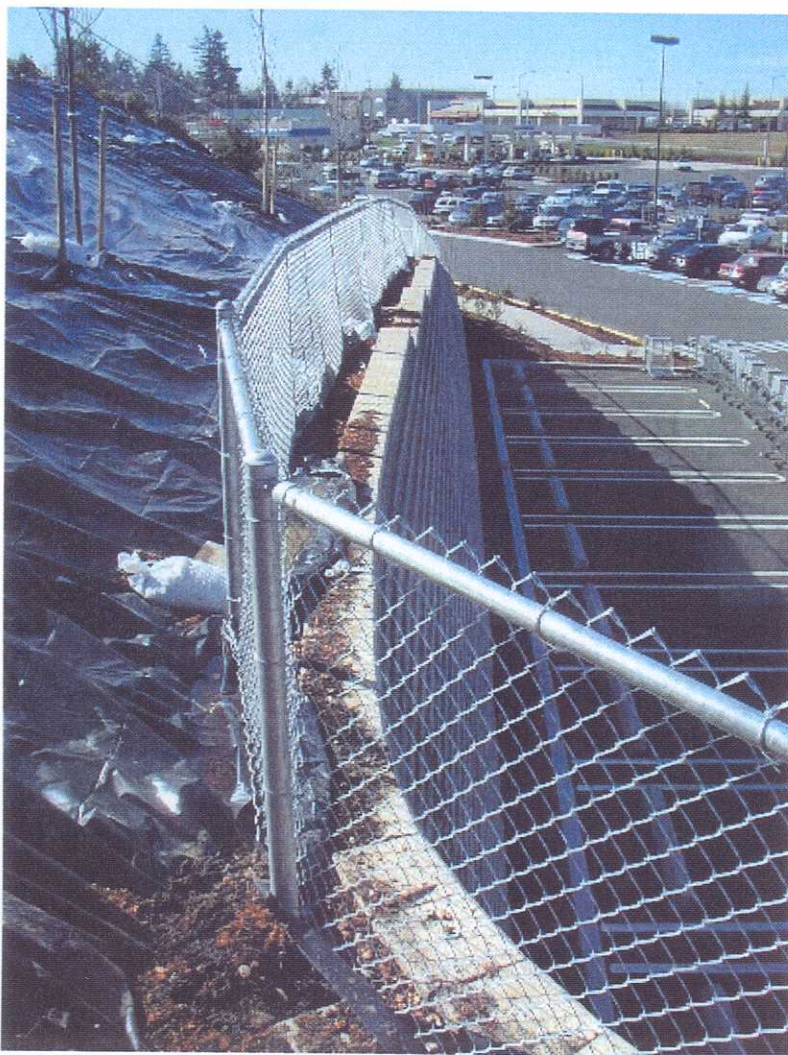
The 2:1 slope above this north-south running 5 m high MSE wall failed during the earthquake. Fill material spilled over the wall. The tarp was installed to prevent precipitation infiltration after the failure.
(N47.22483° W122.46652°; 03/05/2001)

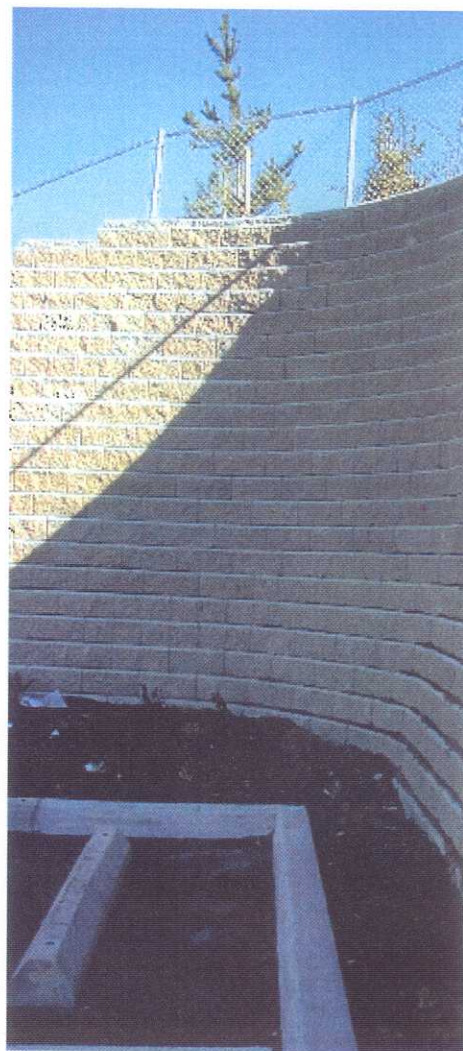
The wall itself appeared largely intact. Moisture was observed seeping through the wall, shown here. A slight bulge was observed at the top of the wall, about half of the width of the wall.
(N47.22452° W122.4667°)

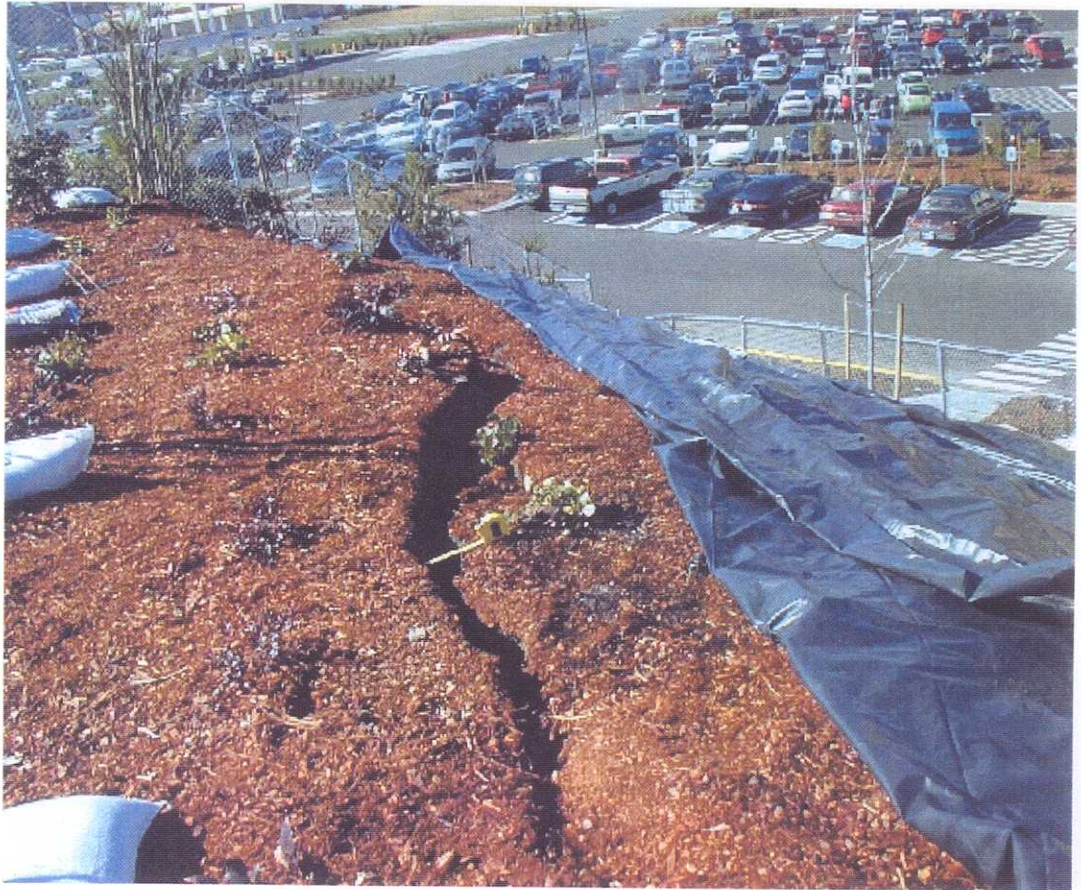
The wedge type failure produced large cracks at the crest of the embankment with horizontal and vertical offsets in the range of 2-3 cm.
(N47.22483° W122.46652°; 03/02/2001)

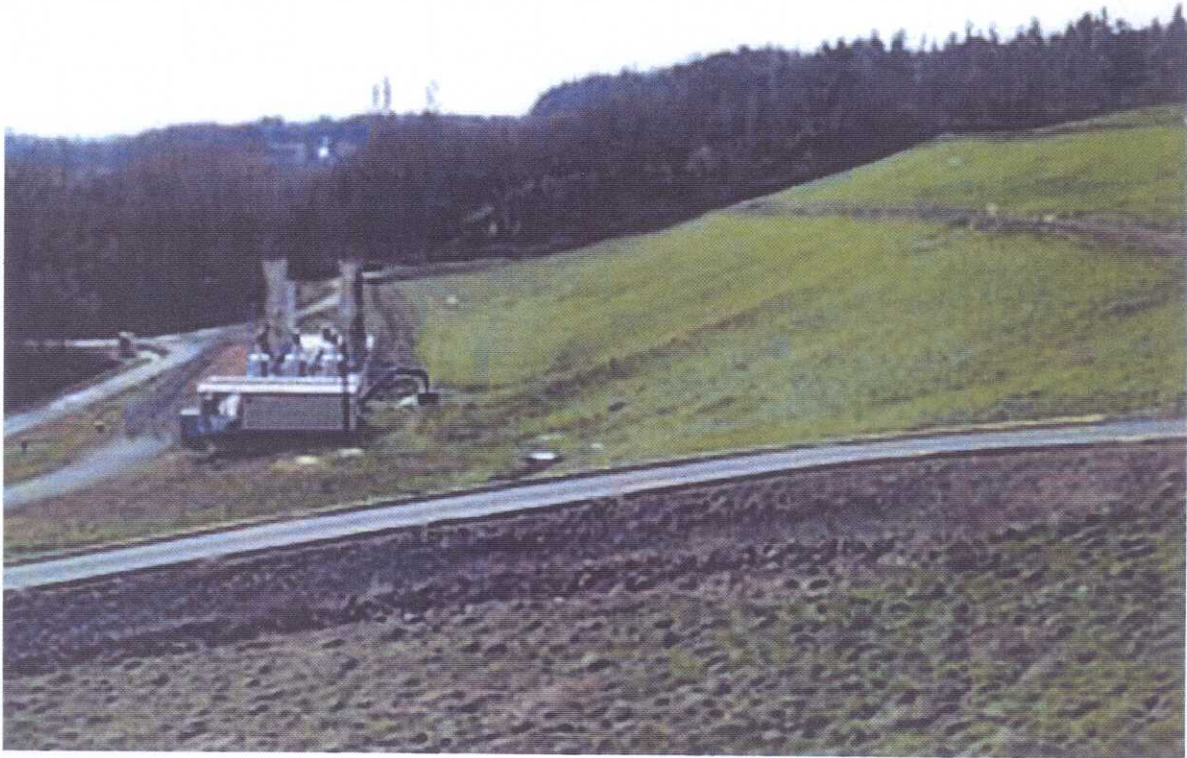
The Kent Landfill generally had fairly flat slopes. However, on the east side these slopes were on the order of 2.5H:1V. The gas extraction system was operating (GPS N47.39191 W122.27612; 1109 03/03/01).

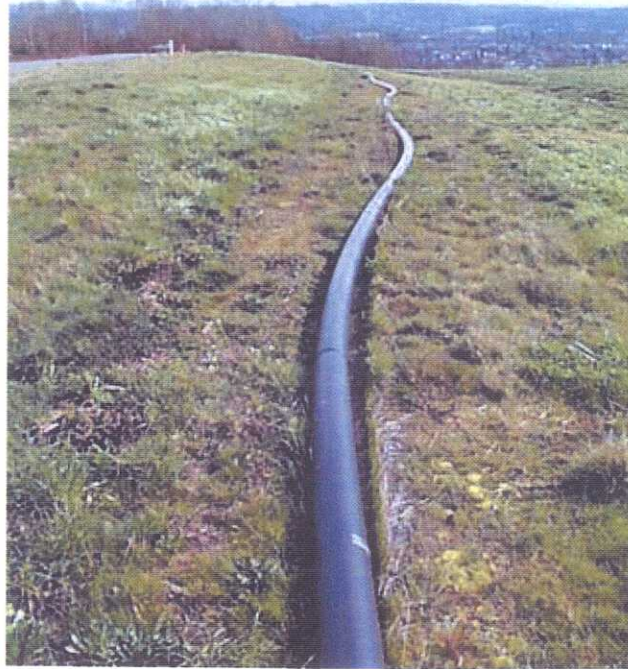
Along the flatter slopes, high density polyethylene piping was used as gas collection piping. This view showing small movements (up to 10 cm) of the piping was typical (GPS N47.39388 W122.28138; 1051 03/03/01).

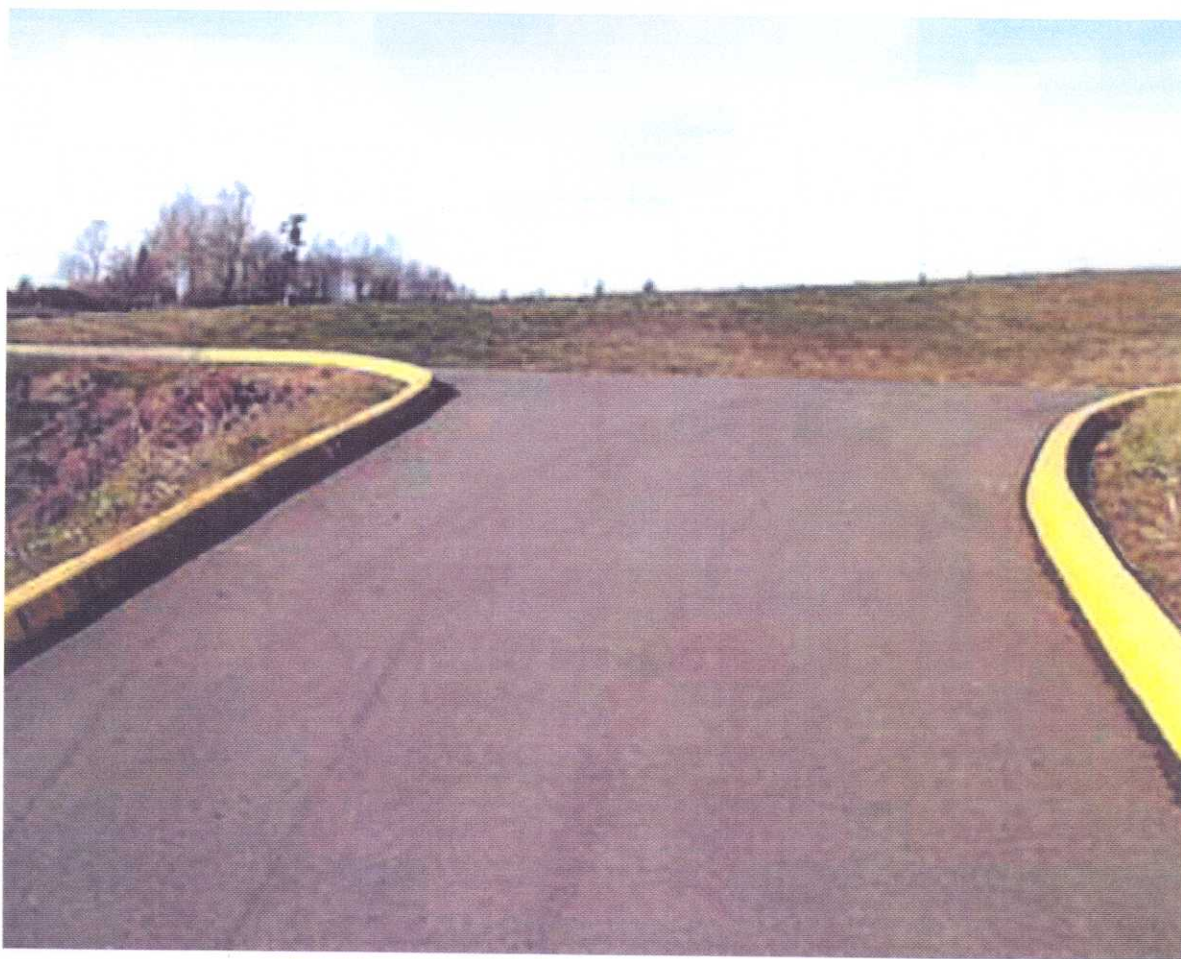
This landfill has asphaltic paving along the cover system. Except on an area at the northeast corner that is adjacent to a very steep slope, no cracking was found anywhere in the paving. The area in the northeast corner has been experiencing long-term deformations as indicated by maintenance efforts (GPS N47.39203 W122.27921; 1103, 03/03/01).

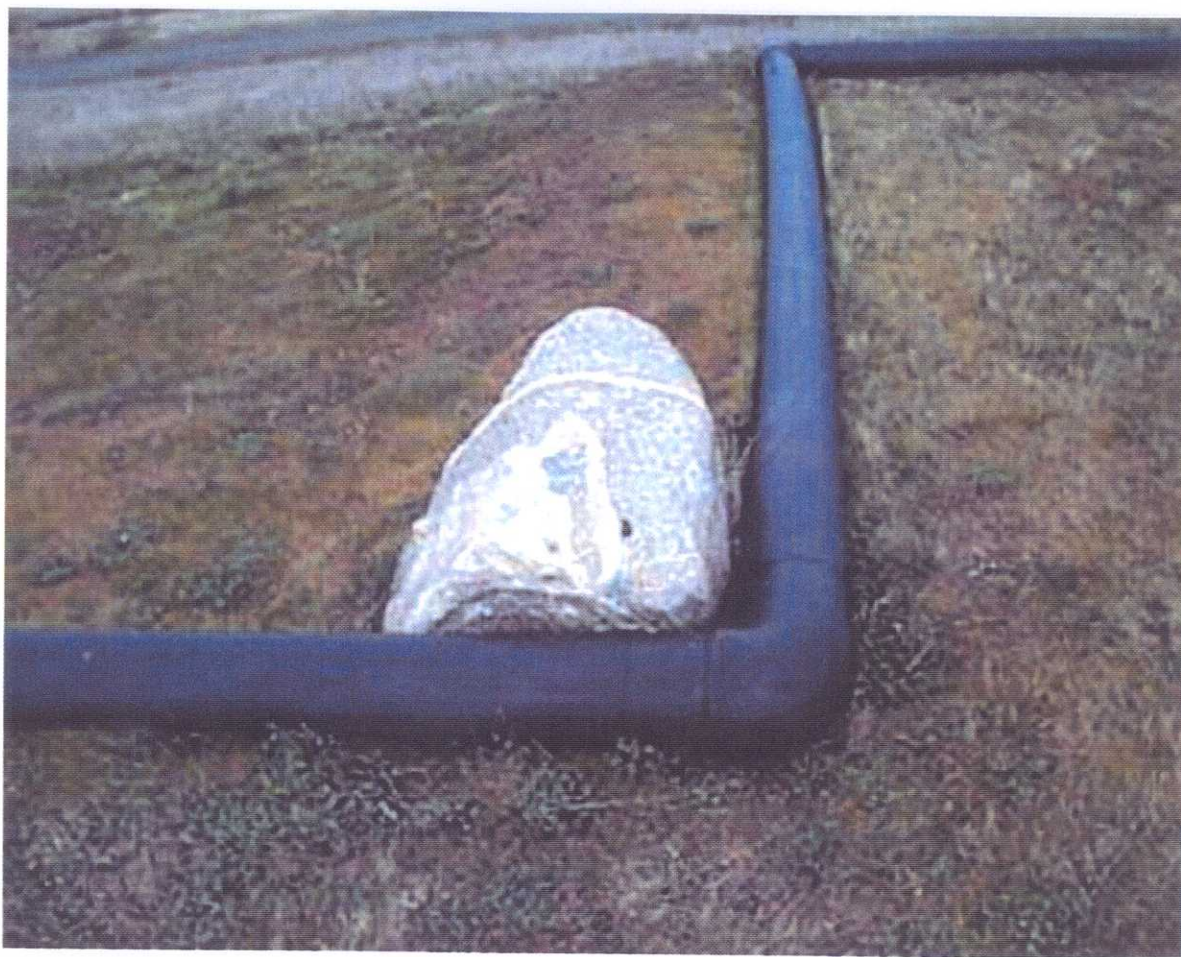
Along the north end, a boulder rested against the HDPE gas collection pipe (GPS N47.38043 W122.29422; 1215 03/03/01).

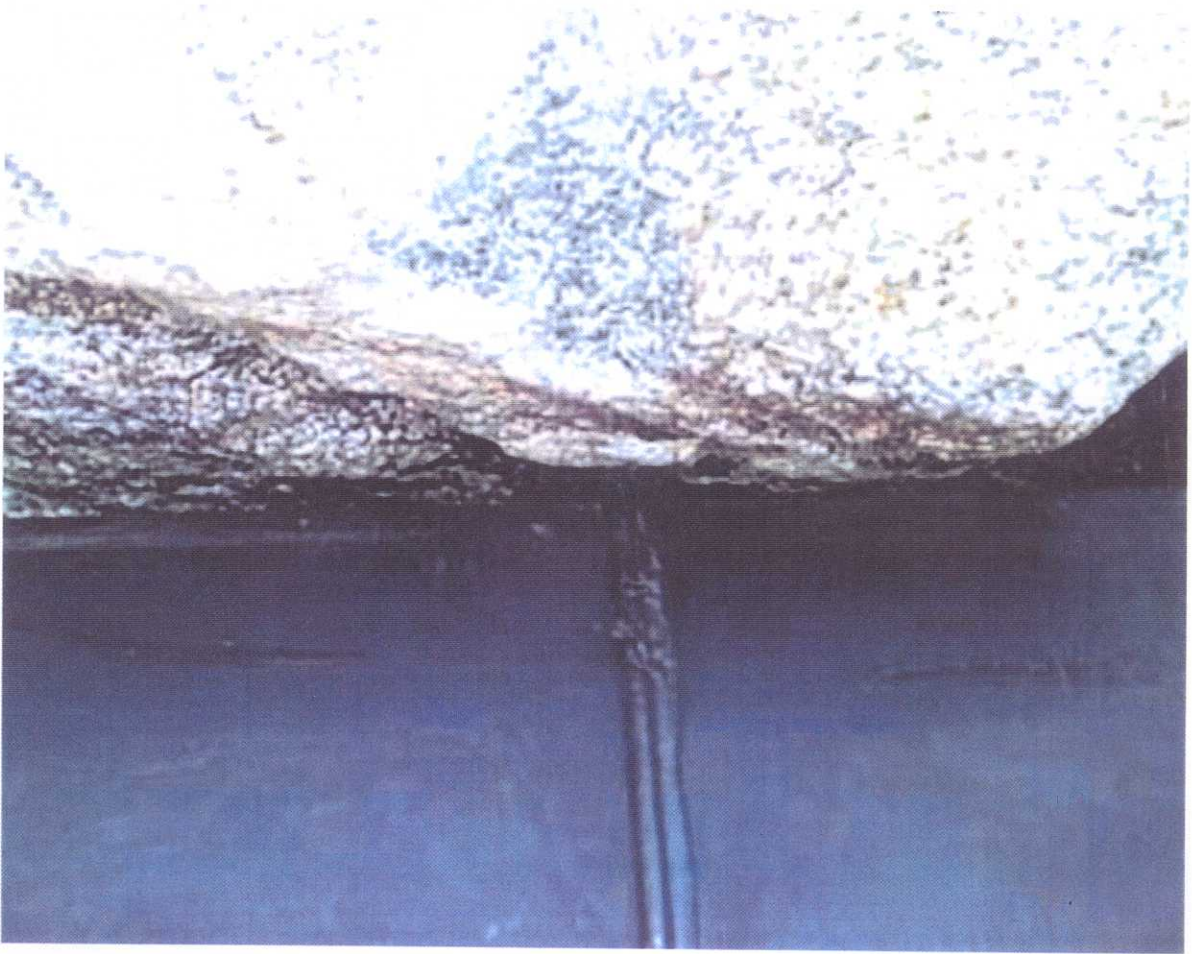
The rock was resting directly at a welded connection. Black marks are visible on the rock indicating relative movement between the rock and the HDPE piping. The rock was momentarily pulled back and the black marks measured. The relative movement was 2.5 cm each way from the point of contact (total movement of 5 cm) (GPS N47.38043 W122.29422; 1216 03/03/01).
