## MEMORANDUM

**RE:** Post-Earthquake Reconnaissance and Photo Documentation  
STIA Third Runway Project  
J-4978-06

This memo and accompanying figures and photographs document observations by Hart Crowser on two occasions following the February 28, 2001, Nisqually earthquake.

**Third Runway Post-Earthquake  
3/2/01 Photo Documentation  
Photo Log Notes**

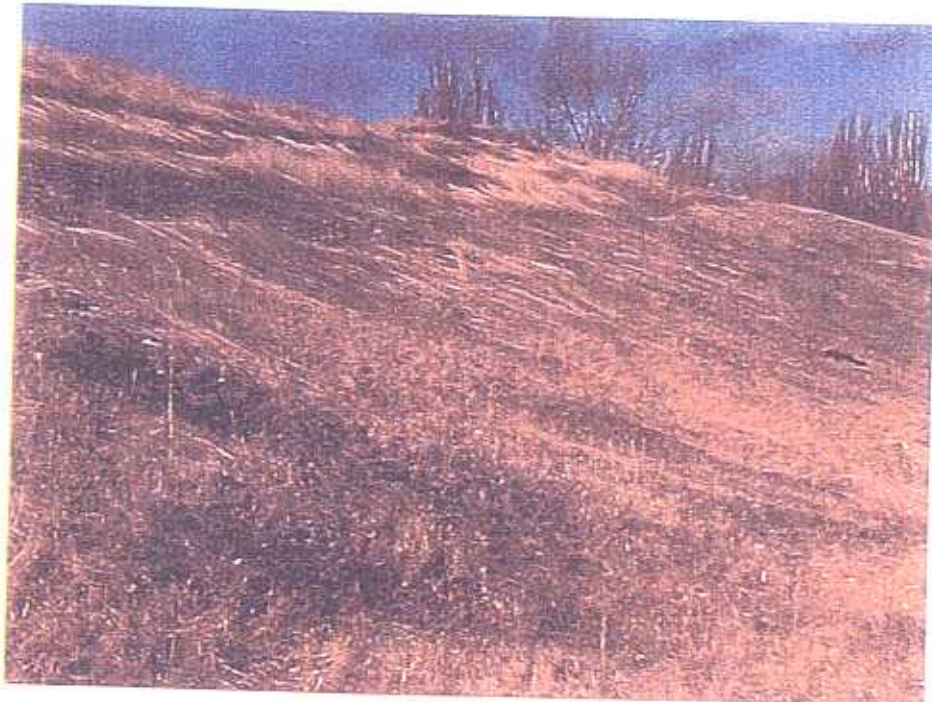
Photograph 4 -

4.	East end (northern half) of 1999 fill. Note: Black spot is visqueen.
5.	North end of 1999 fill (eastern portion).
6.	North end of 1999 fill (central portion).

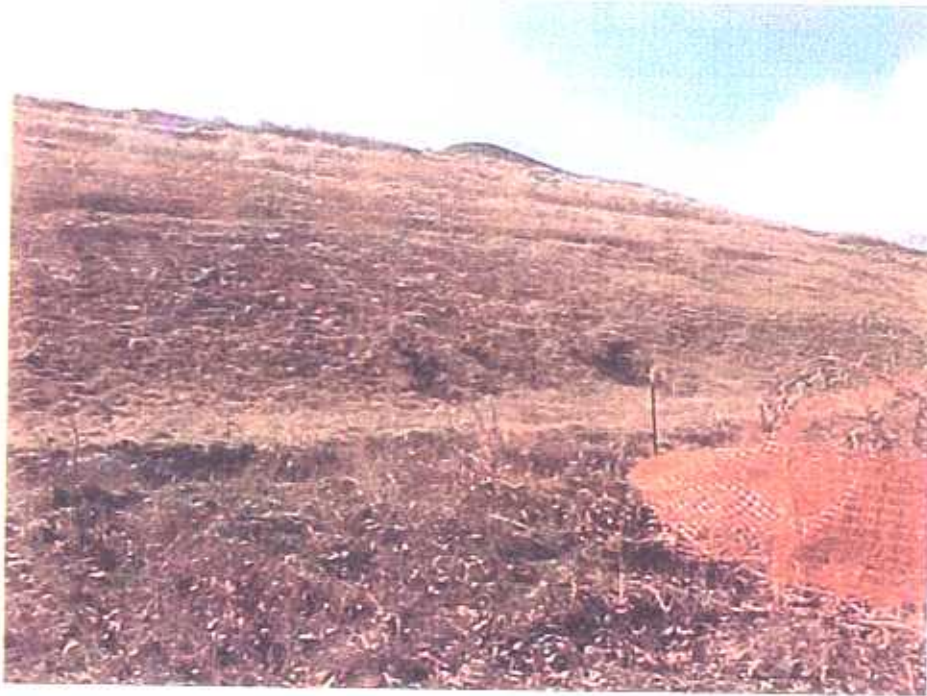
Photograph 7 -

7.	North end of 1999 fill (western portion). Note: Recent Phase 3 stockpile at top.
8.	Northwest corner of 1999 fill.
9.	West end of 1999 fill. Note: Contact with 2000 fill.

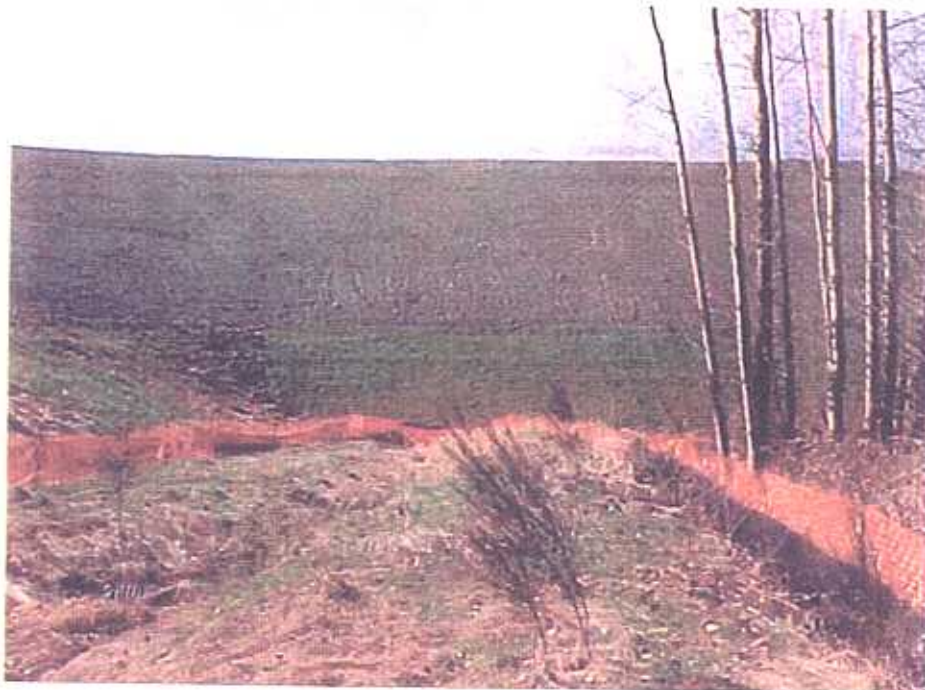
Photograph 12 -

10.	North facing section of 2000 fill from "pocket" wetland.
11.	Same, adjacent to photo 10.
12.	East facing section of 2000 fill from pocket wetland. Note: Minor sloughs on north facing area contain growing material and/or recent hydroseed (i.e., predate earthquake).

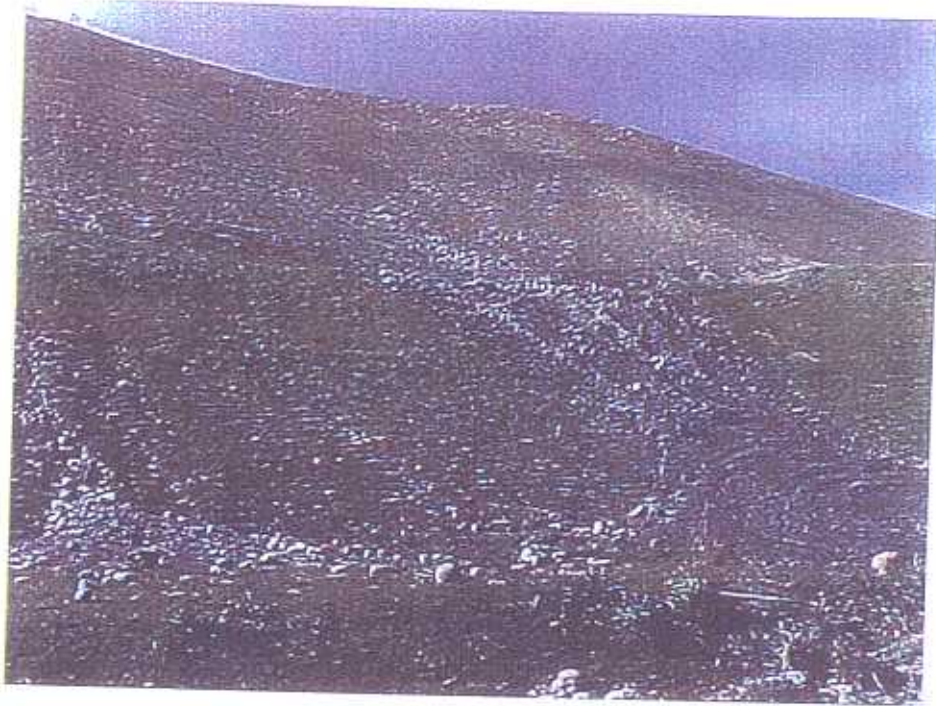
Photograph 13 -

13.	Northeast facing portion of 2000 fill. Note hydroseed on previously sloughed area.
14.	North extension - east face of 2000 fill - minor sloughs preceded earthquake.

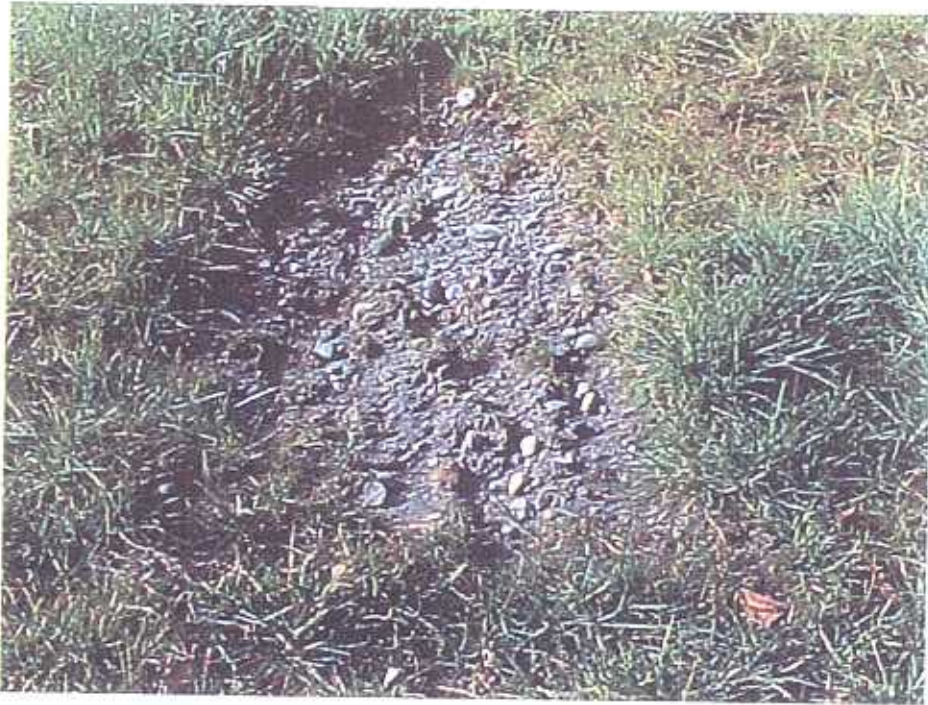
Photograph 15 -

15.	Close up of old slough area on east face of north extension on 2000 fill. (Note: Grass growing in and below slough indicates pre-earthquake condition).

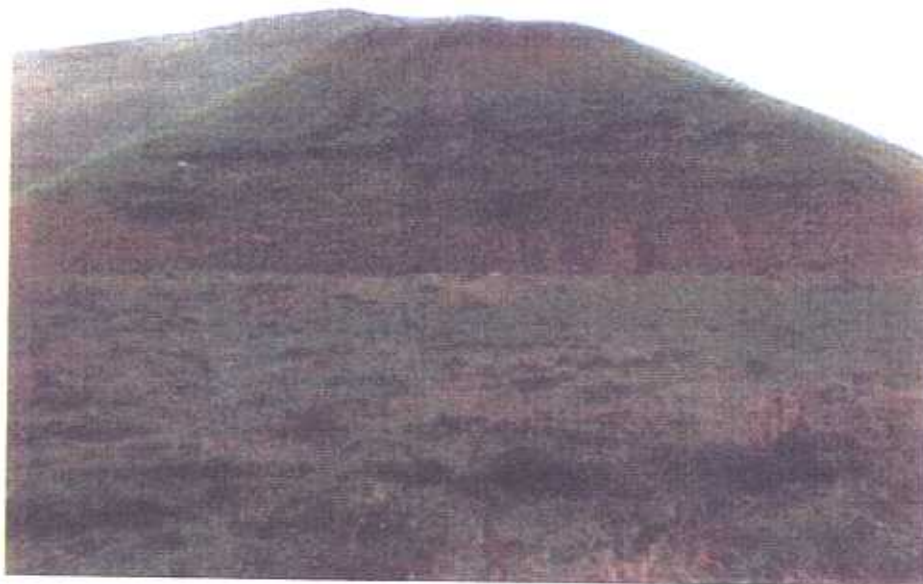
Photograph 16 -

16.	North end of north extension of 2000 fill, slough has grass growing in it.
17.	Northwest face of north extension of 2000 fill.
18.	West face (north end) of 2000 fill - hydroseed existing in all slough areas.

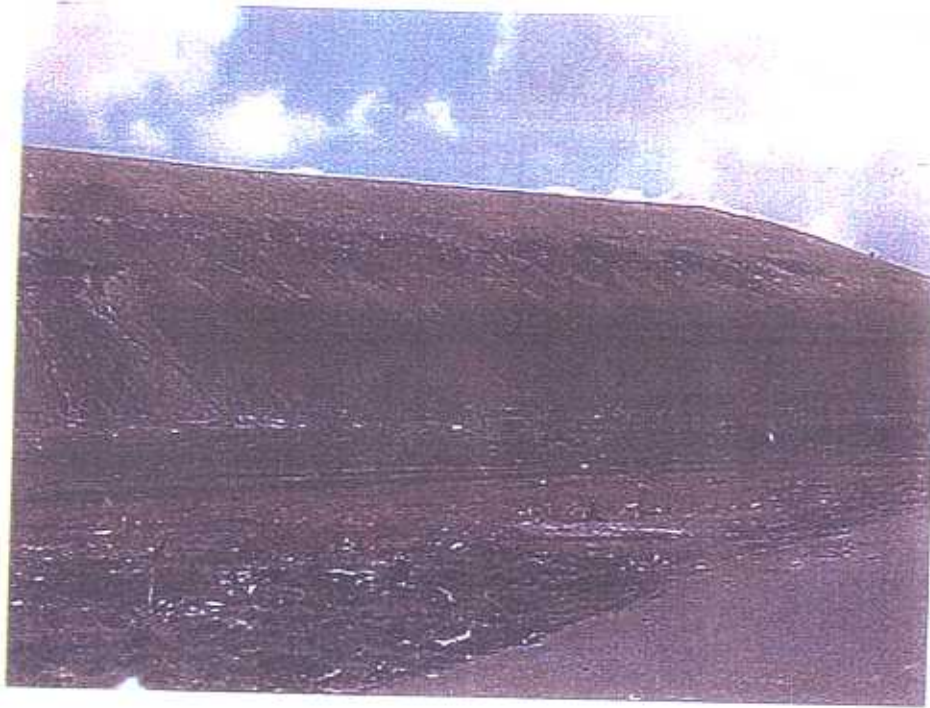
Photograph 19 -

19.	West face of bulk of 2000 fill - hydroseed existing in all slough areas. Note: Cobble layer on surface left from construction.
20.	West face of 2000 fill.

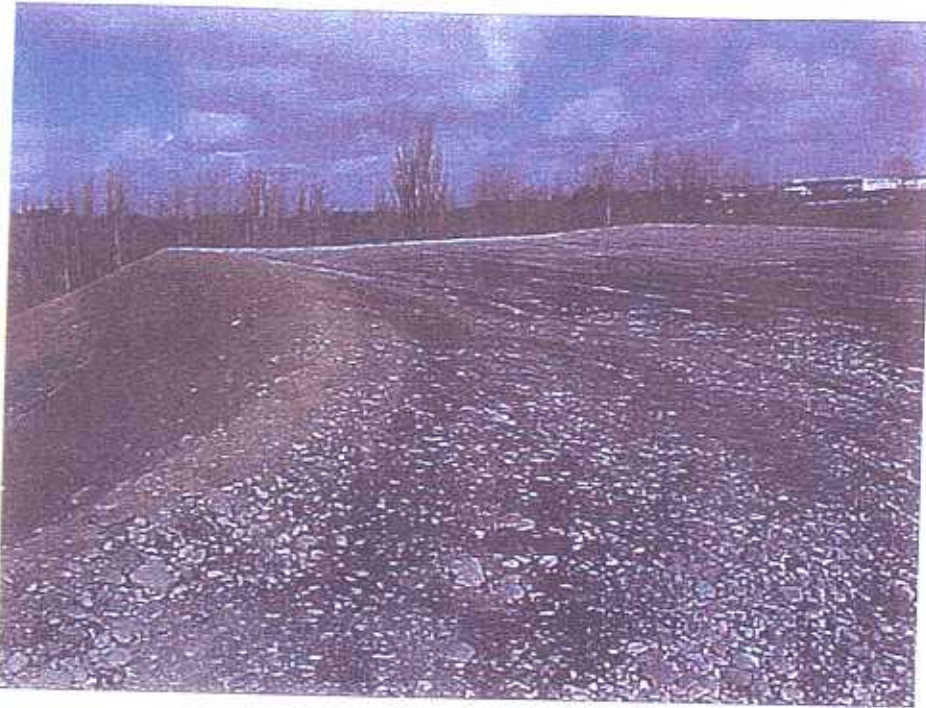
Photograph 23 -

Photo Number	Description of Photo and Notes
22.	South face of 2000 fill.
23.	Surface of 1999/2000 fill looking north above 1999 fill - no cracks.
24.	Cobble spoil from construction on west face as viewed from above. Note: Hydroseed on the new fill (Winter 2000/2001) has not yet sprouted.

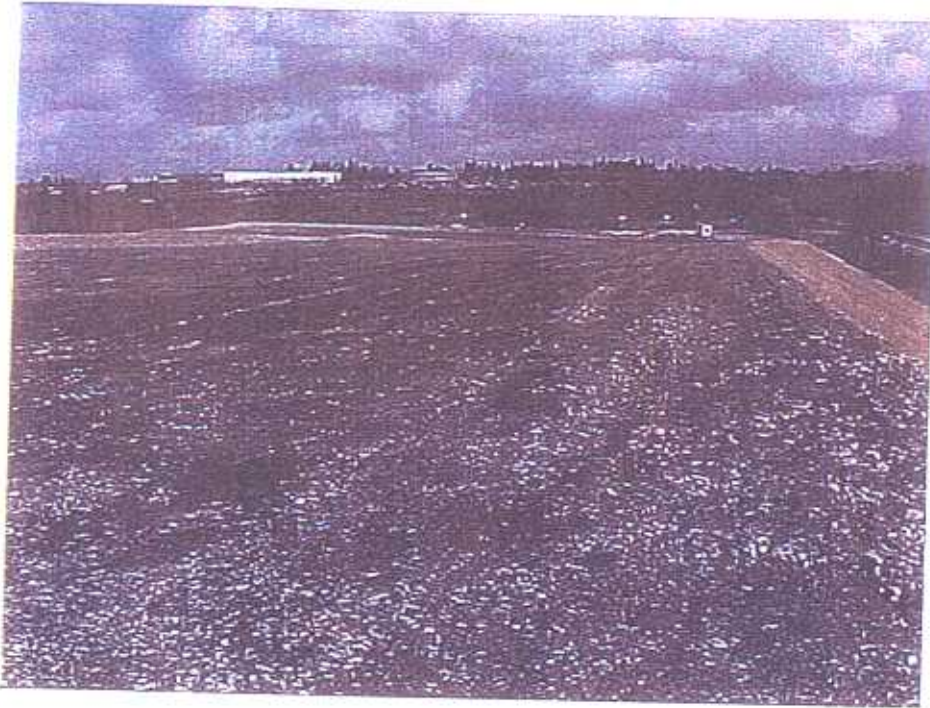
Photograph 25 -

25.	Surface of 2000 fill - no cracks observed.
26.	AOA fill - north face from 2000 fill.
27.	AOA fill - west face from 2000 fill.
28.	2001 fill - south side.

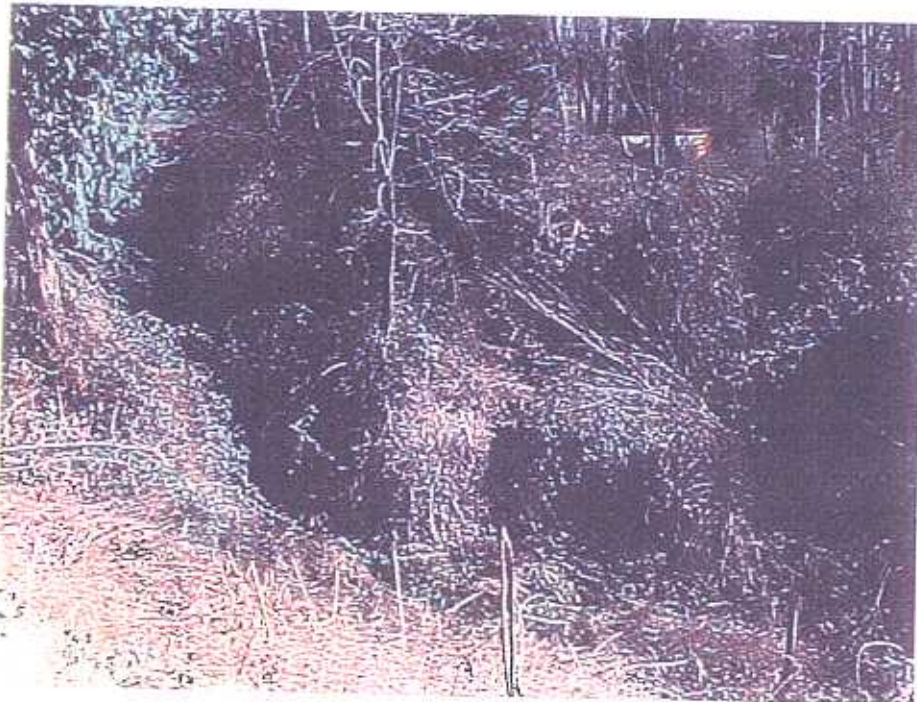
Photograph 42 -

40.	West Wall area, note proposed wall stakes.
41.	West Wall area.
42.	South wall area, pre-existing steep sided gully feature.

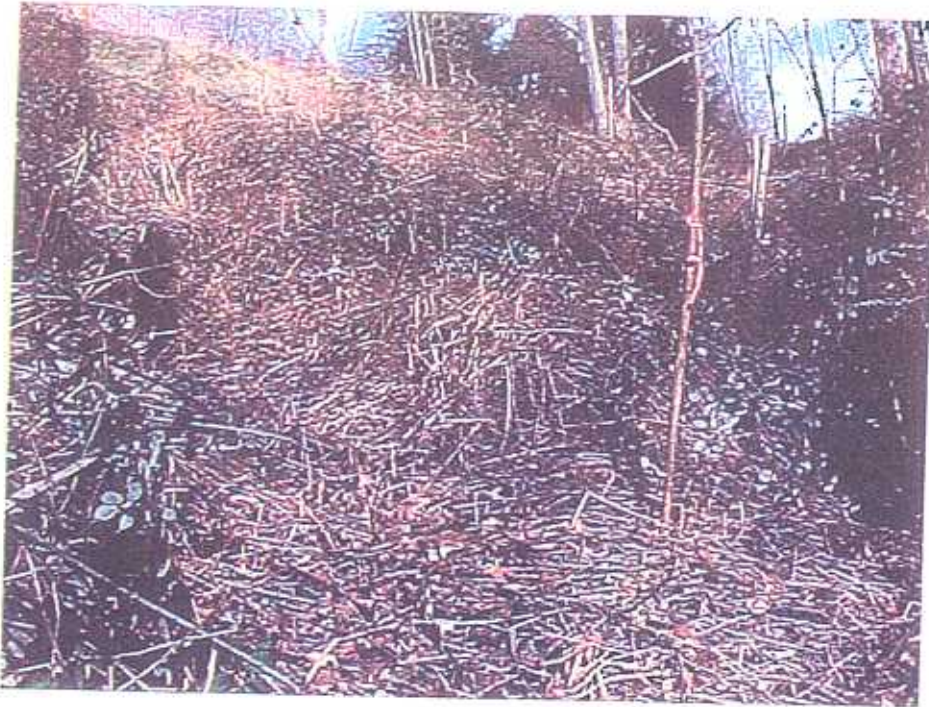
Photograph 43 -

Photo Number	Description of Photo and Notes
43.	South wall area, pre-existing steep sided gully feature.
44.	South end AOA fill, west face, southern end.

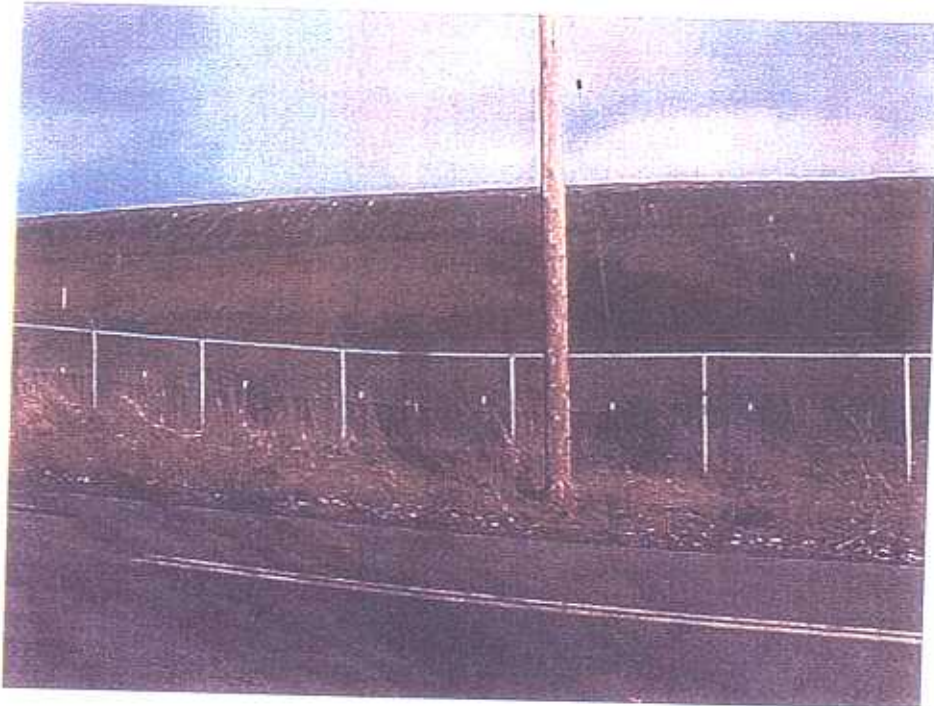
Photograph 45 -

45.	Just north of photo 44. Note: Minor slough features have new grass growing in them.
46.	South end of AOA fill, west face - looking at northern end. Minor sloughing, apparently predates earthquake based on vegetation.

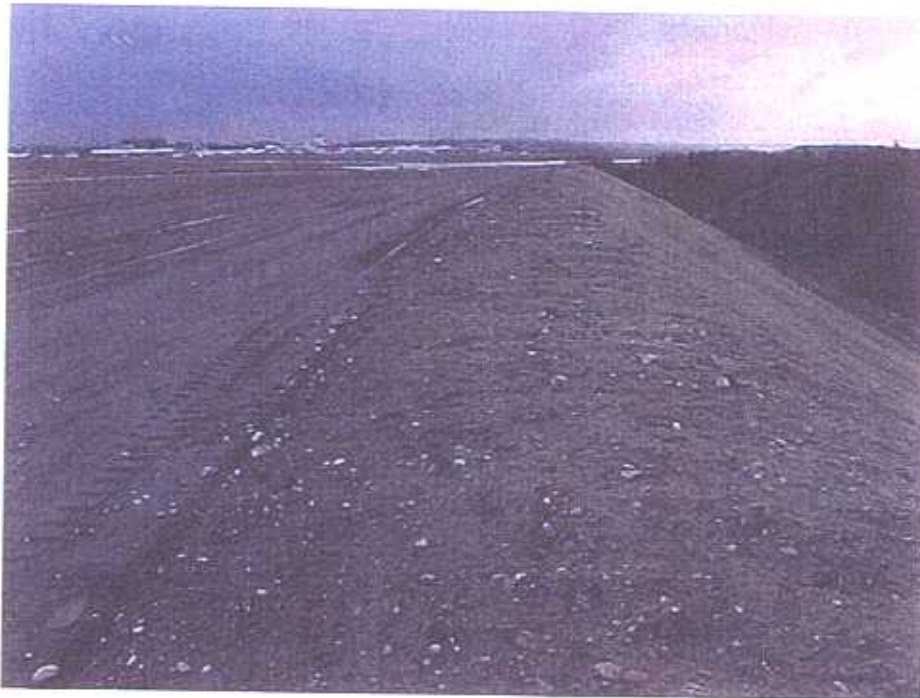
Photograph 52 -

50.	Same, just south of photo 49.
51.	West face of AOA fill looking north.
52.	Surface of southwest face of AOA fill - no cracks.
53.	Surface of west face of AOA fill - no cracks.
