Some Typical Examples Of Port Package Problems

These are examples which attempt to capture the various *types* of Port Package issues that cannot be attributed to normal wear and tear or 'user-error'. The distribution of problems is roughly equal throughout the geographic area where Port Packages have been installed, although the *types* of problems occasionally vary due to a particular product and contractor.

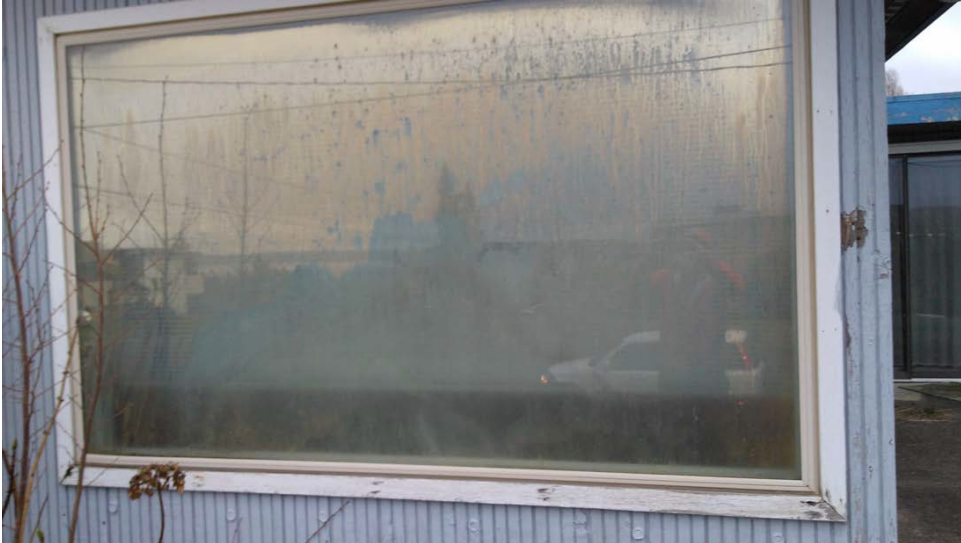
Two examples of very typical exterior mold (aka 'Mr. Lee'). This not 'dirt'. **Over time it becomes so pervasive as to impede visibility.**

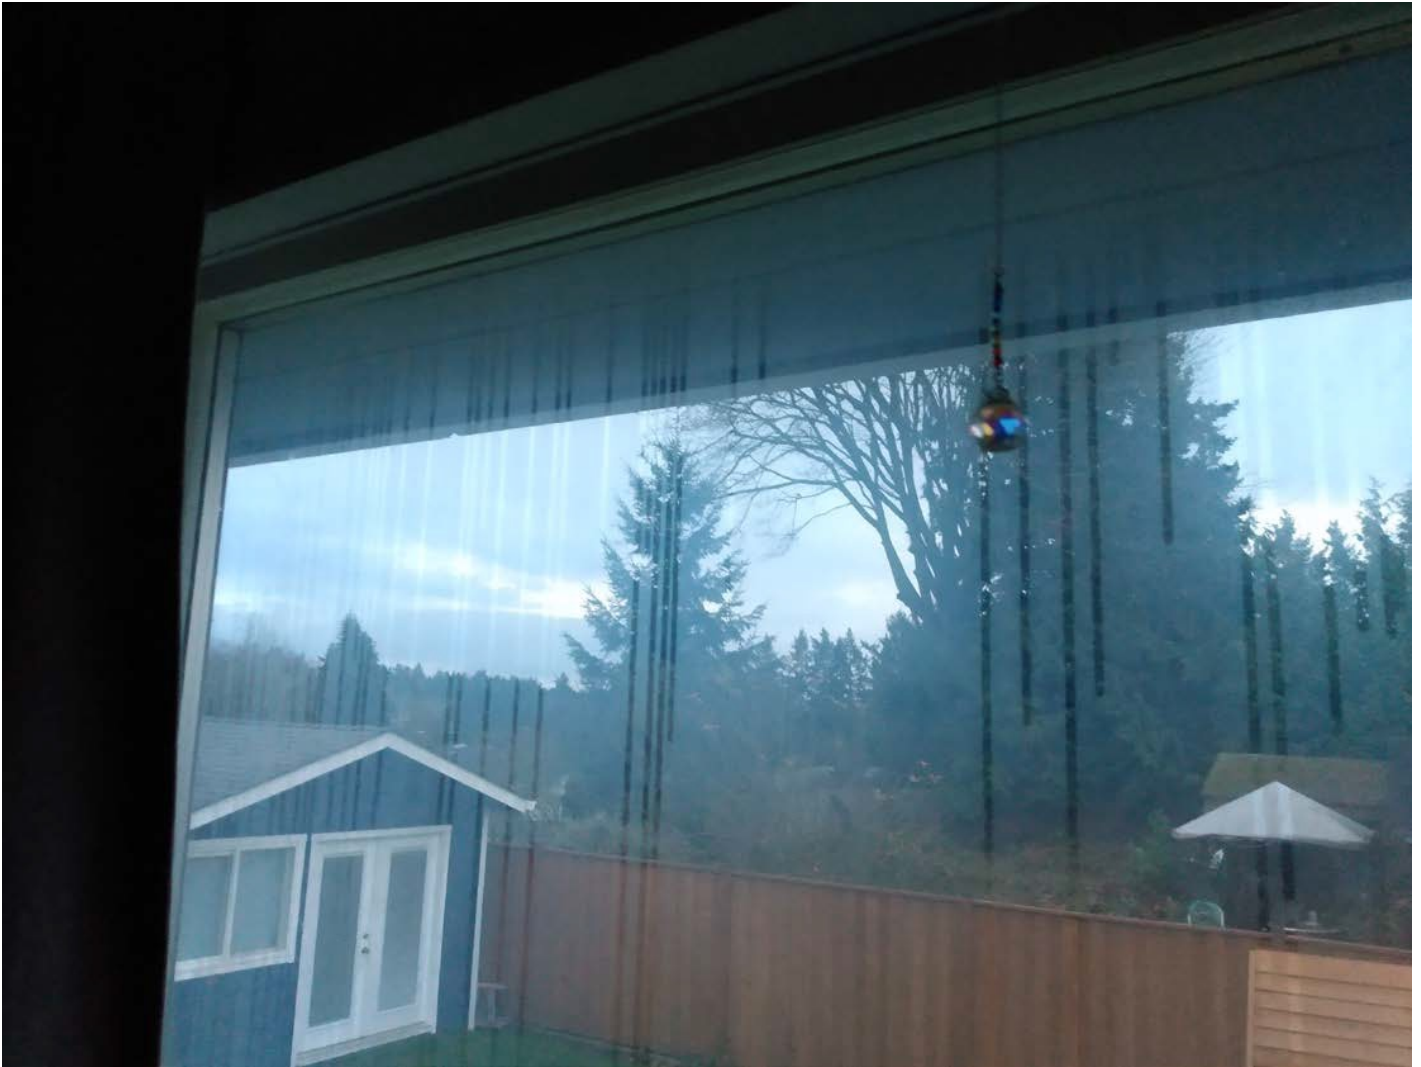
This is a very common problem. **This is not condensation. It is active water leakage *between* window panes and onto sill and into interior space.**

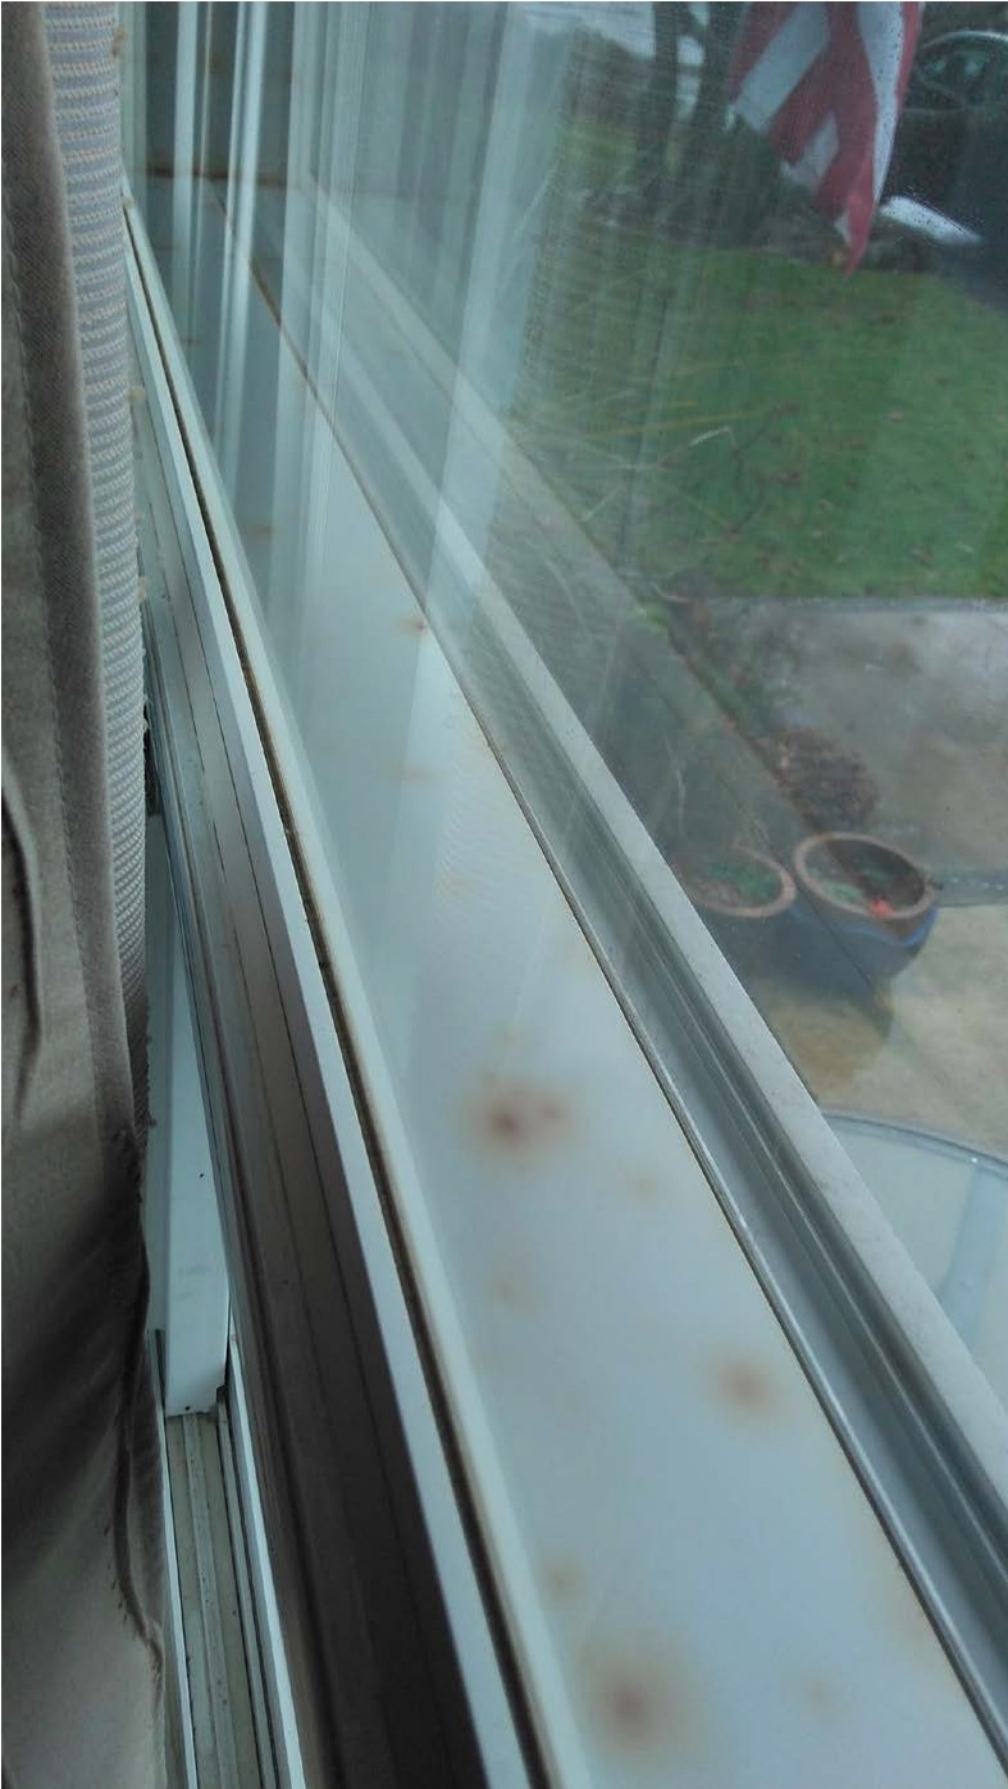
This kind of brown mold spotting is another common variant that will appear on every window in the home. It cannot be cleaned as it is imbedded into the window.

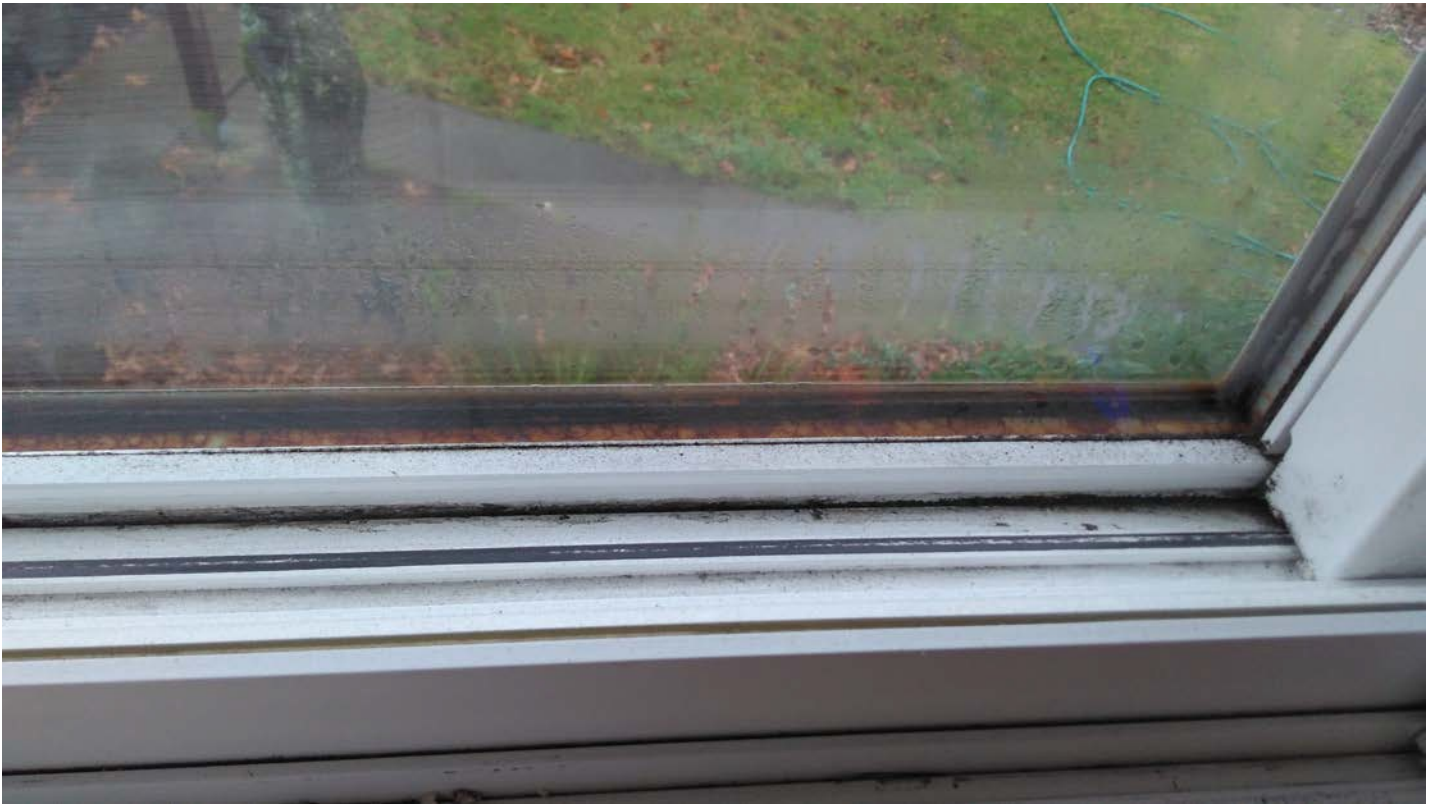
Corrosion. Once water finds a path between the panes, this becomes inevitable.

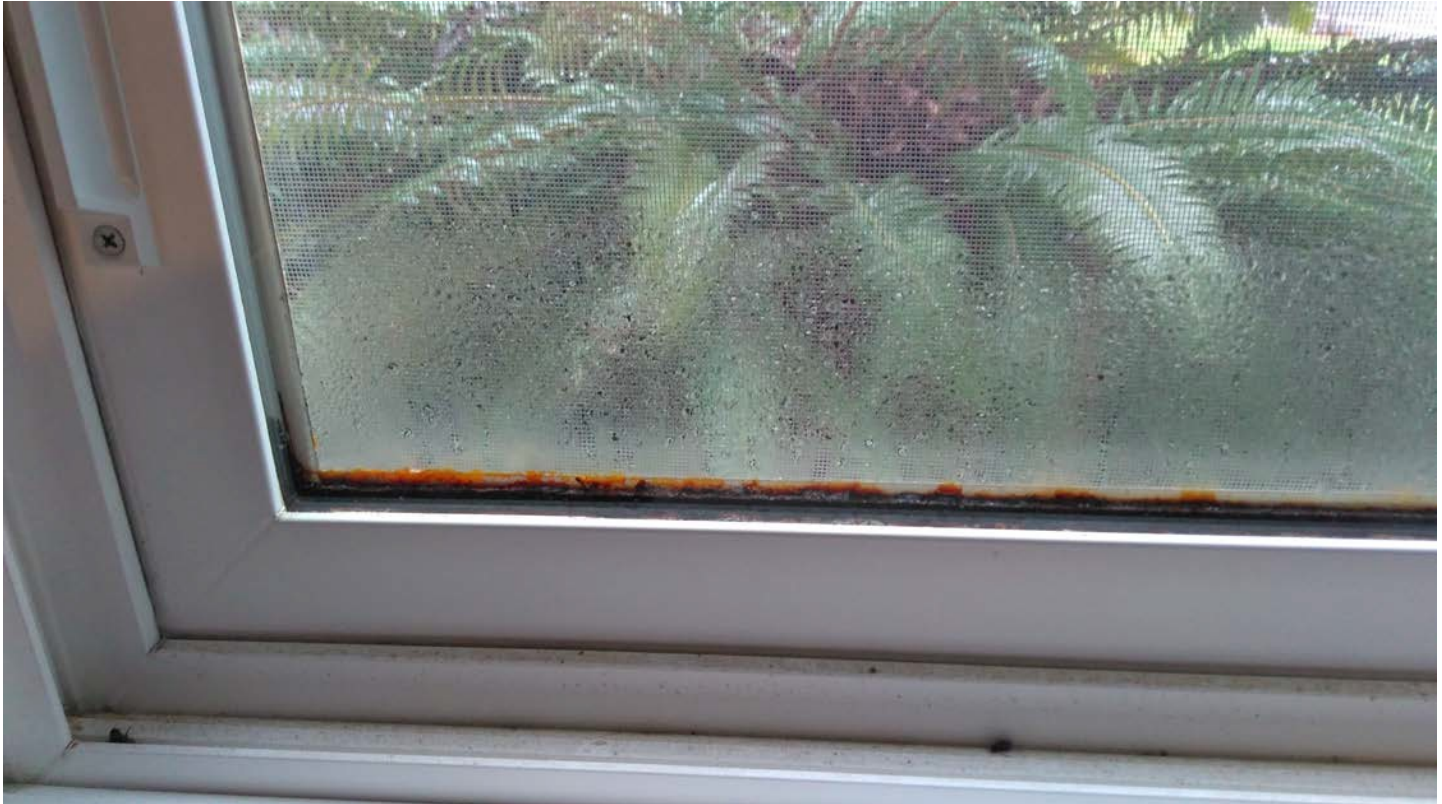
Typical 'Alpine Corrosion' and then water between panes going onto frame and sill.

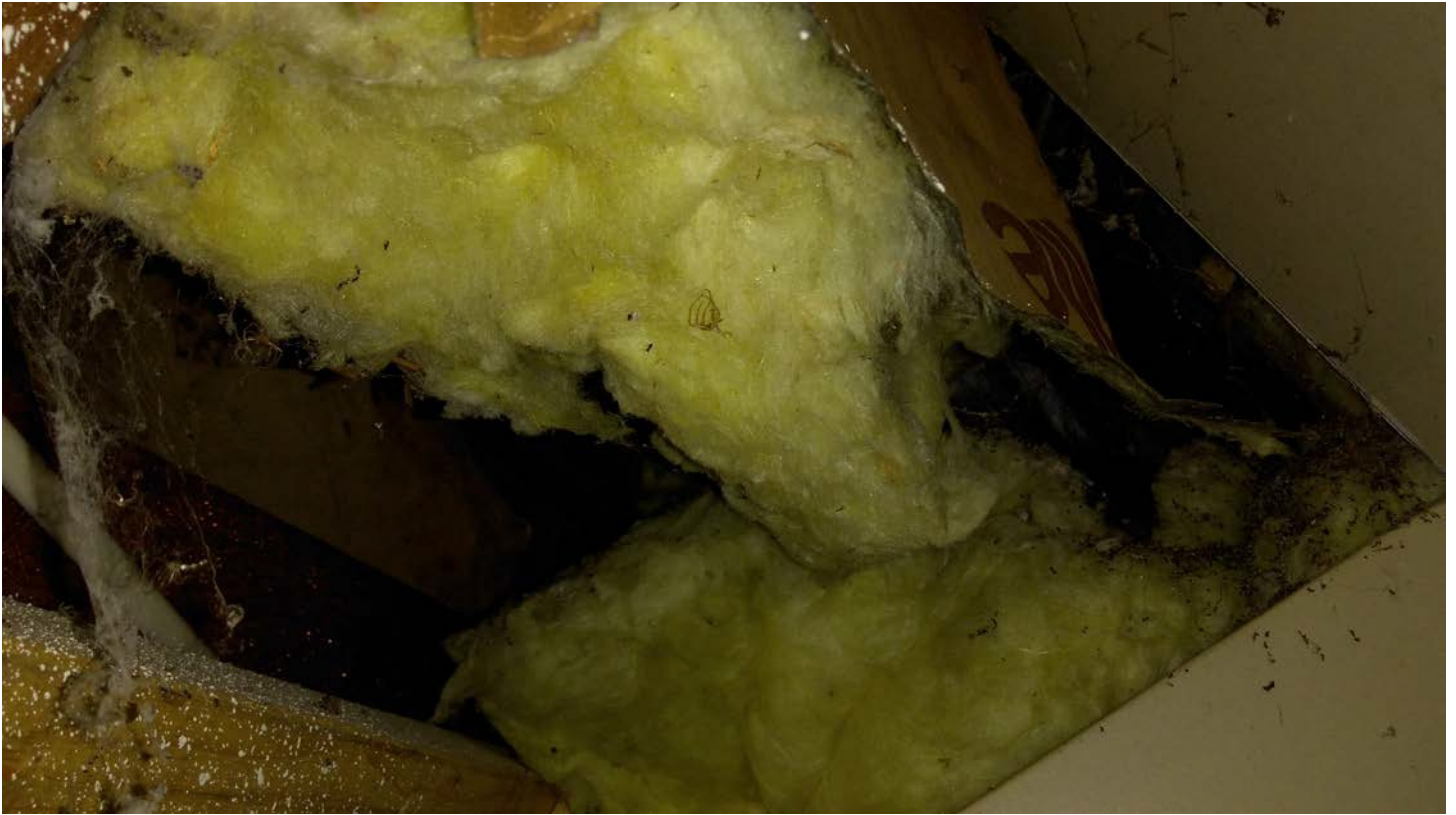
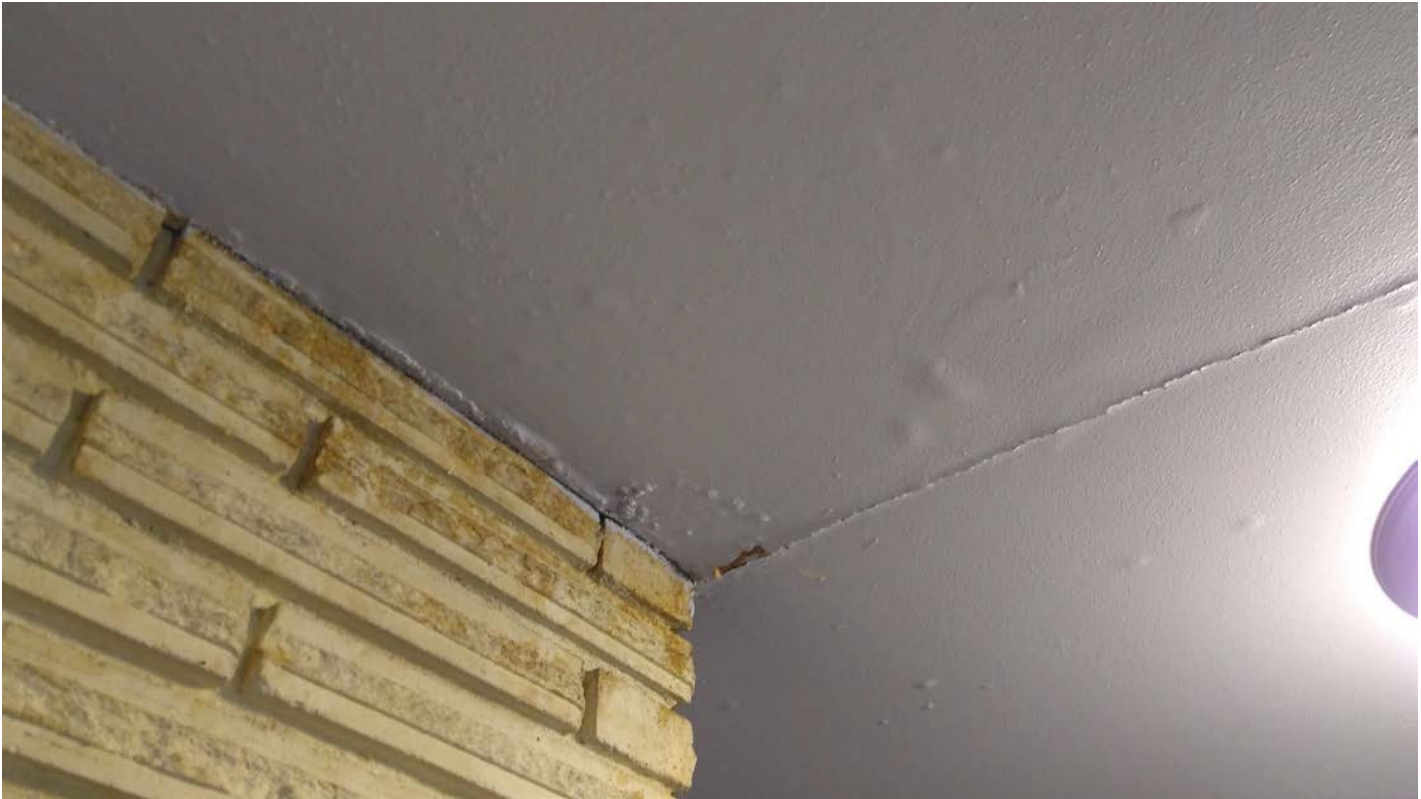
Black mold in attic Port Package-specific high density ceiling insulation. Many homes with this type of insulation develop moisture issues in the attic due to poor ventilation/HVAC design. This causes moisture which has migrated into the ceiling in the lower photo. **At minimum, this requires replacement of both insulation and ceiling.**
