**DRAFT
TECHNICAL MEMORANDUM**

**ANALYSIS OF PREFERENTIAL GROUND WATER
FLOW PATHS RELATIVE TO
PROPOSED THIRD RUNWAY**

SEATTLE-TACOMA INTERNATIONAL AIRPORT

**AESI PROJECT No. BV99122C
JUNE 19, 2001**

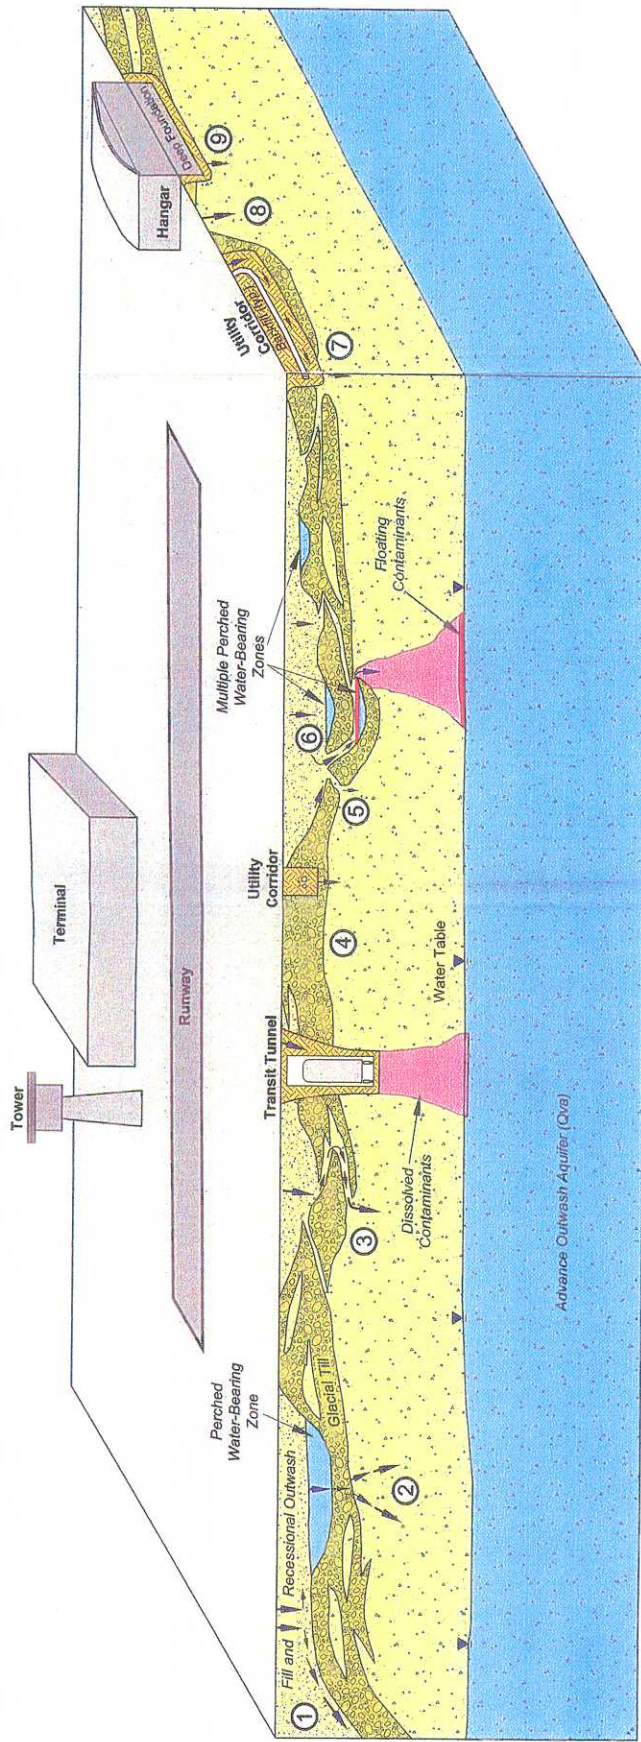
Within the AOMA, areas of contaminated ground water exist in both shallow perched zones and in the Qva. The perched zones are isolated and discontinuous, while the Qva is continuous. Figure 1 is a conceptual diagram illustrating the typical hydrogeologic properties and relationships below the AOMA. Figure 1 significantly simplifies typical conditions, but identifies key features:

- Perched Zone – The perched zone is discontinuous and is present in isolated areas of the AOMA. Perched ground water may appear on local till surfaces (where present) and may also collect in interbeds and lenses within the till. Therefore, multiple discontinuous perching “layers” are frequently identified as discrete water bearing zones within the same area. To the extent there is horizontal perched flow, it is typically localized and flows along the top surface of the till unit, but becomes more vertical at the edge of perching surface; there is no regionally extensive predominant horizontal perched flow direction. Typical low permeability geologic units (glacial till), that result in perched ground water conditions, are located from the near surface to about 40 feet below ground surface (about 10 to 32 feet below ground surface below most AOMA contaminated sites); the unsaturated region between the perching zone and ground water surface in the Qva is approximately 20 to 50 feet thick. Glacial till and perching conditions are not uniformly present below the AOMA. Till is absent in some locations due to natural processes, as well as construction related activities (such as deep excavations for building foundations, excavation for transit tunnels, and site grading activities) which appear to have breached the till unit at several locations at STIA.

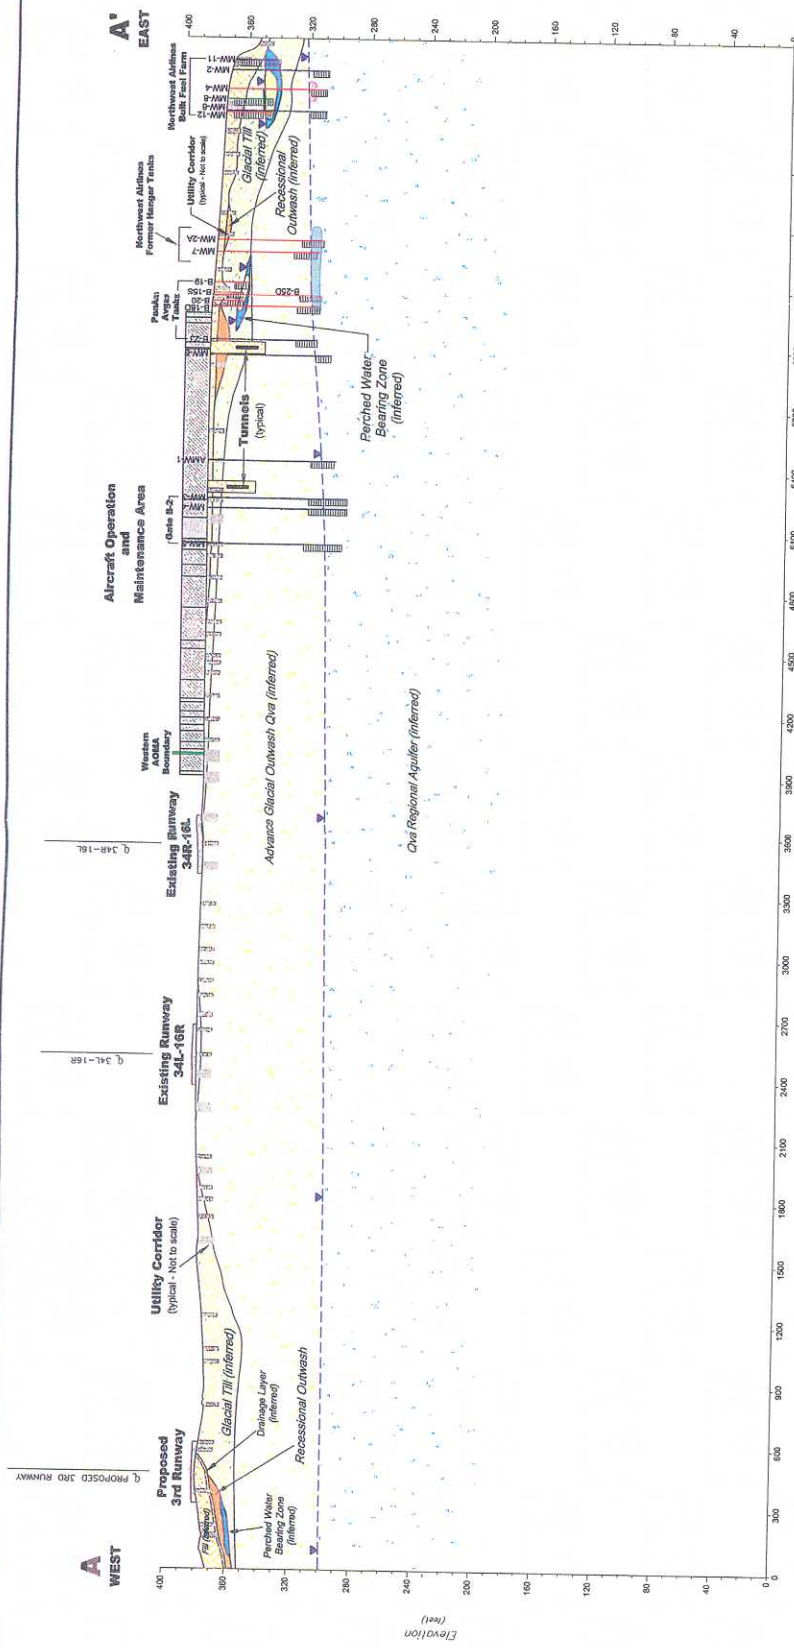
- Figure 6 – Figure 6 is a conceptual cross section that shows a generalized representation of geologic formations, ground water conditions, typical STIA utility trench depths, monitoring well completion details and general AOMA site features. The cross section is developed from the eastern boundary of the AOMA past the western end of the proposed Third Runway embankment, oriented generally parallel to the Qva ground water flow direction. Isolated perched ground water zones are identified within glacial till horizons within the AOMA and in recessional sandy outwash soils near the proposed Third Runway horizon. The inferred thickness of the glacial till horizon has been determined based on available subsurface soil data compiled throughout STIA. These data indicate an irregular till surface with variable thickness and show several areas along the cross section where the till unit is absent as a result of either natural processes or construction activities.

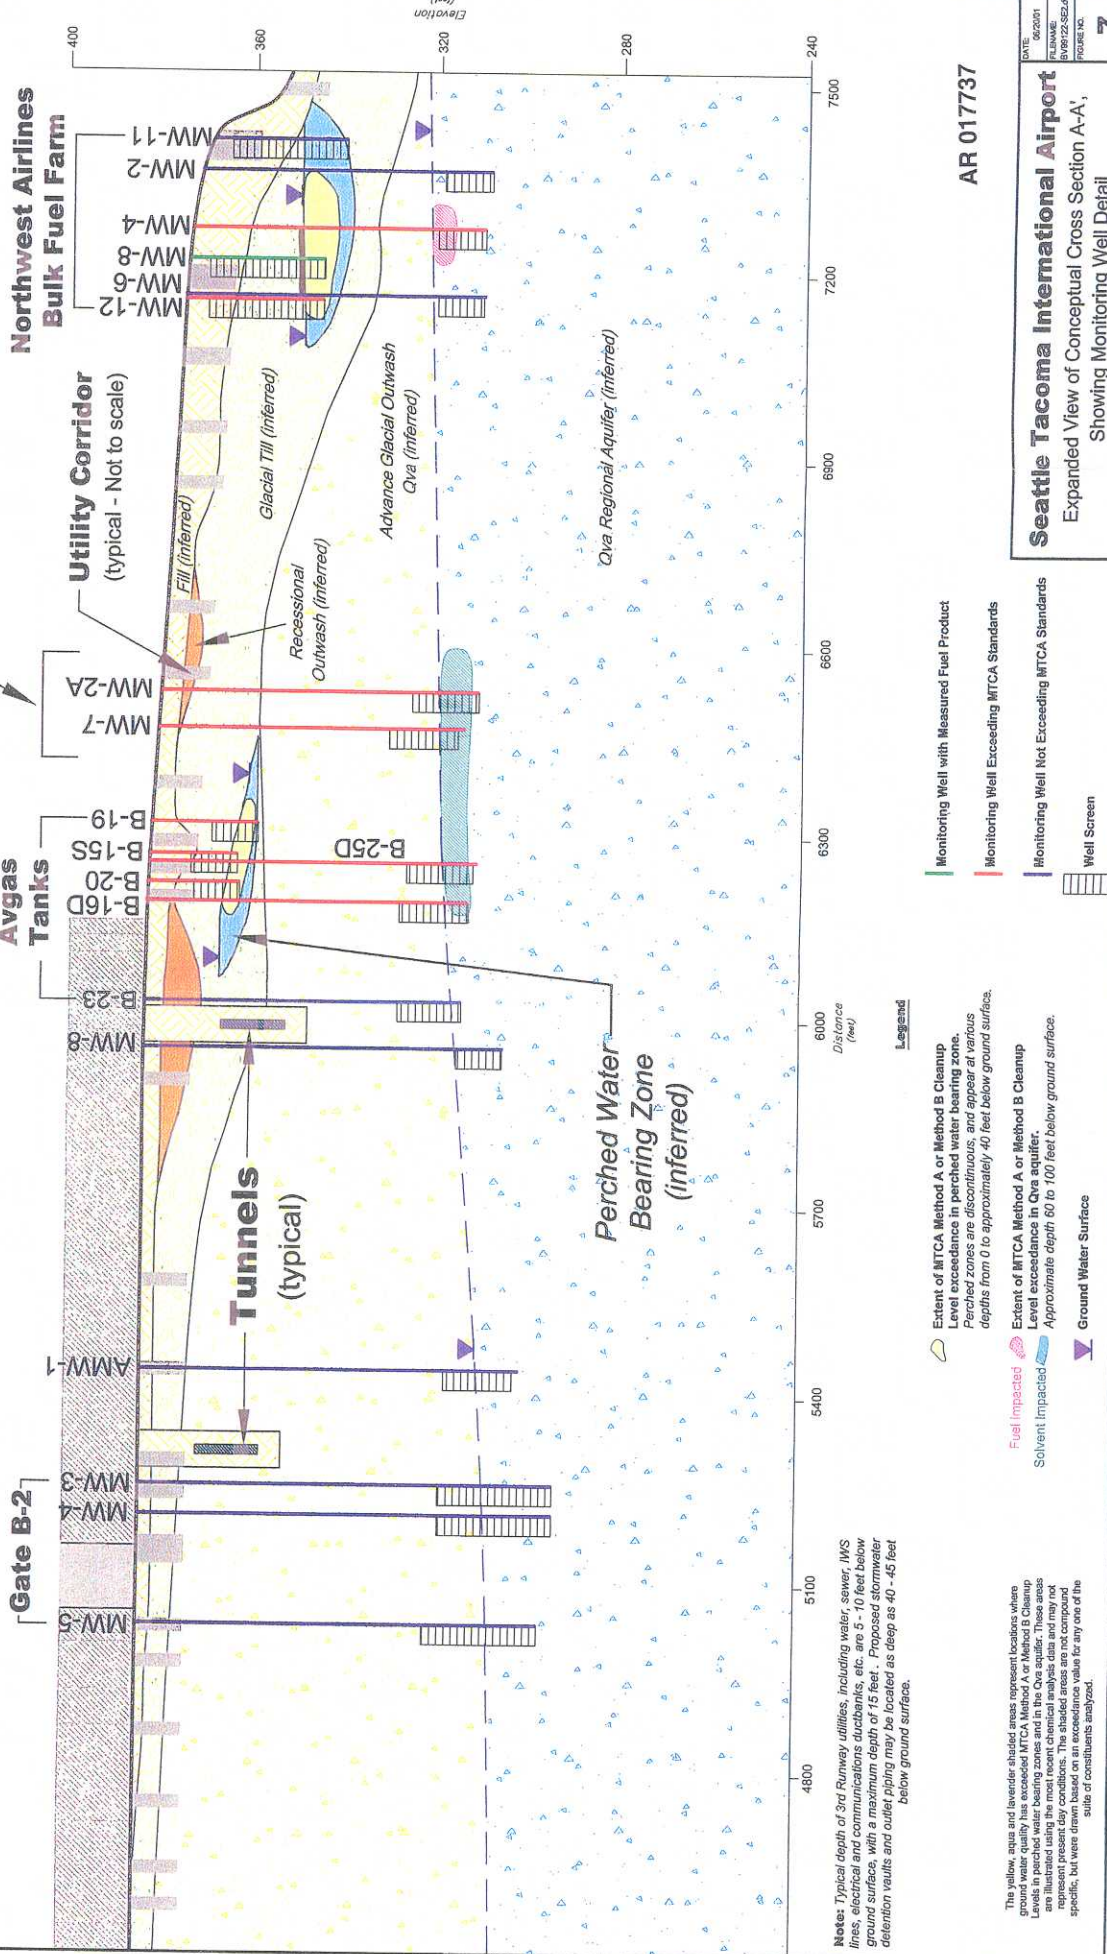
Seattle Tacoma International Airport
Expanded View of Conceptual Cross Section A-A',
Showing Monitoring Well Detail

- Figure 7 – Figure 7 presents an enlargement of the Figure 6 cross-section through the AOMA area. The enlarged cross section is developed through the Northwest Bulk Fuel Farm and the Pan Am Avgas Tanksites, areas where impacted perched ground water has been characterized. The perched ground water observed at the Pan Am Avgas Tank site represents the western-most area within the AOMA that contains impacted perched ground water exceeding MTCA standards. The cross section shows wells completed in the perched horizons at both the Northwest Bulk Fuel Farm and Pan Am Avgas Tank sites and indicates the perched water level elevation as shown by the blue triangle. Utility lines are shown on the cross section, which are positioned at a typical construction depth of 10 feet.
