**ANALYSIS OF PREFERENTIAL GROUND WATER
FLOW PATHS RELATIVE TO
PROPOSED THIRD RUNWAY**

SEATTLE-TACOMA INTERNATIONAL AIRPORT

**PREPARED FOR:
PORT OF SEATTLE**

**AESI PROJECT No. BV99122C
JUNE 19, 2001**

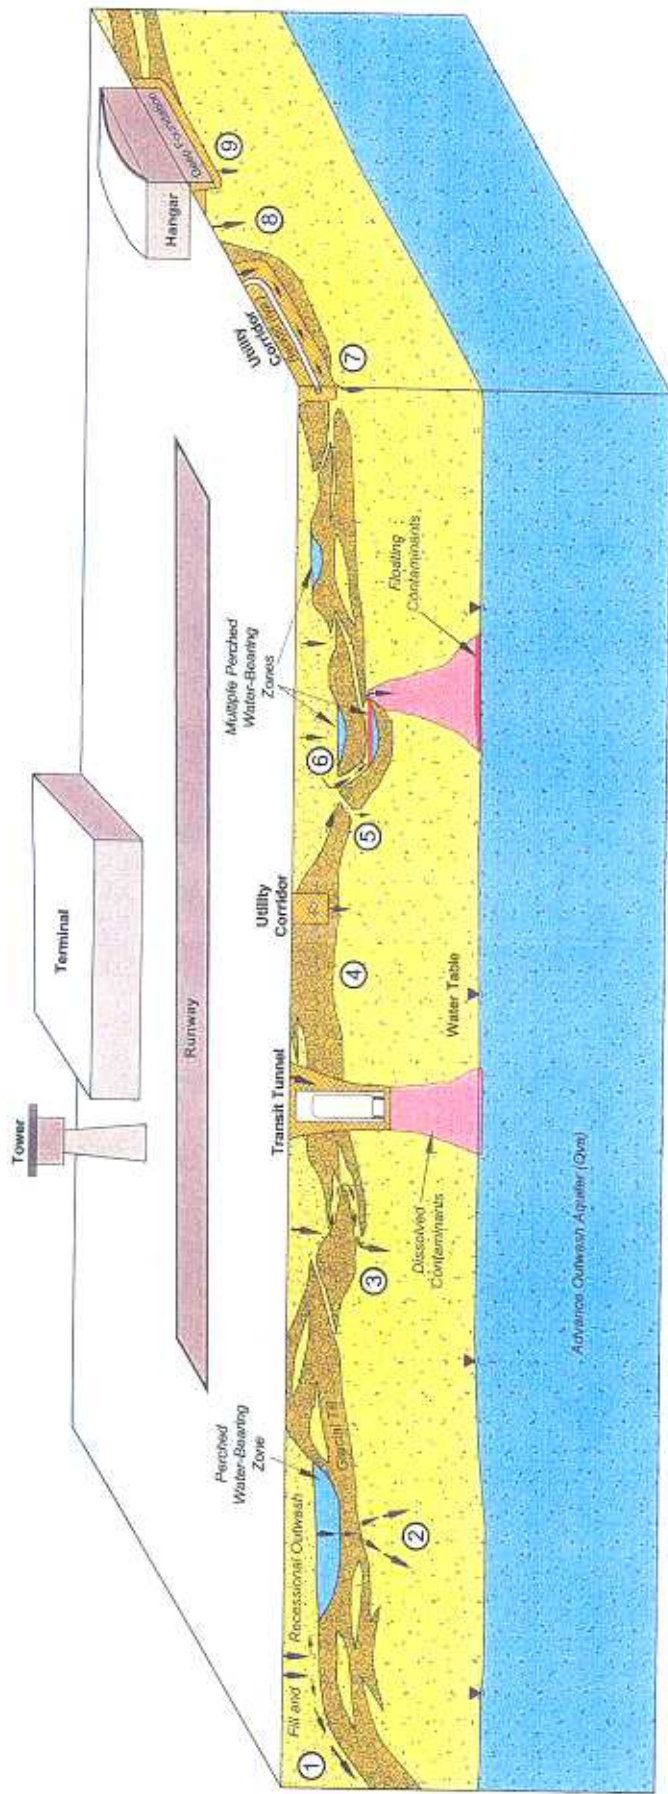
Within the AOMA, areas of contaminated ground water exist in both shallow perched zones and in the Qva. The perched zones are isolated and discontinuous, while the Qva is continuous. Figure 1 is a conceptual diagram illustrating the typical hydrogeologic properties and relationships below the AOMA. Figure 1 significantly simplifies typical conditions, but identifies key features:

- Perched Zone – The perched zone is discontinuous and is present in isolated areas of the AOMA. Perched ground water may appear on local till surfaces (where present) and may also collect in interbeds and lenses within the till. Therefore, multiple discontinuous perching “layers” are frequently identified as discrete water bearing zones within the same area. To the extent there is horizontal perched flow, it is typically localized and flows along the top surface of the till unit, but becomes more vertical at the edge of perching surface; there is no regionally extensive predominant horizontal perched flow direction. Typical low permeability geologic units (glacial till), that result in perched ground water conditions, are located from the near surface to about 40 feet below ground surface (about 10 to 32 feet below ground surface below most AOMA contaminated sites); the unsaturated region between the perching zone and ground water surface in the Qva is approximately 20 to 50 feet thick. Glacial till and perching conditions are not uniformly present below the AOMA. Till is absent in some locations due to natural processes, as well as construction related activities (such as deep excavations for building foundations, excavation for transit tunnels, and site grading activities) which appear to have breached the till unit at several locations at STIA.

- Qva aquifer in the STIA area – The Qva aquifer is the uppermost aquifer of regional extent. It is continuous throughout the AOMA and STIA and is in most areas of STIA classified as an unconfined aquifer. In some locations it is interconnected with the underlying regional aquifer which is identified in the South King County Groundwater Management Plan as the

“intermediate” regional aquifer. Typical ground water flow in the Qva aquifer is to the west, varying from northwest to southwest as a result of influence of local discharge zones such as Miller Creek, Des Moines Creek and associated wetlands. Typical depth to the Qva aquifer below the AOMA is about 60-90 feet below ground surface, with the variability primarily due to changes in surface elevation across STIA.

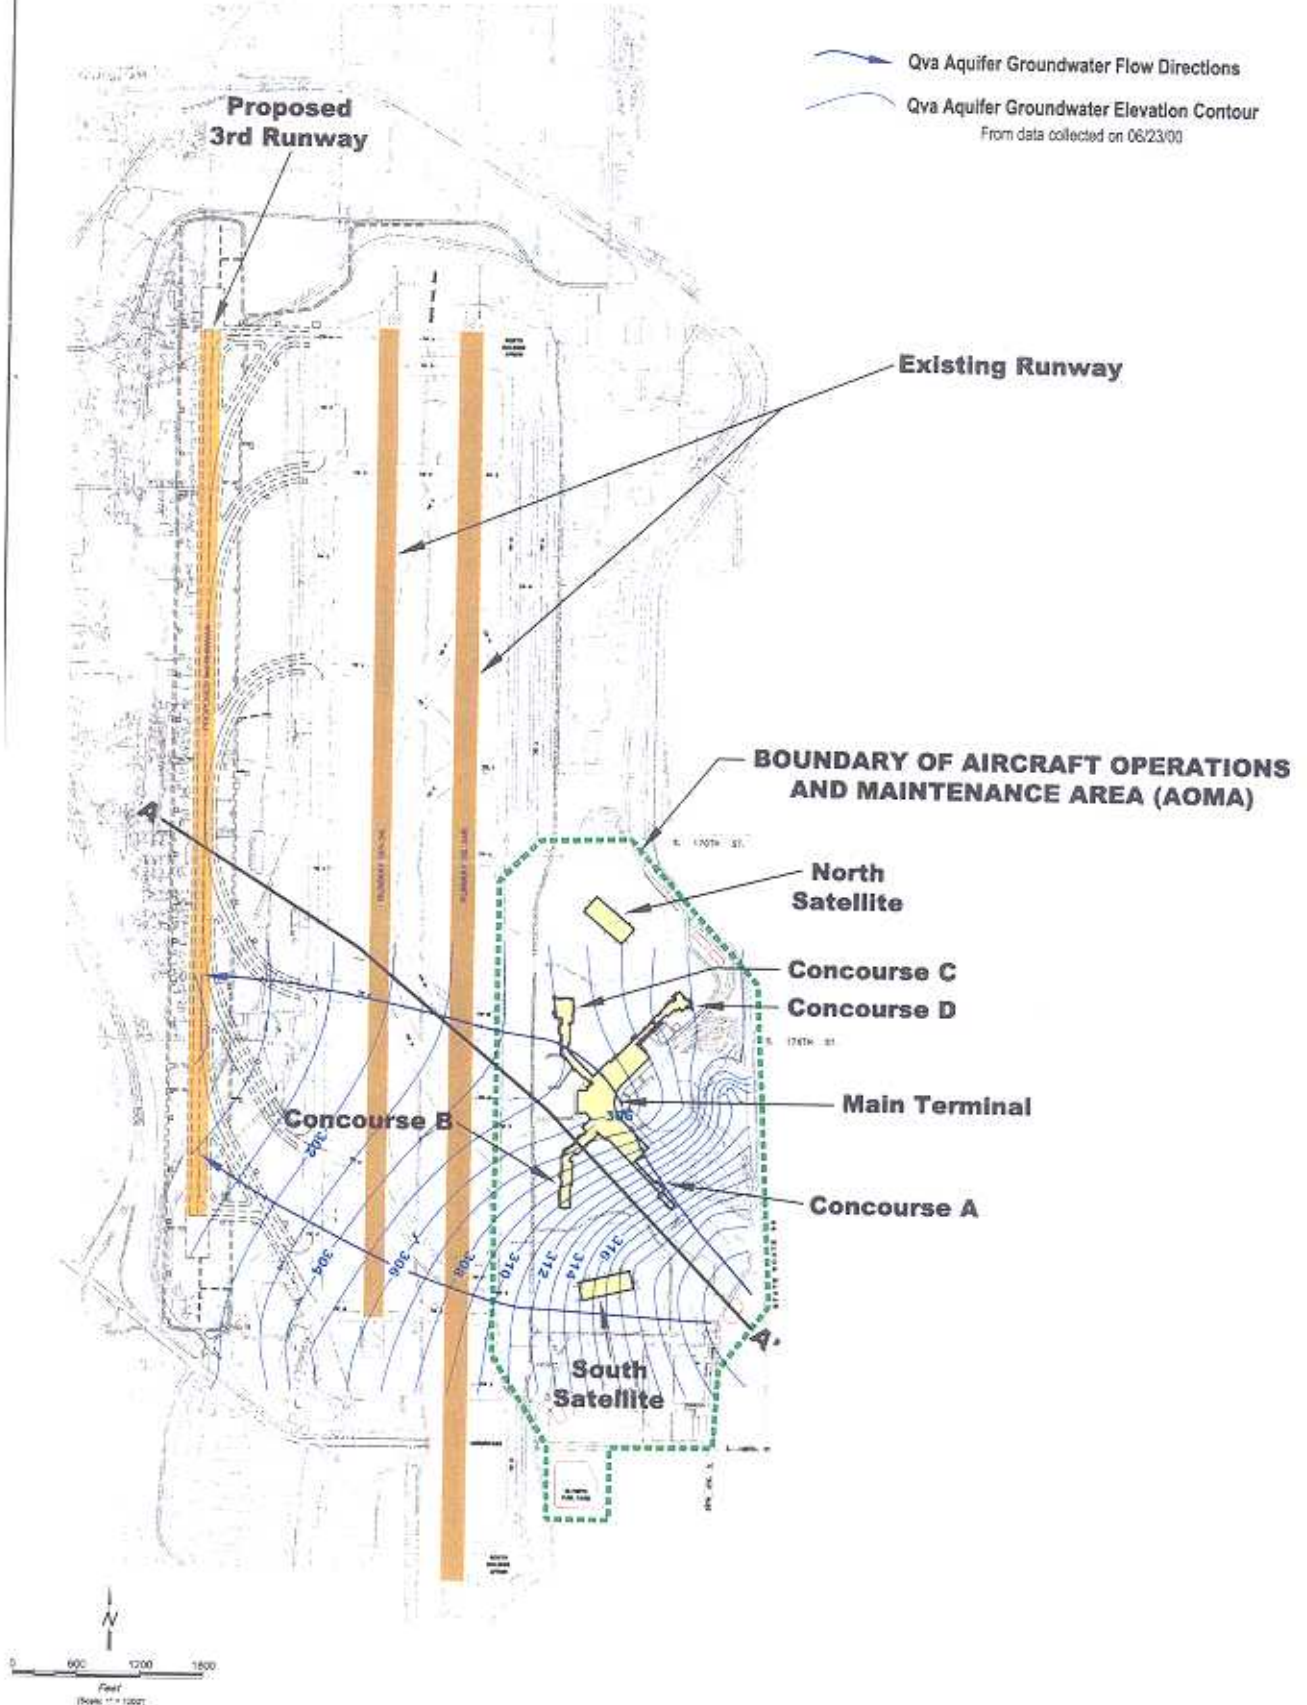
DATE	06/14/01
FILE NUMBER	AV/00122.02.000
FIGURE NO.	2

Figure 2 is a site map that presents the major features at STIA. The AOMA is shown in the southeastern portion of STIA and contains the main terminal area and airport concourses. The majority of the impacted ground water resulting from airport operations is located within the AOMA. The third runway construction area is located approximately 2800 feet to the west of the AOMA. Figure 2 also presents the typical Qva ground water contours and flow direction, a west to northwest flow direction in the Qva aquifer. The location of a conceptual cross section through the AOMA, extending to the proposed third runway embankment area, is shown as A-A' (see Figure 6 and Figure 7).

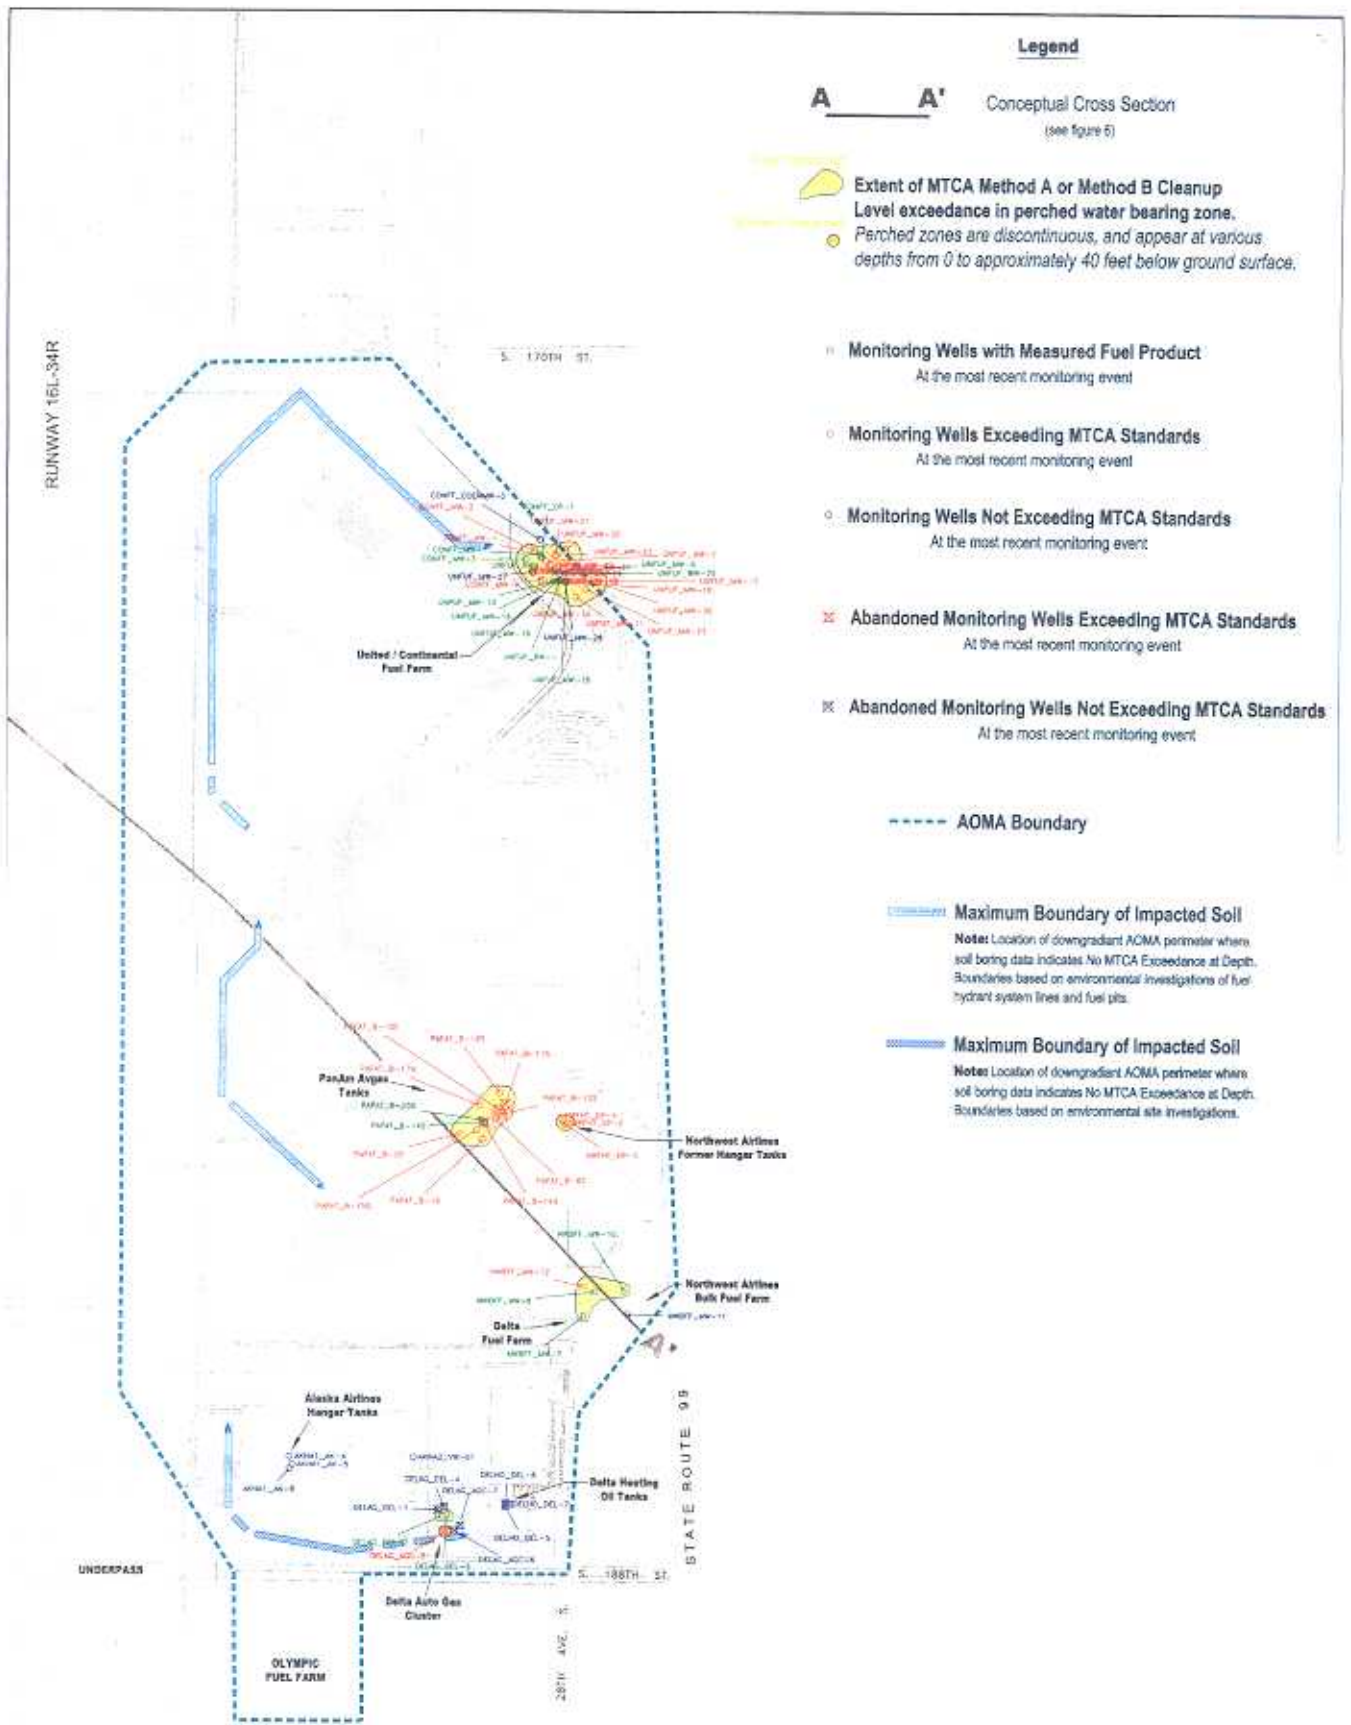
- Figure 3 – Figure 3 is a map that indicates the extent of impacted perched ground water in the area of the AOMA. Ground water monitoring wells completed in perched water bearing zones are plotted based on the most recent ground water quality data in the Ground Water Study database. The ground water quality data are compared to MTCA standards, and wells are distinguished by colors indicating whether sample data contain compounds exceeding MTCA standards. Figure 3 also includes a portion of the conceptual cross section line A-A', which extends to the proposed Third Runway area (see Figure 2 for the entire cross section line; the cross sections are illustrated in Figures 6 and 7. The map also presents data for the following conditions:

Four sites within the AOMA are shown in yellow shading, indicating the approximate area of fuel impacted perched ground water. These sites include the United/Continental Fuel Farm Area, the PanAm Avgas Tanks, the Northwest Airlines Bulk Fuel Farm and the Delta Autogas Tank site. Two additional areas in the AOMA, the Northwest Airlines Former Hanger Tank site and monitoring well AGC-5 at the Delta Autogas Tank site, shown with gold shading, represent areas that contain solvent impacted perched ground water. The shaded boundaries were established within areas surrounding monitoring wells that have exhibited ground water quality that has exceeded MTCA standards.

Figure 3 also illustrates additional evidence of the limit of the extent of impacted perched ground water in the AOMA. The hatched blue lines shown on Figure 3 at the south end of the AOMA are based on environmental investigations at several potential sites in that area. The unhatched blue lines around the northern and western AOMA are based on environmental soil boring data adjacent to the fuel hydrant pits and along fuel supply lines. The unbroken sections of the blue lines indicates soil conditions that do not exceed MTCA standards. The criteria for establishing this boundary was that the two deepest soil samples collected at a specific location were below MTCA standards. Areas that do not meet this requirement are shown by breaks in the lines and are of a very limited extent. Likewise, areas where no soil data currently exist are between the jagged ends of the blue lines (e.g., between the South Satellite and Concourse B).

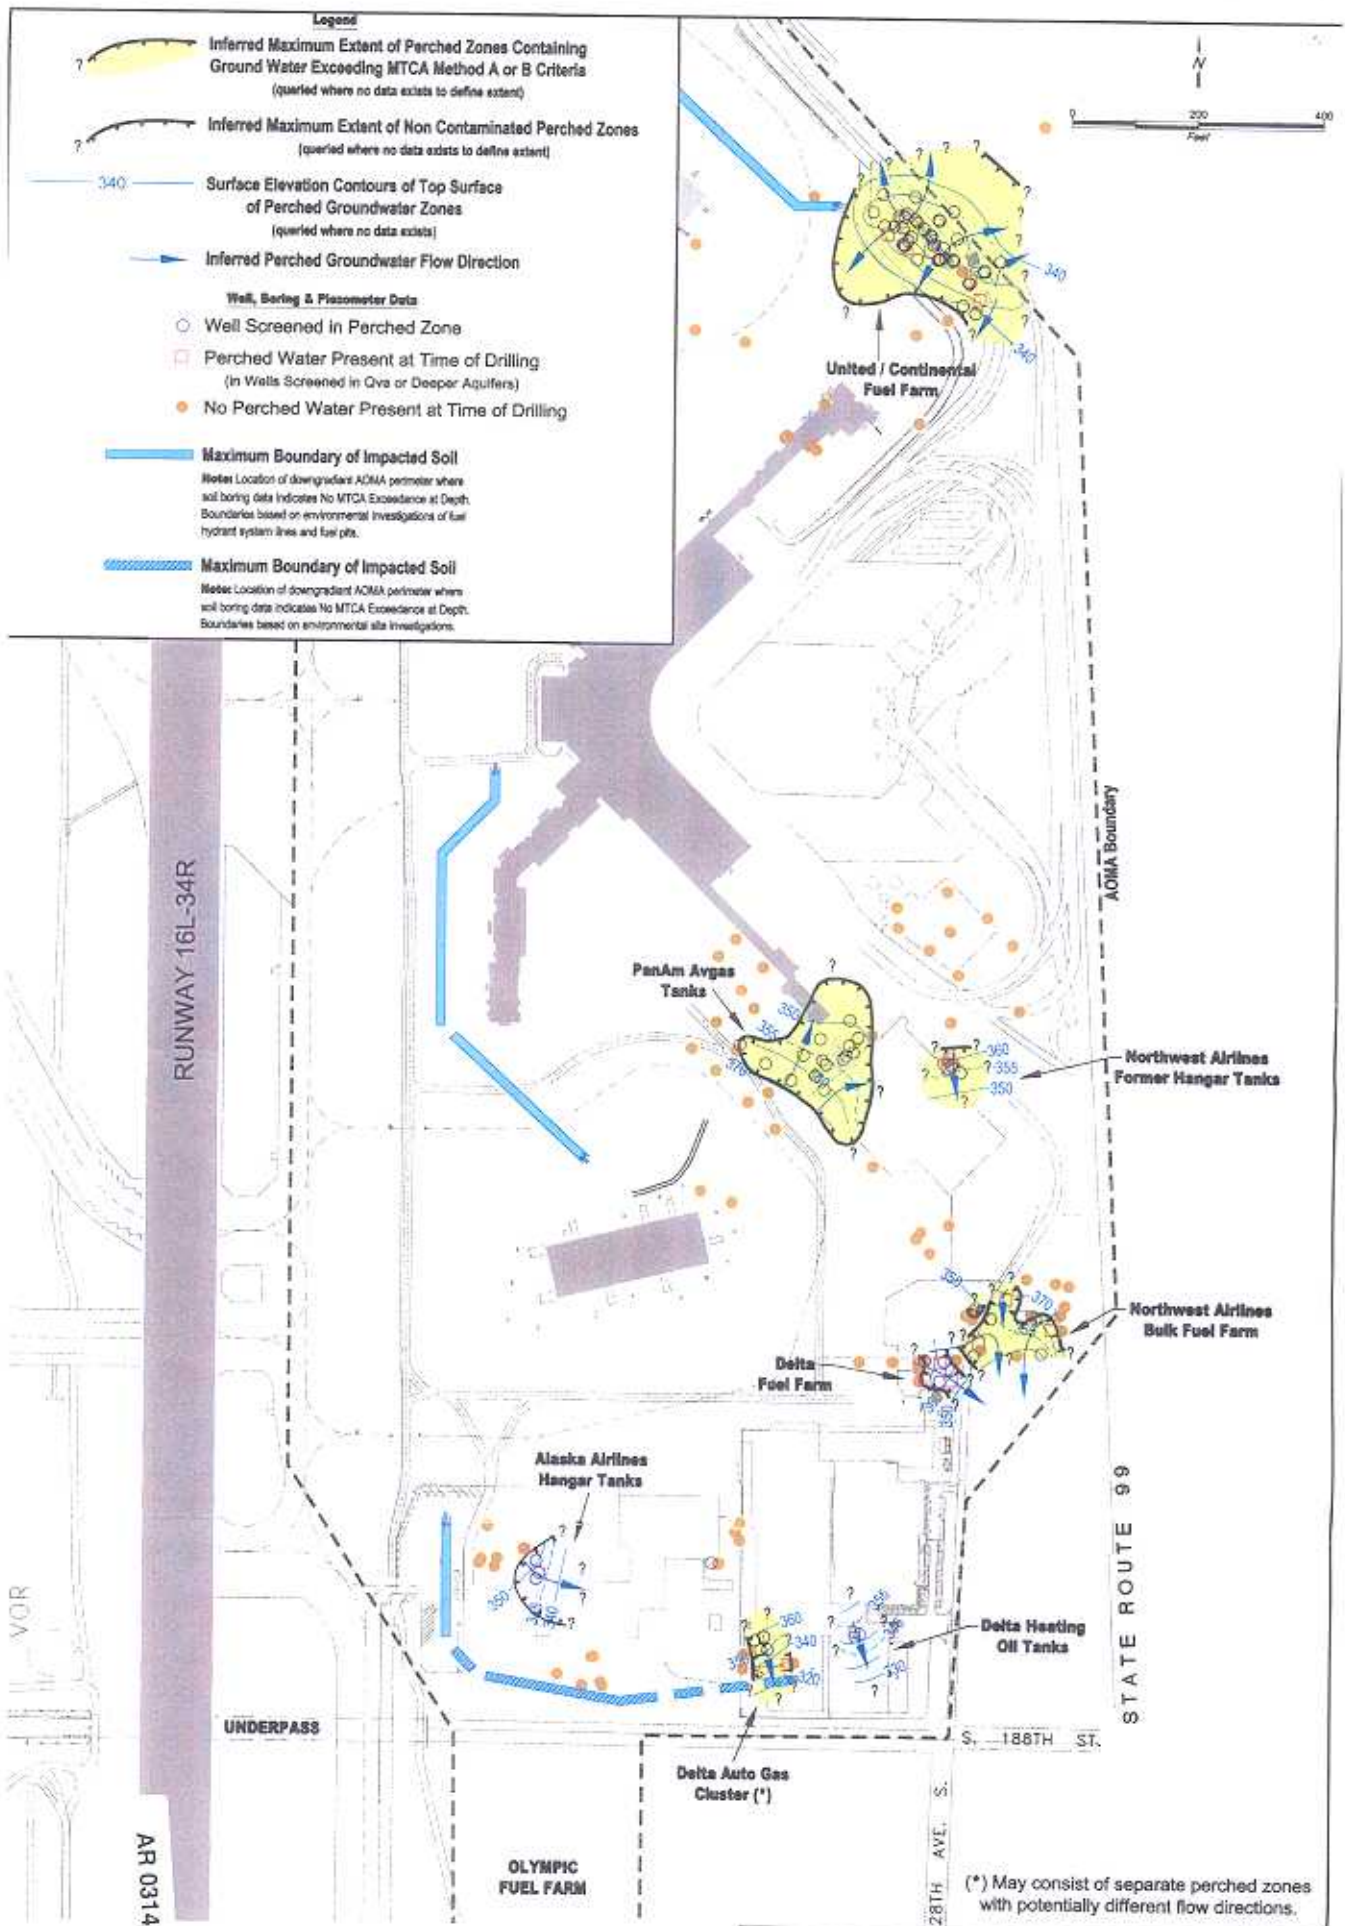
- Figure 4 – Figure 4 provides supporting evidence that perched ground water is limited in extent at several locations within the AOMA. The inferred western extent of the perched zone horizons at each of the known release sites appears to be bound by soil conditions that do not indicate wet, saturated or perched ground water conditions. Data points presented on Figure 4 as brown solid circles indicate soil conditions that do not contain evidence for wet soil conditions or perched ground water conditions at the time of drilling. These data were obtained from environmental and geotechnical explorations performed at areas surrounding known perched ground water zones. These data show that the extent of the perched zones are limited in a western direction and that the perched ground water is confined to isolated areas.

Figure 4 also presents generalized perched ground water elevation contours and associated flow directions. The ground water contours were developed by plotting the average ground water surface elevation that has been measured in monitoring wells completed in the perched zones at the various sites. The contoured data set also includes the elevation of saturated conditions noted on logs of the boreholes and wells completed below the perched aquifer. An average ground water level was used where multiple measurements were available from a well. This reduced variability from seasonal fluctuations and simplified complex perching levels in areas that contain multiple perched zones. Flow direction arrows indicate the general direction of ground water flow and indicate that the perched ground water flow is

variable and generally in directions that are away from the proposed Third Runway construction area.

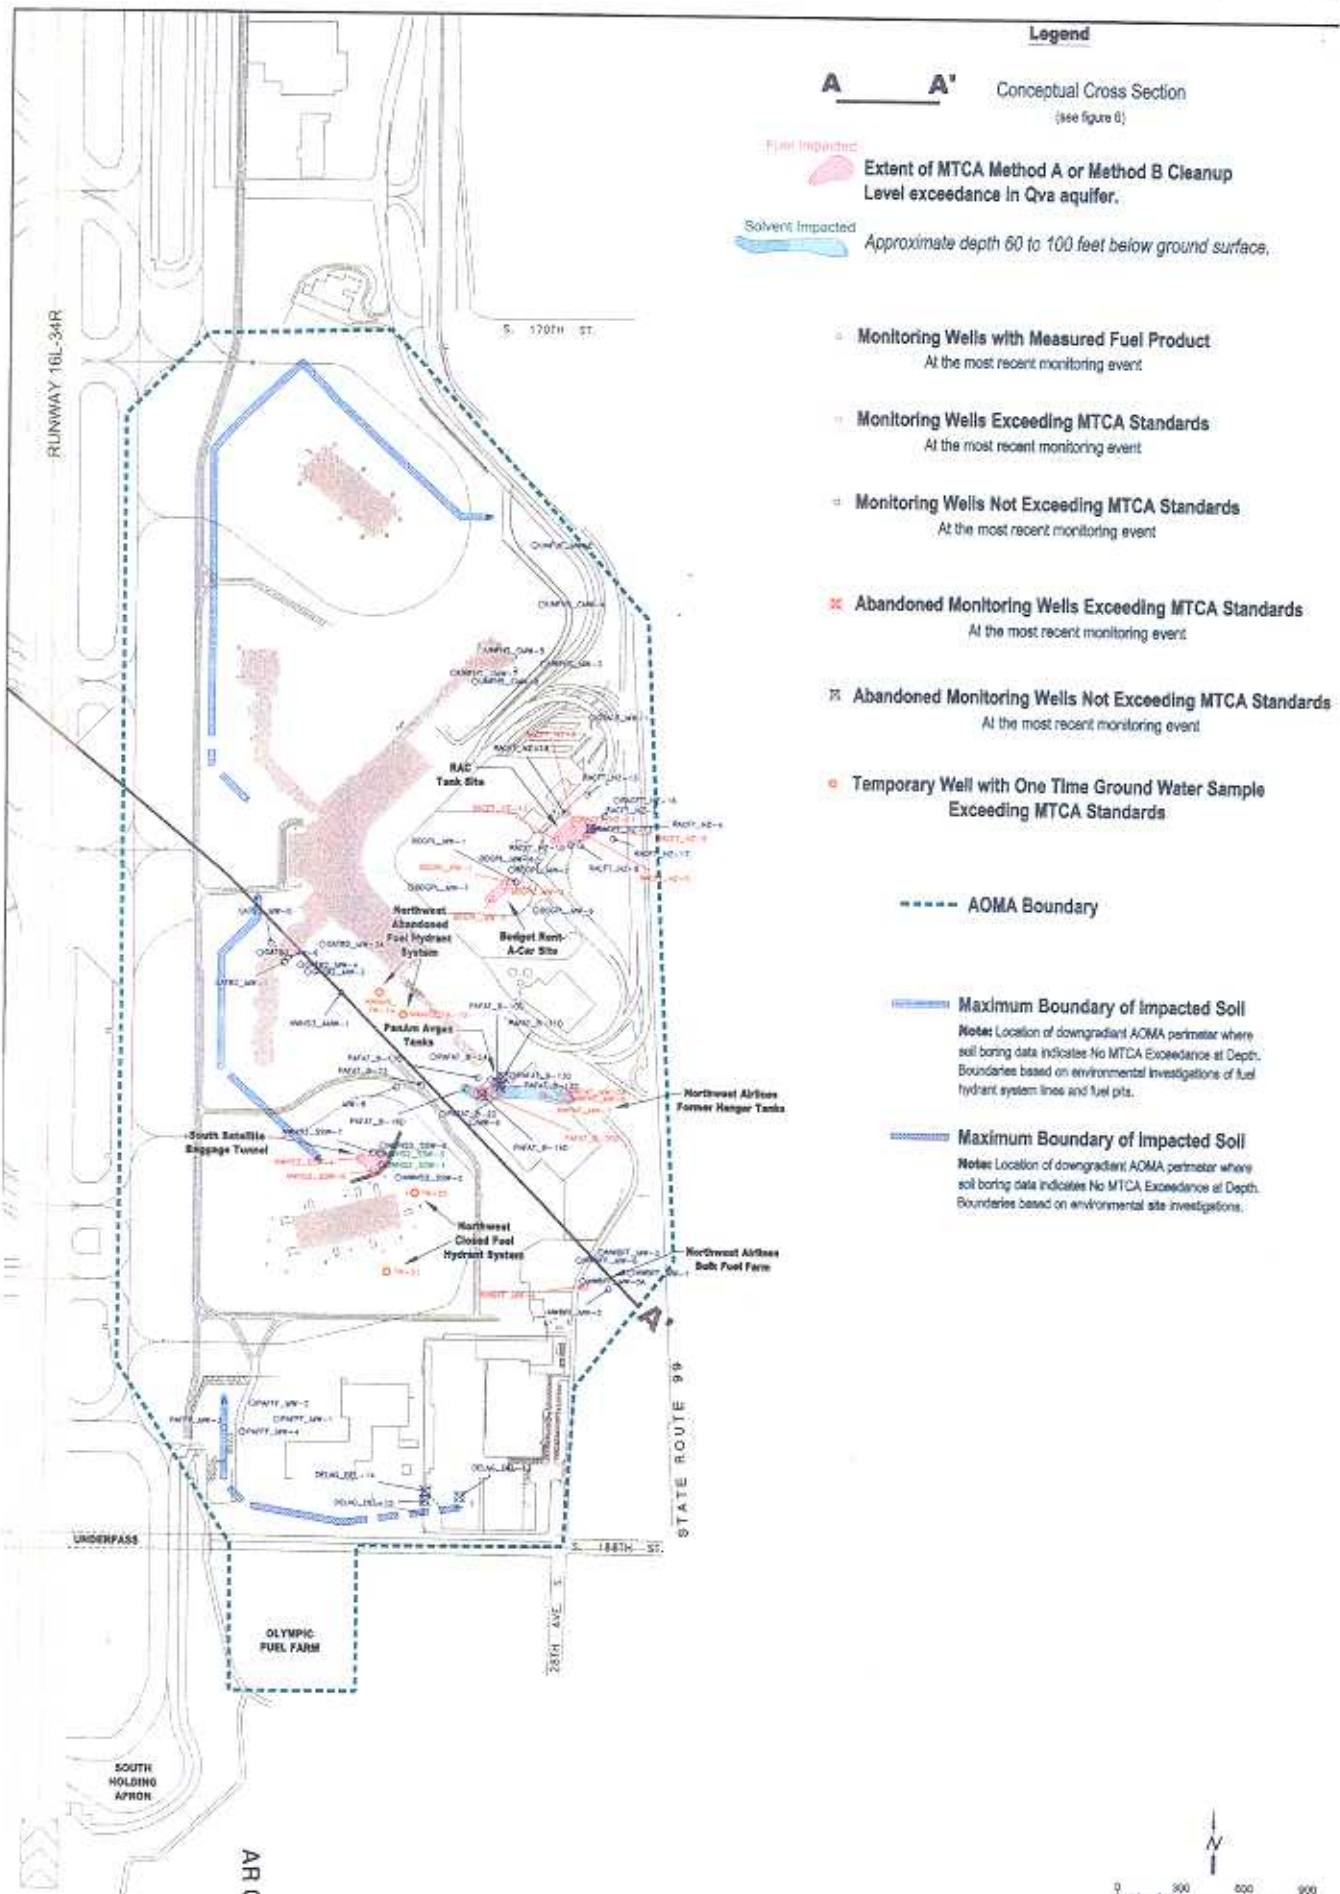
- Figure 5 – Figure 5 presents the extent of impacted ground water in the Qva aquifer within the AOMA. See Section 2.3 for a description of this figure.

Figure 5 is a map that shows the extent of Qva impacted ground water. Ground water flow direction in the Qva aquifer is to the west/northwest between the AOMA and the proposed Third Runway project (Figure 2). Figure 5 indicates that the impacted ground water areas in the Qva are bounded by data from downgradient monitoring wells that do not exceed MTCA standards. The wells that generate data below MTCA standards are located to the west of the impacted ground water areas, between the contaminant release areas and the western AOMA boundary.

Ground water and soil samples collected from individual site investigations within the AOMA have also indicated that existing Qva aquifer contamination remains localized, despite the presence of several facilities that have been constructed at depth within the AOMA. For example, the maximum measured migration of impacted Qva ground water is about 550 feet in a down gradient direction from a specific source (tanks that were installed around 1949 and removed in 1990). This area is well within the AOMA and suggests that impacted Qva ground water is not migrating beyond the AOMA boundary. Natural attenuation and dispersion conditions are also probably limiting the extent of migration of impacted Qva ground water. Contaminant source control and remediation measures also function to limit the size of the ground water plumes observed in the Qva aquifer.

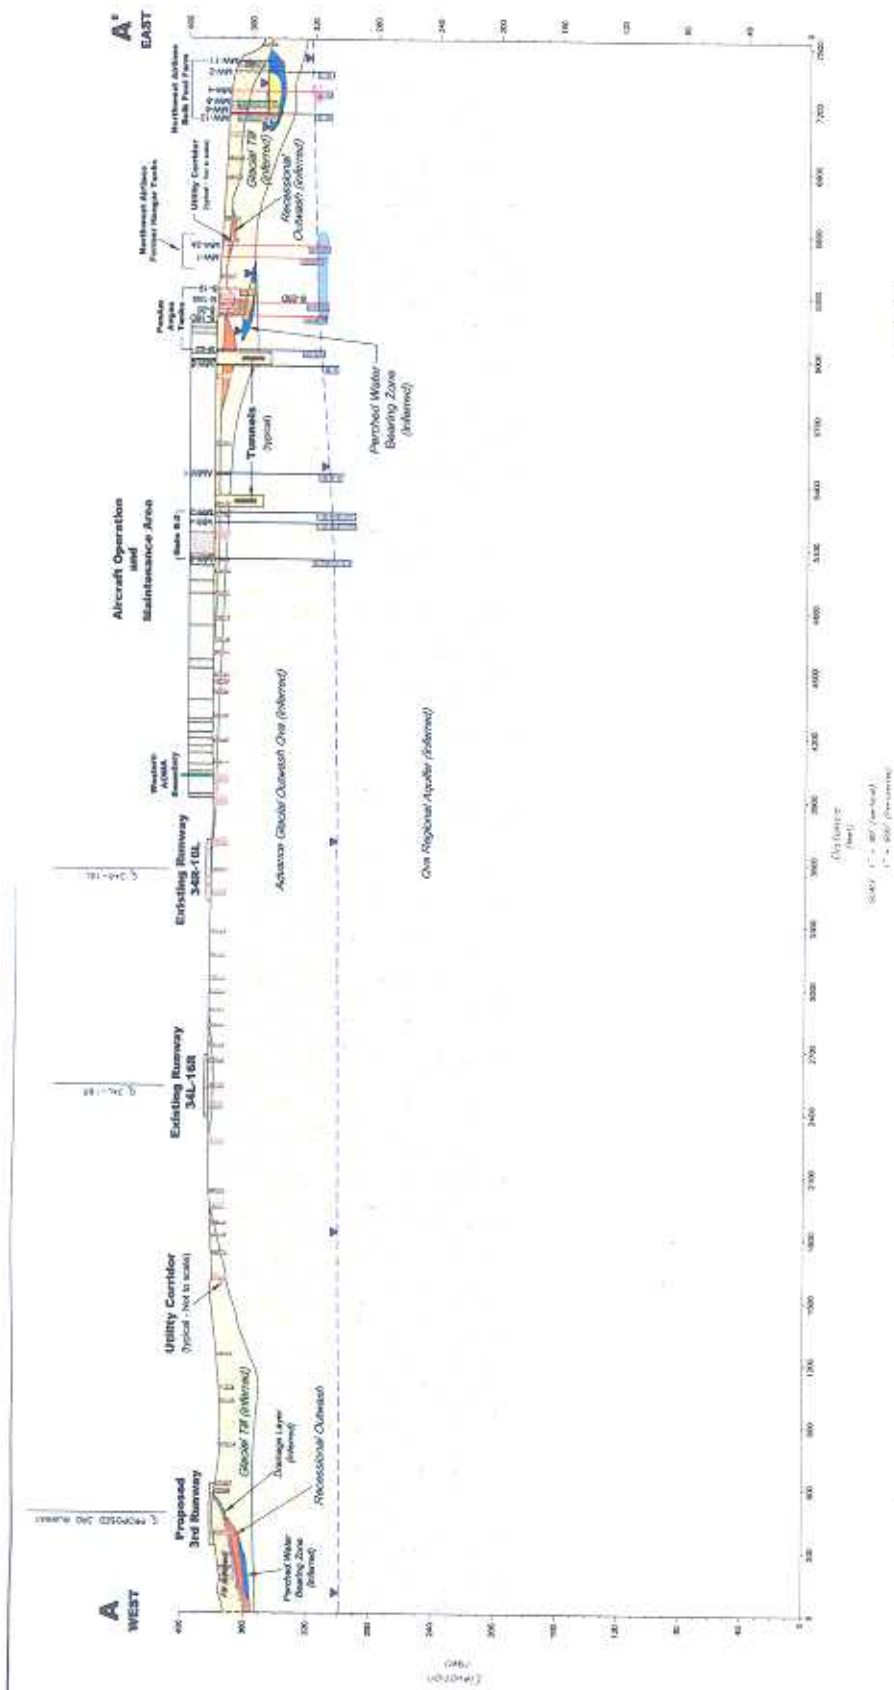
- Figure 6 – Figure 6 is a conceptual cross section that shows a generalized representation of geologic formations, ground water conditions, typical STIA utility trench depths, monitoring well completion details and general AOMA site features. The cross section is developed from the eastern boundary of the AOMA past the western end of the proposed Third Runway embankment, oriented generally parallel to the Qva ground water flow direction. Isolated perched ground water zones are identified within glacial till horizons within the AOMA and in recessional sandy outwash soils near the proposed Third Runway horizon. The inferred thickness of the glacial till horizon has been determined based on available subsurface soil data compiled throughout STIA. These data indicate an irregular till surface with variable thickness and show several areas along the cross section where the till unit is absent as a result of either natural processes or construction activities.

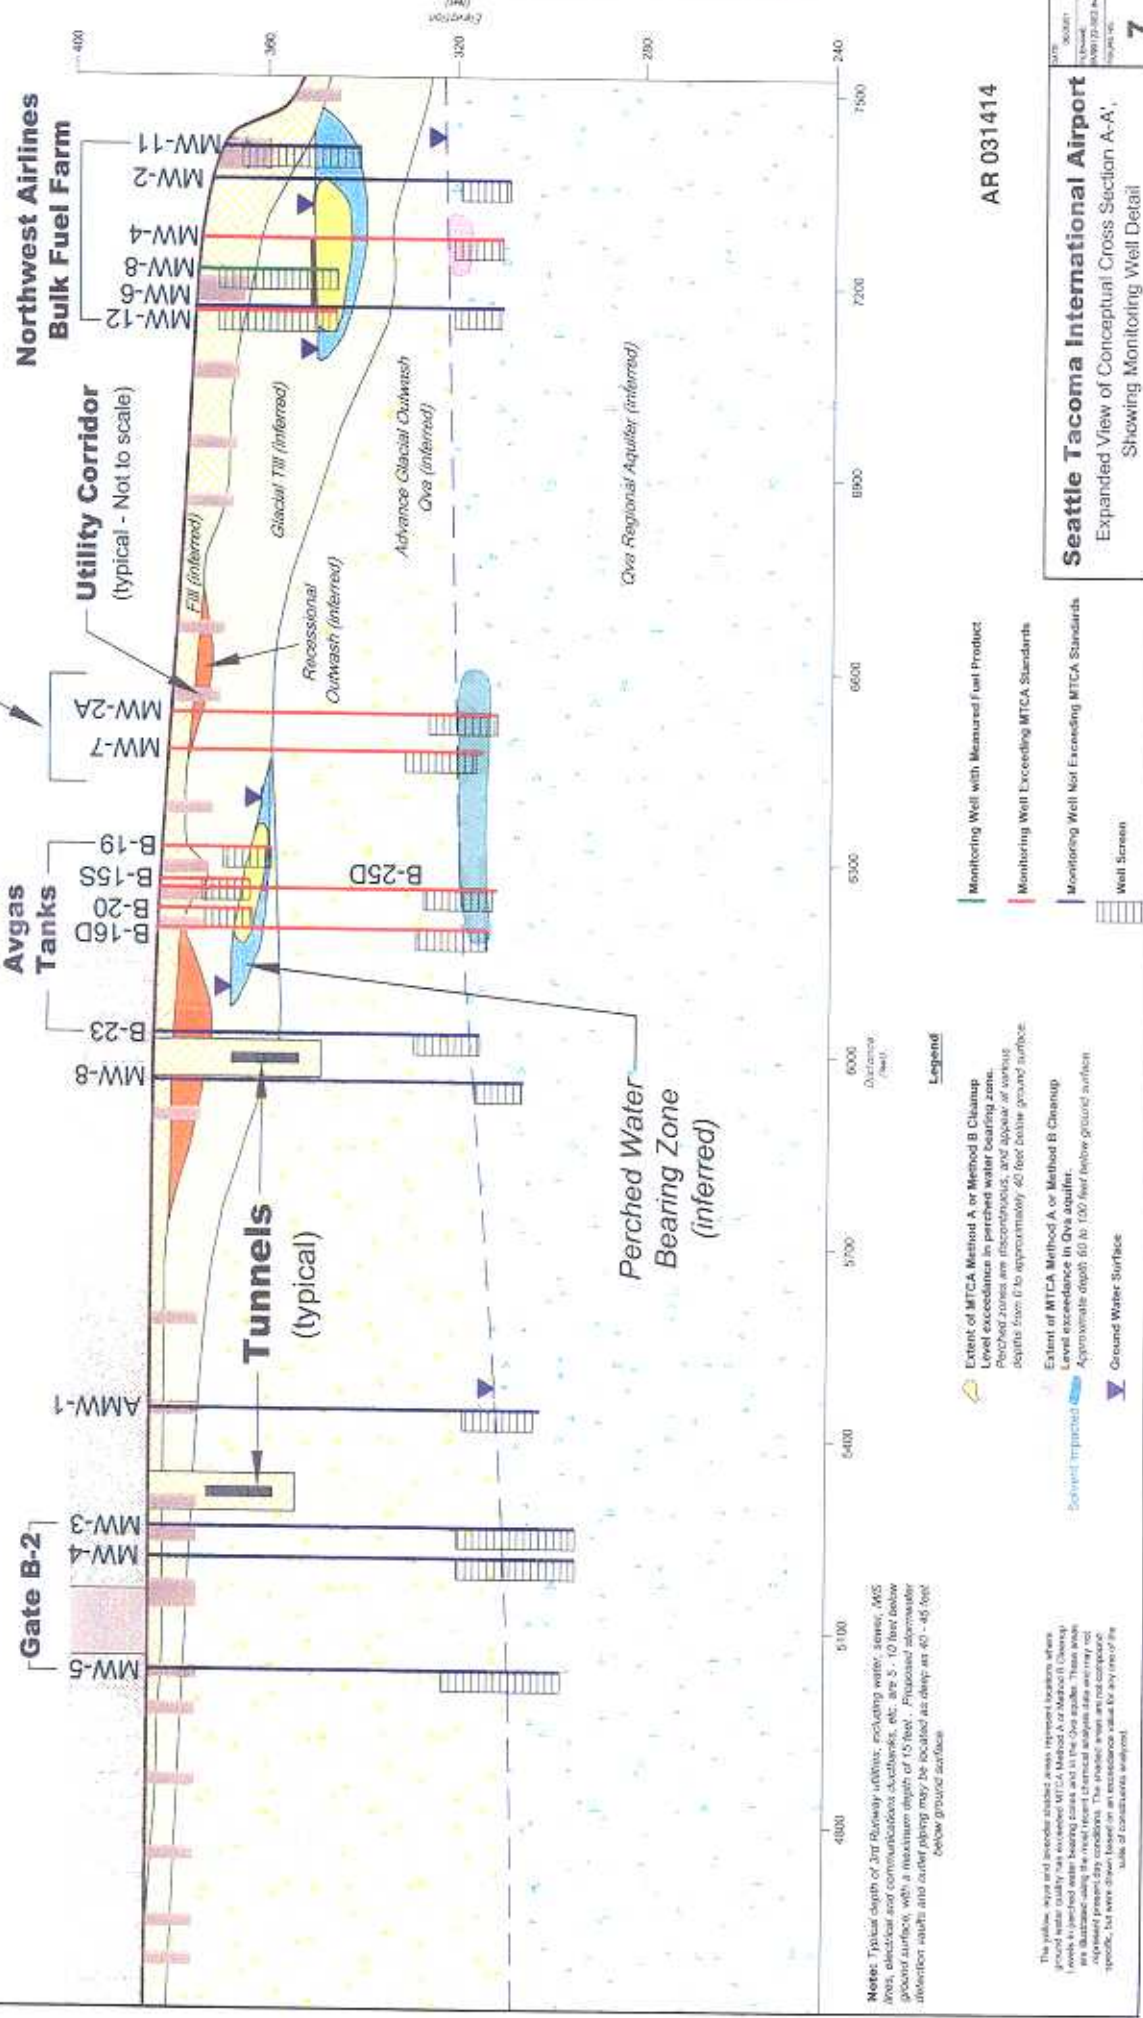
Seattle Tacoma International Airport
Expanded View of Conceptual Cross Section A-A'
Showing Monitoring Well Detail

- Figure 7 – Figure 7 presents an enlargement of the Figure 6 cross-section through the AOMA area. The enlarged cross section is developed through the Northwest Bulk Fuel Farm and the Pan Am Avgas Tanksites, areas where impacted perched ground water has been characterized. The perched ground water observed at the Pan Am Avgas Tank site represents the western-most area within the AOMA that contains impacted perched ground water exceeding MTCA standards. The cross section shows wells completed in the perched horizons at both the Northwest Bulk Fuel Farm and Pan Am Avgas Tank sites and indicates the perched water level elevation as shown by the blue triangle. Utility lines are shown on the cross section, which are positioned at a typical construction depth of 10 feet.
