FIVE-YEAR PROJECT REPORT

**City of Des Moines
Water Quality Monitoring Program**

City of Des Moines
Surface Water Management Utility

February 21, 2001

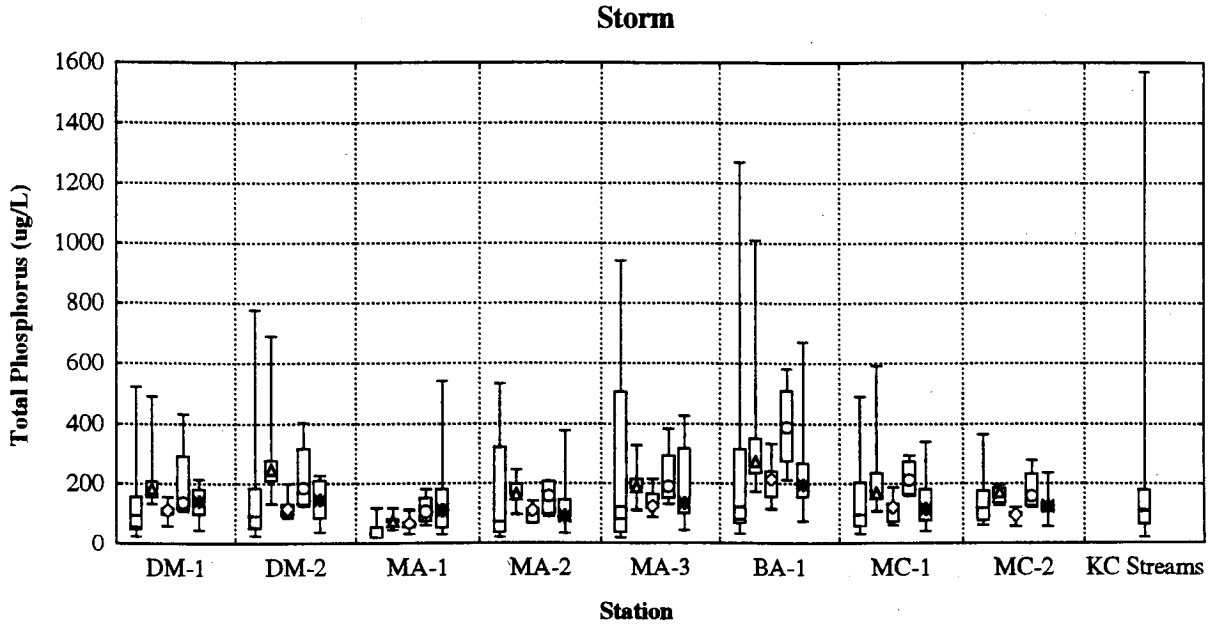
Figure 12. Total phosphorus concentrations during storm and base flow sampling events in Des Moines streams and in other King County (KC) streams.

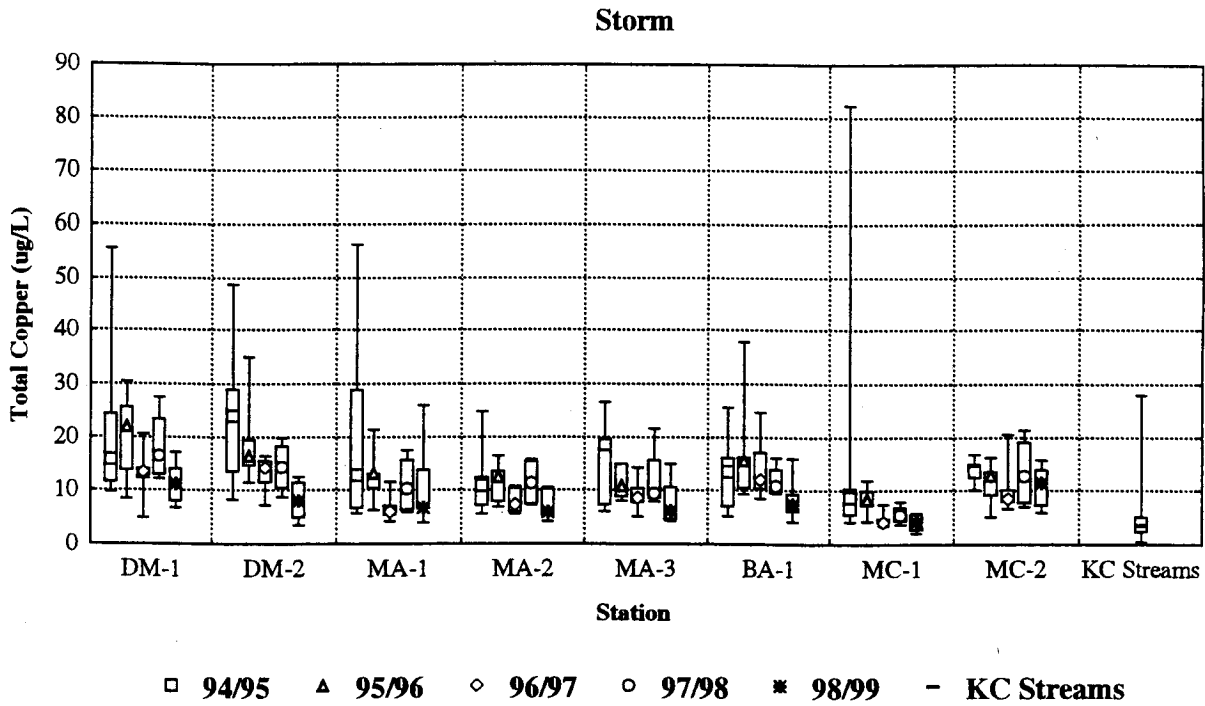
Figure 16. Total copper concentrations during storm flow sampling events in Des Moines streams and in other King County (KC) streams.

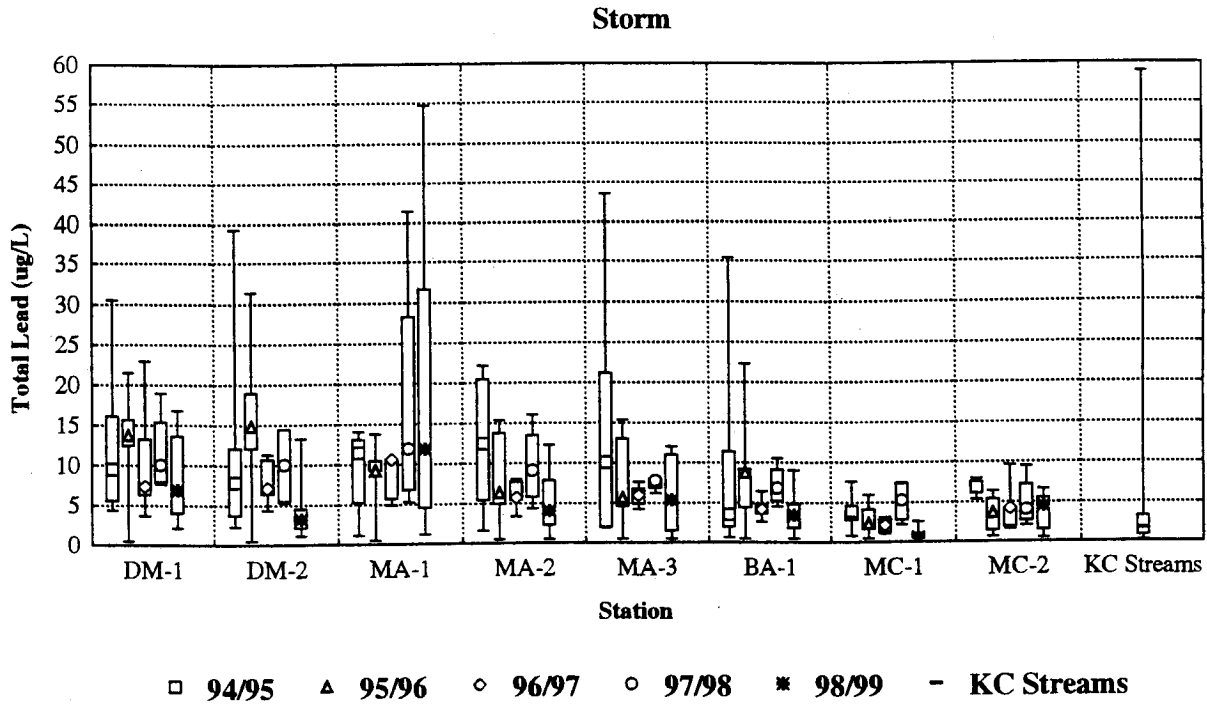
Figure 18. Total lead concentrations during storm flow sampling events in Des Moines streams and in other King County (KC) streams.

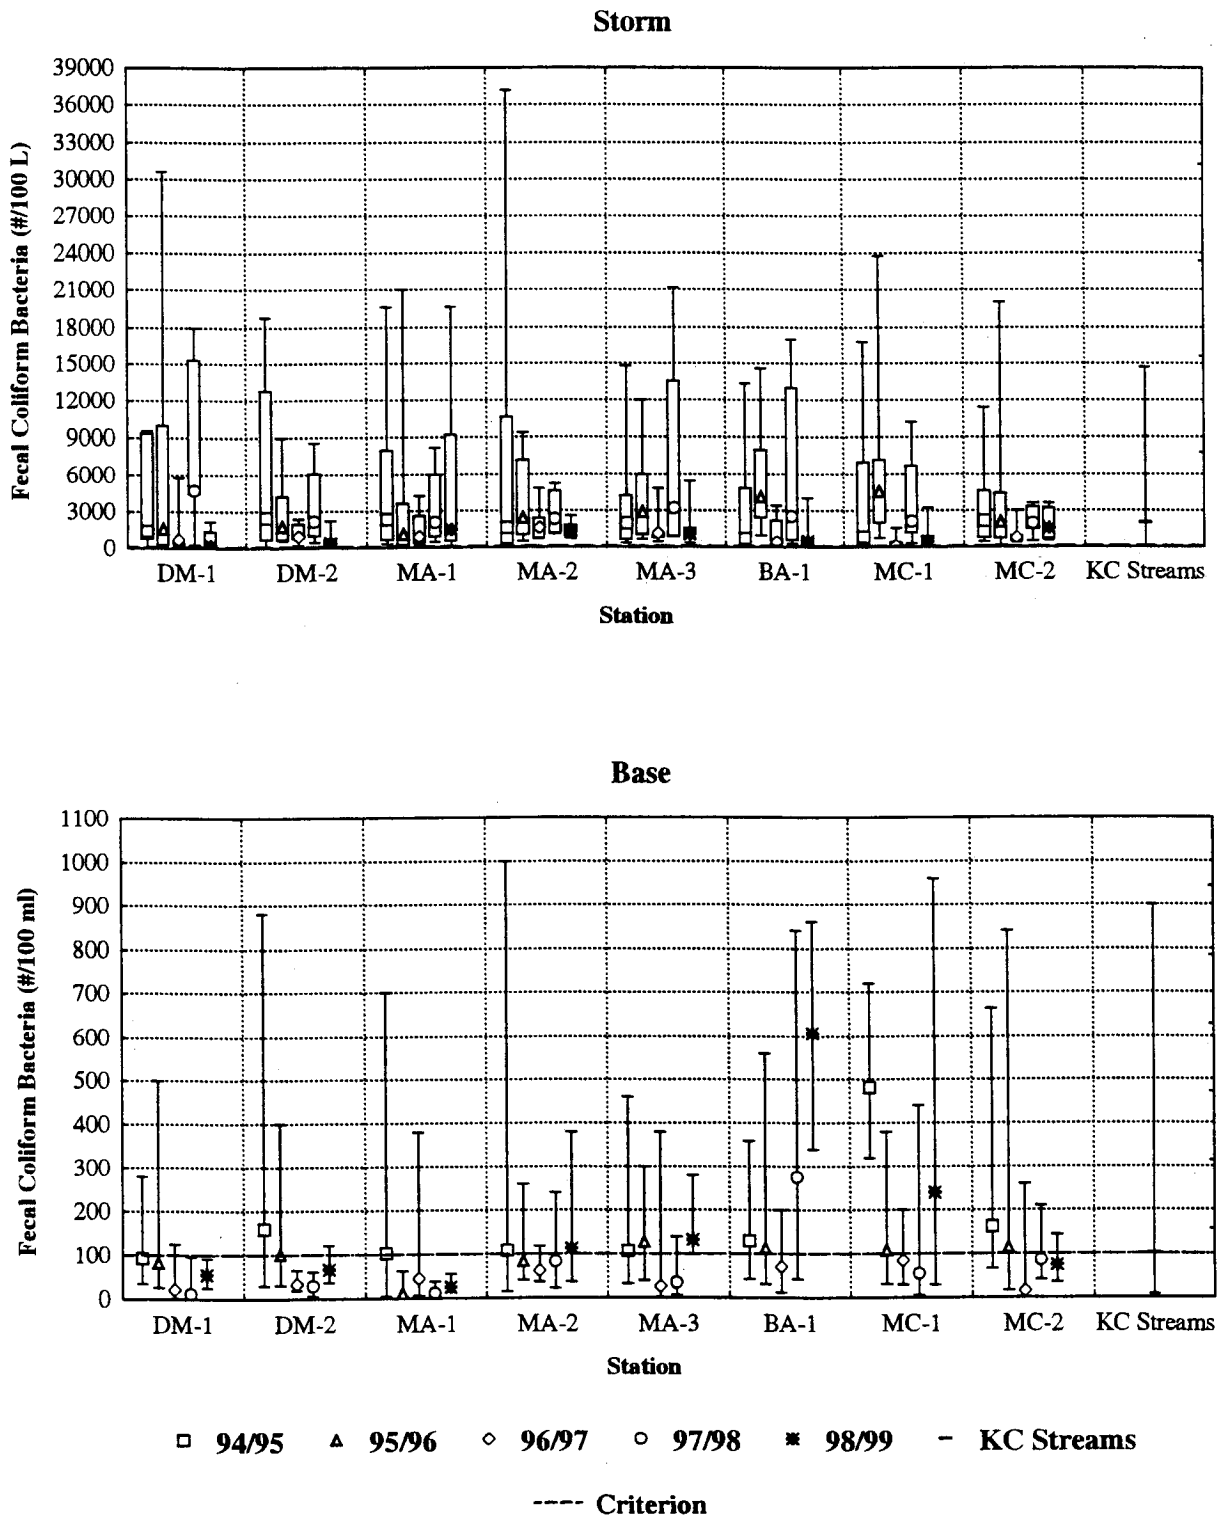
Figure 22. Fecal coliform bacteria concentrations during storm and base flow sampling events in Des Moines streams and in other King County (KC) streams.

The statistical analysis for trends by monitoring year showed no significant differences in fecal coliform bacteria concentrations between monitoring years at any of the stations (Appendix C). The analysis for temporal trends over the entire 5-year monitoring program showed a significant increasing trend for fecal coliform bacteria concentrations in Barnes Creek (station BA-1) (Table 9 and Appendix C).

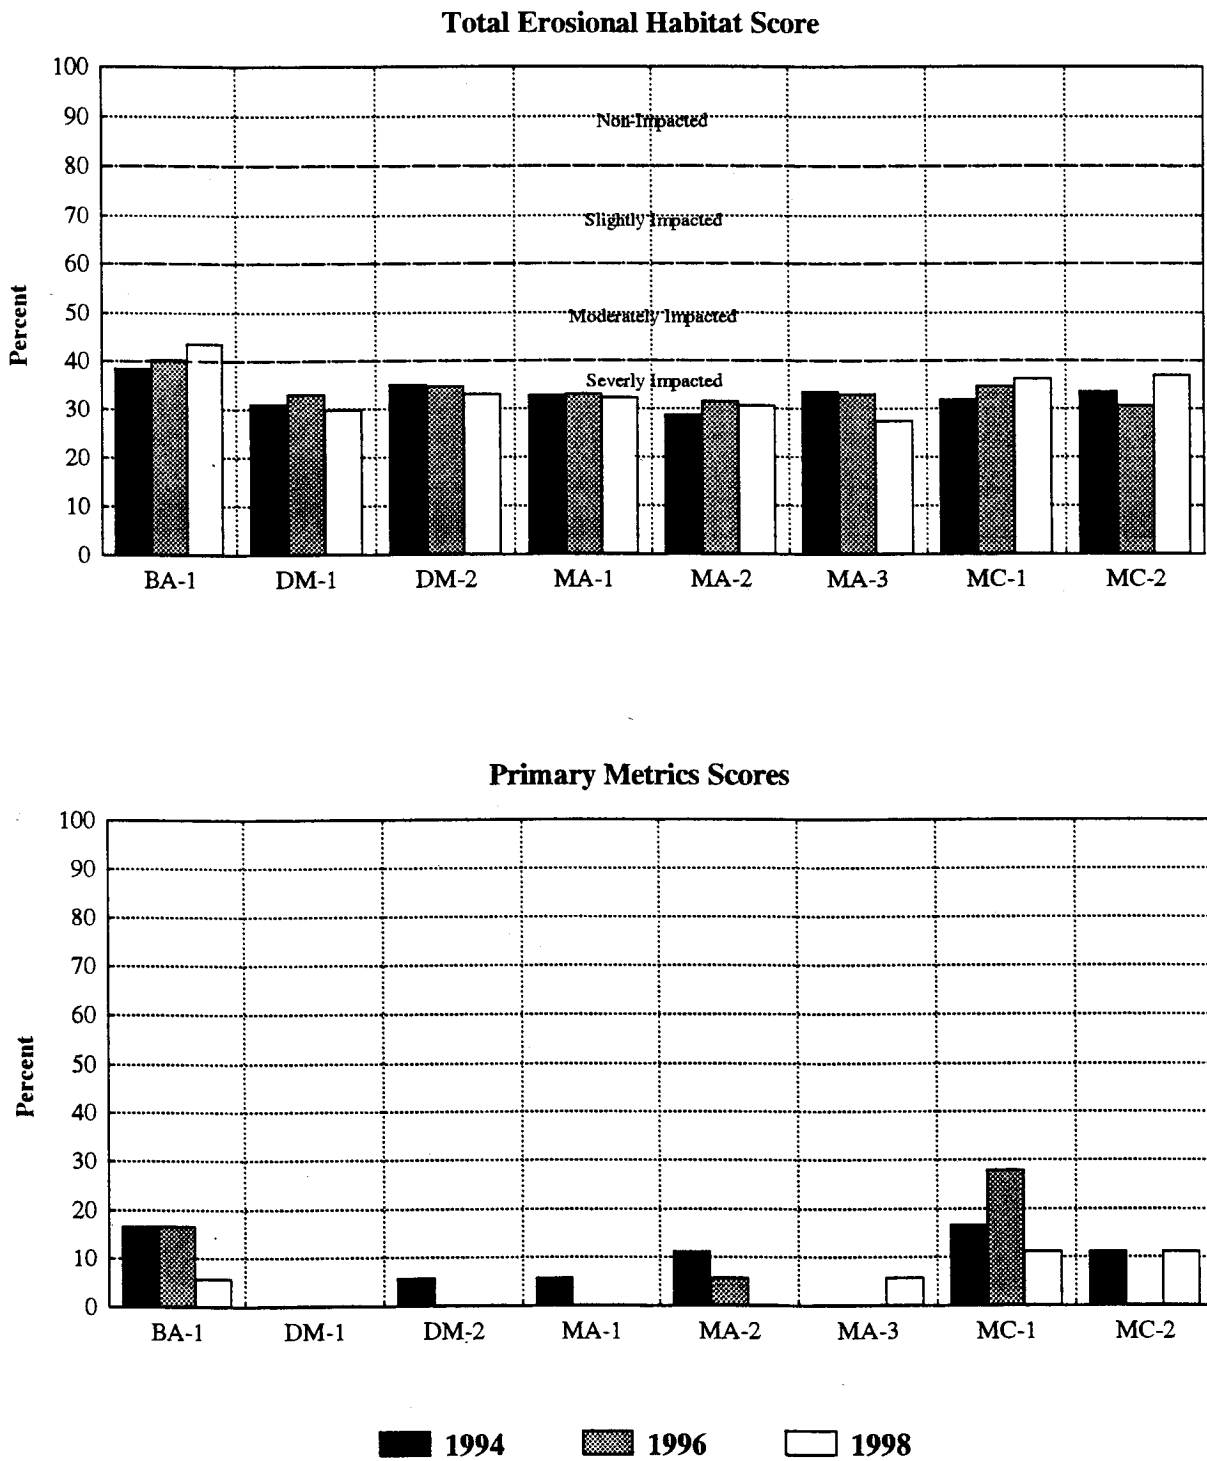
Figure 23. Total erosional habitat indices and primary metrics scores for benthic invertebrate monitoring of Des Moines streams.

The Aquatic Biology Associates bioassessment format is based on a model of undisturbed mid-order, forested, higher-gradient, cool/cold montane streams with high water quality and habitat complexity. The streams monitored in this study are low-gradient Puget Sound lowland streams. These streams are not expected to exhibit the same macroinvertebrate assemblages as the streams used to calibrate the index. The full potential of a Puget Sound lowland stream in a pristine condition is estimated to be a score of 60 to 80 percent for the total erosional habitat index (Appendix G).
