Exhibit J: Exposed face of fill embankment at site of slope failure near South 160<sup>th</sup> Street showing distinct layering and lack of homogeneity, 28 January 2002

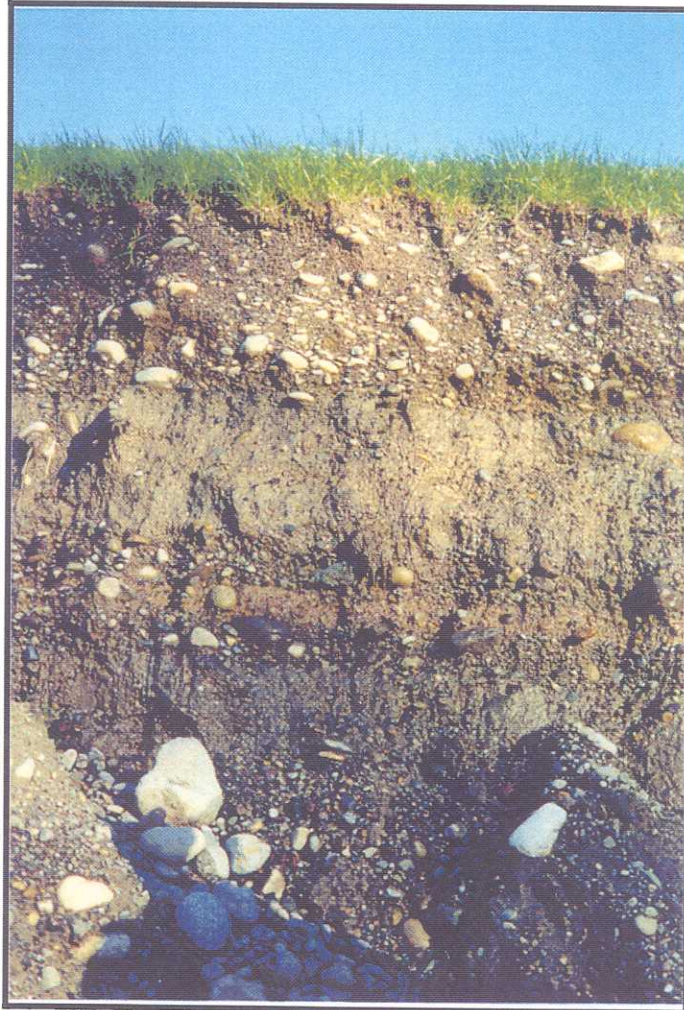
Note: Exposed face in photograph is approximately 4 feet high by 3 feet wide.
