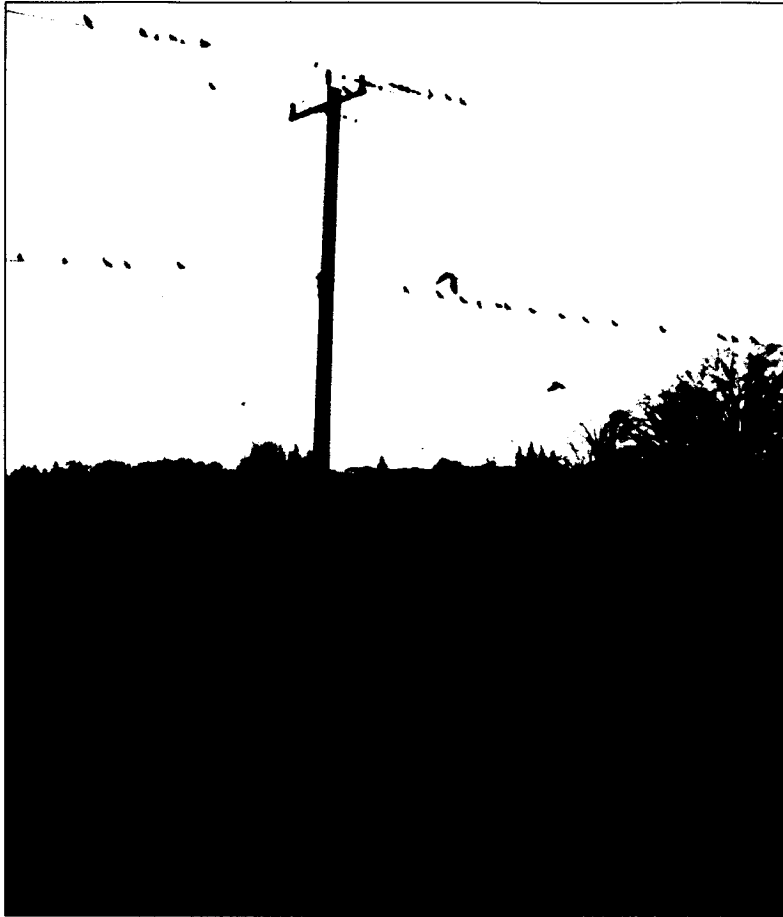
PHOTO A: Discarded pumpkins at Vacca Farm, 11-16-98. Hundreds of crows, starlings and seagulls were feeding on the pumpkins before being scared away by my visit. Notice highly degraded condition of wetland, where wetland plant community is disrupted yearly by agricultural planting. Vegetable stand (on east side of Des Moines Memorial Drive) was located to right of blackberry bramble in center right of photo. The yearly disposal of pumpkins at site attracts a significant number of birds which in turn creates a significant bird strike hazard.

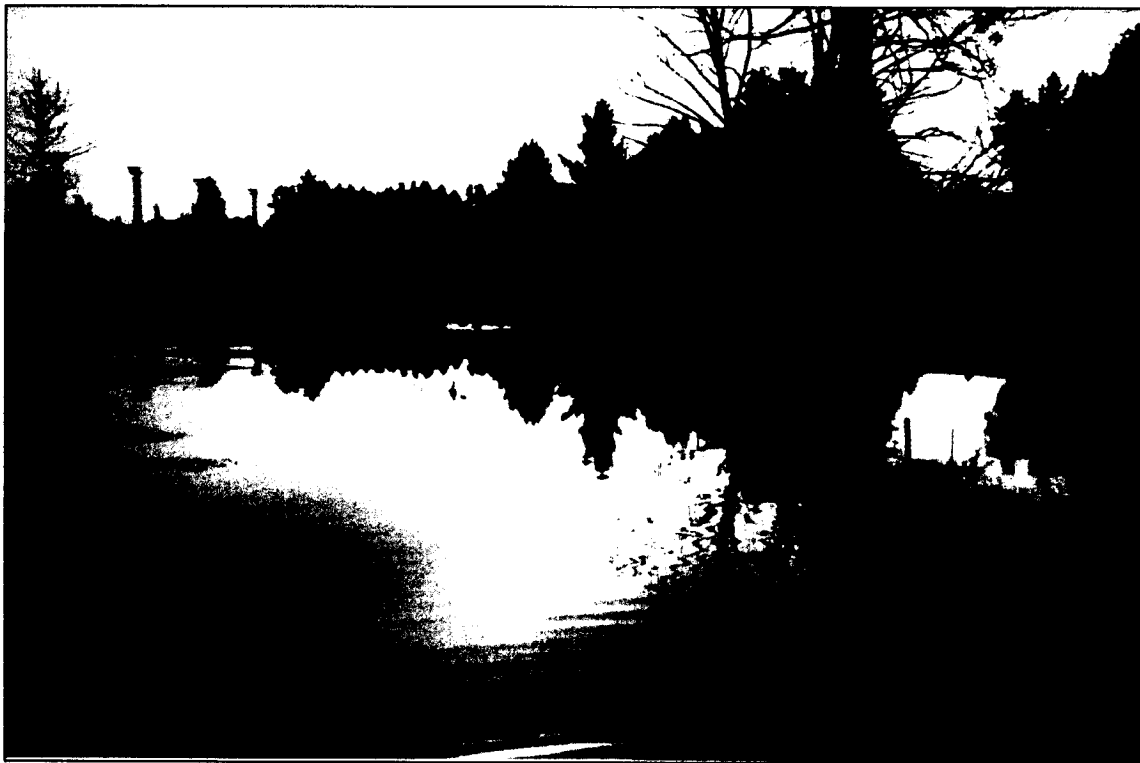
Photo H: Tyee Golf Course, flooding after storm event. Des Moines Creek flows from right to left. Use of golf course by waterfowl presents a significant bird strike hazard. Taken 11-16-98.
