# **Cumulative Impacts to Wetlands and Streams**

## **Master Plan Update Improvements Seattle-Tacoma International Airport**

**PORT OF SEATTLE**  
Seattle-Tacoma International Airport  
Seattle, Washington 98158

**PARAMETRIX, INC.**  
5808 Lake Washington Blvd. NE, Suite 200  
Kirkland, Washington 98033-7350

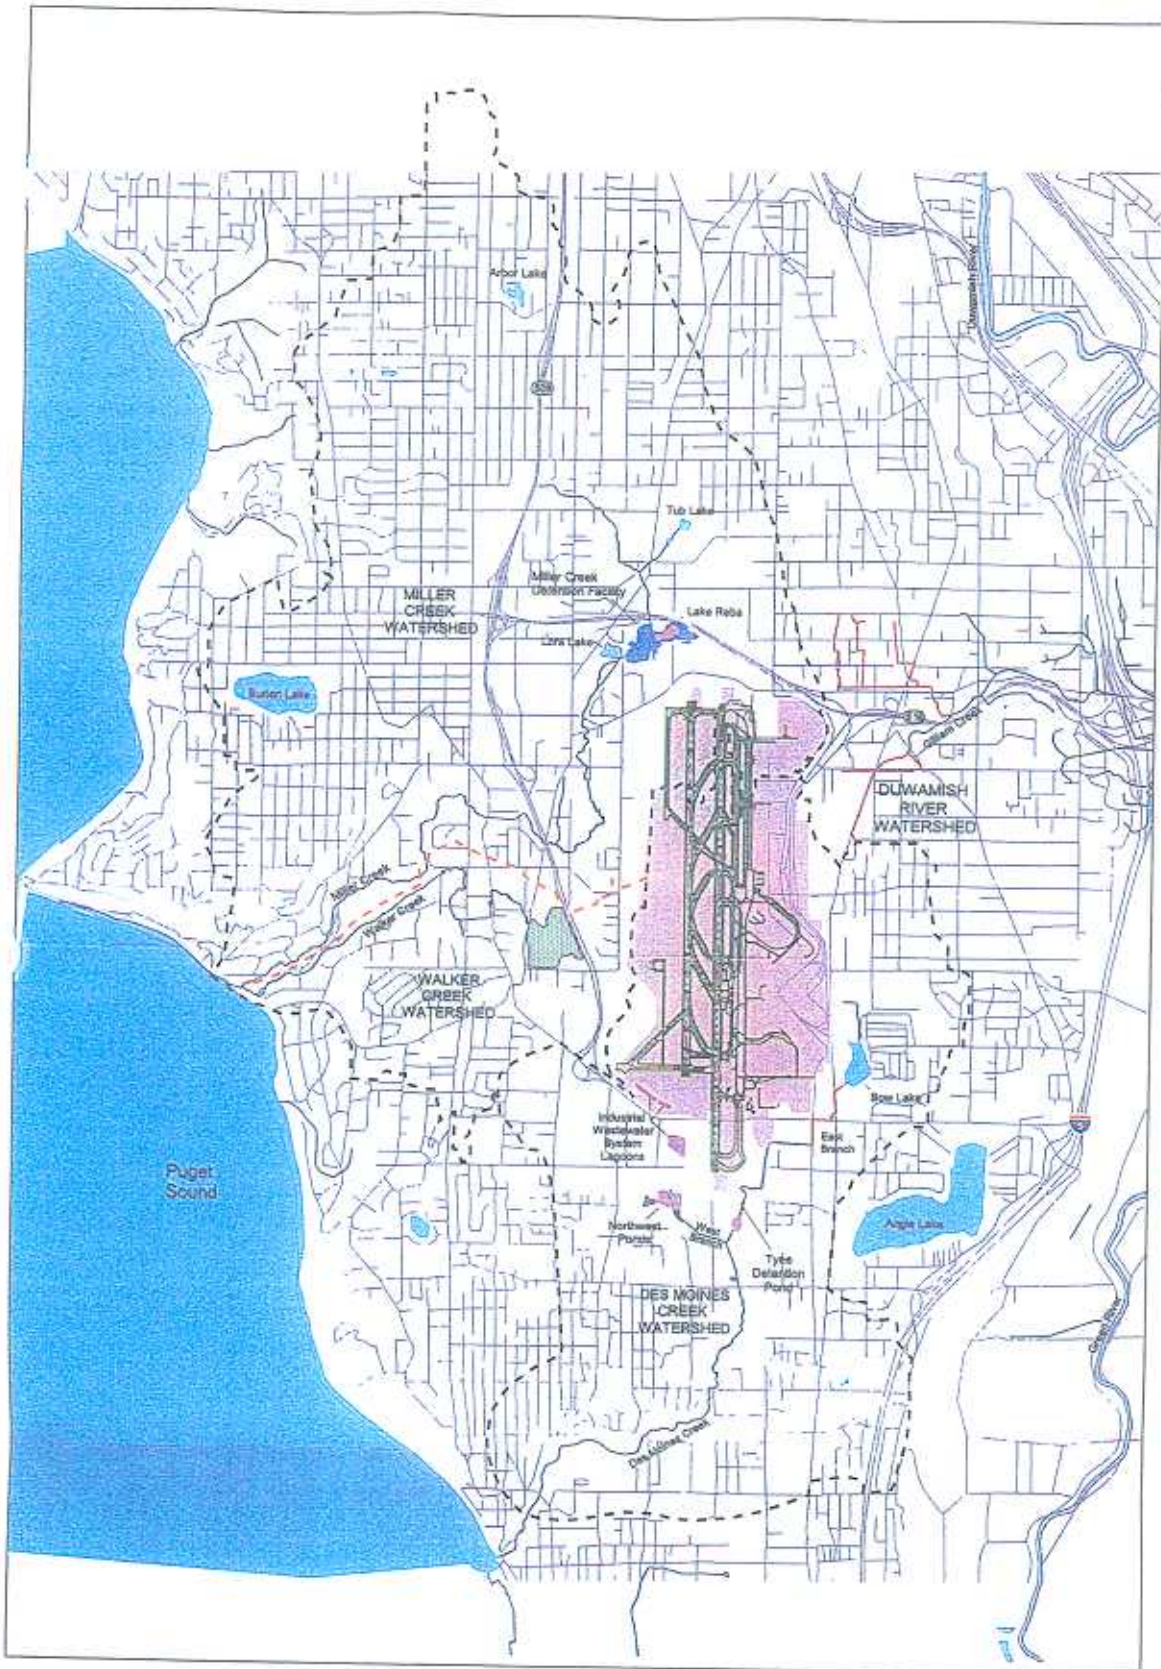
**Figure 1**  
**Miller Creek, Walker Creek**  
**Des Moines Creek and their**  
**Watershed Boundaries**

Parsons, Inc. Sea-Tac Airport (5A-212-001) File: E:\042012\042012001\042012001\_1\_jerdley.apr  
 Notes: Shaded areas are King County GIS. Water bodies defined from 1995 topography data.  
 Wetland boundaries are approximate. Wetland wetland boundaries are based on field measurements by Parsons, Inc.

The Seattle-Tacoma International Airport project area drains to several streams, including Miller Creek (and its Walker Creek tributary), Des Moines Creek, and the Green River via Gilliam Creek (see Figure 1). Baseline and historic watershed and fish habitat conditions in drainage areas affected by Master Plan Update improvement projects (Miller and Des Moines Creeks) are described in this section.
