Baseline Soil and Groundwater Quality Assessment Seattle City Light Long-Term Lease Option Seattle, Washington

Boeing Environmental Affairs
Seattle, Washington

May 1990

WESTON
MANAGERS DESIGNERS/CONSULTANTS

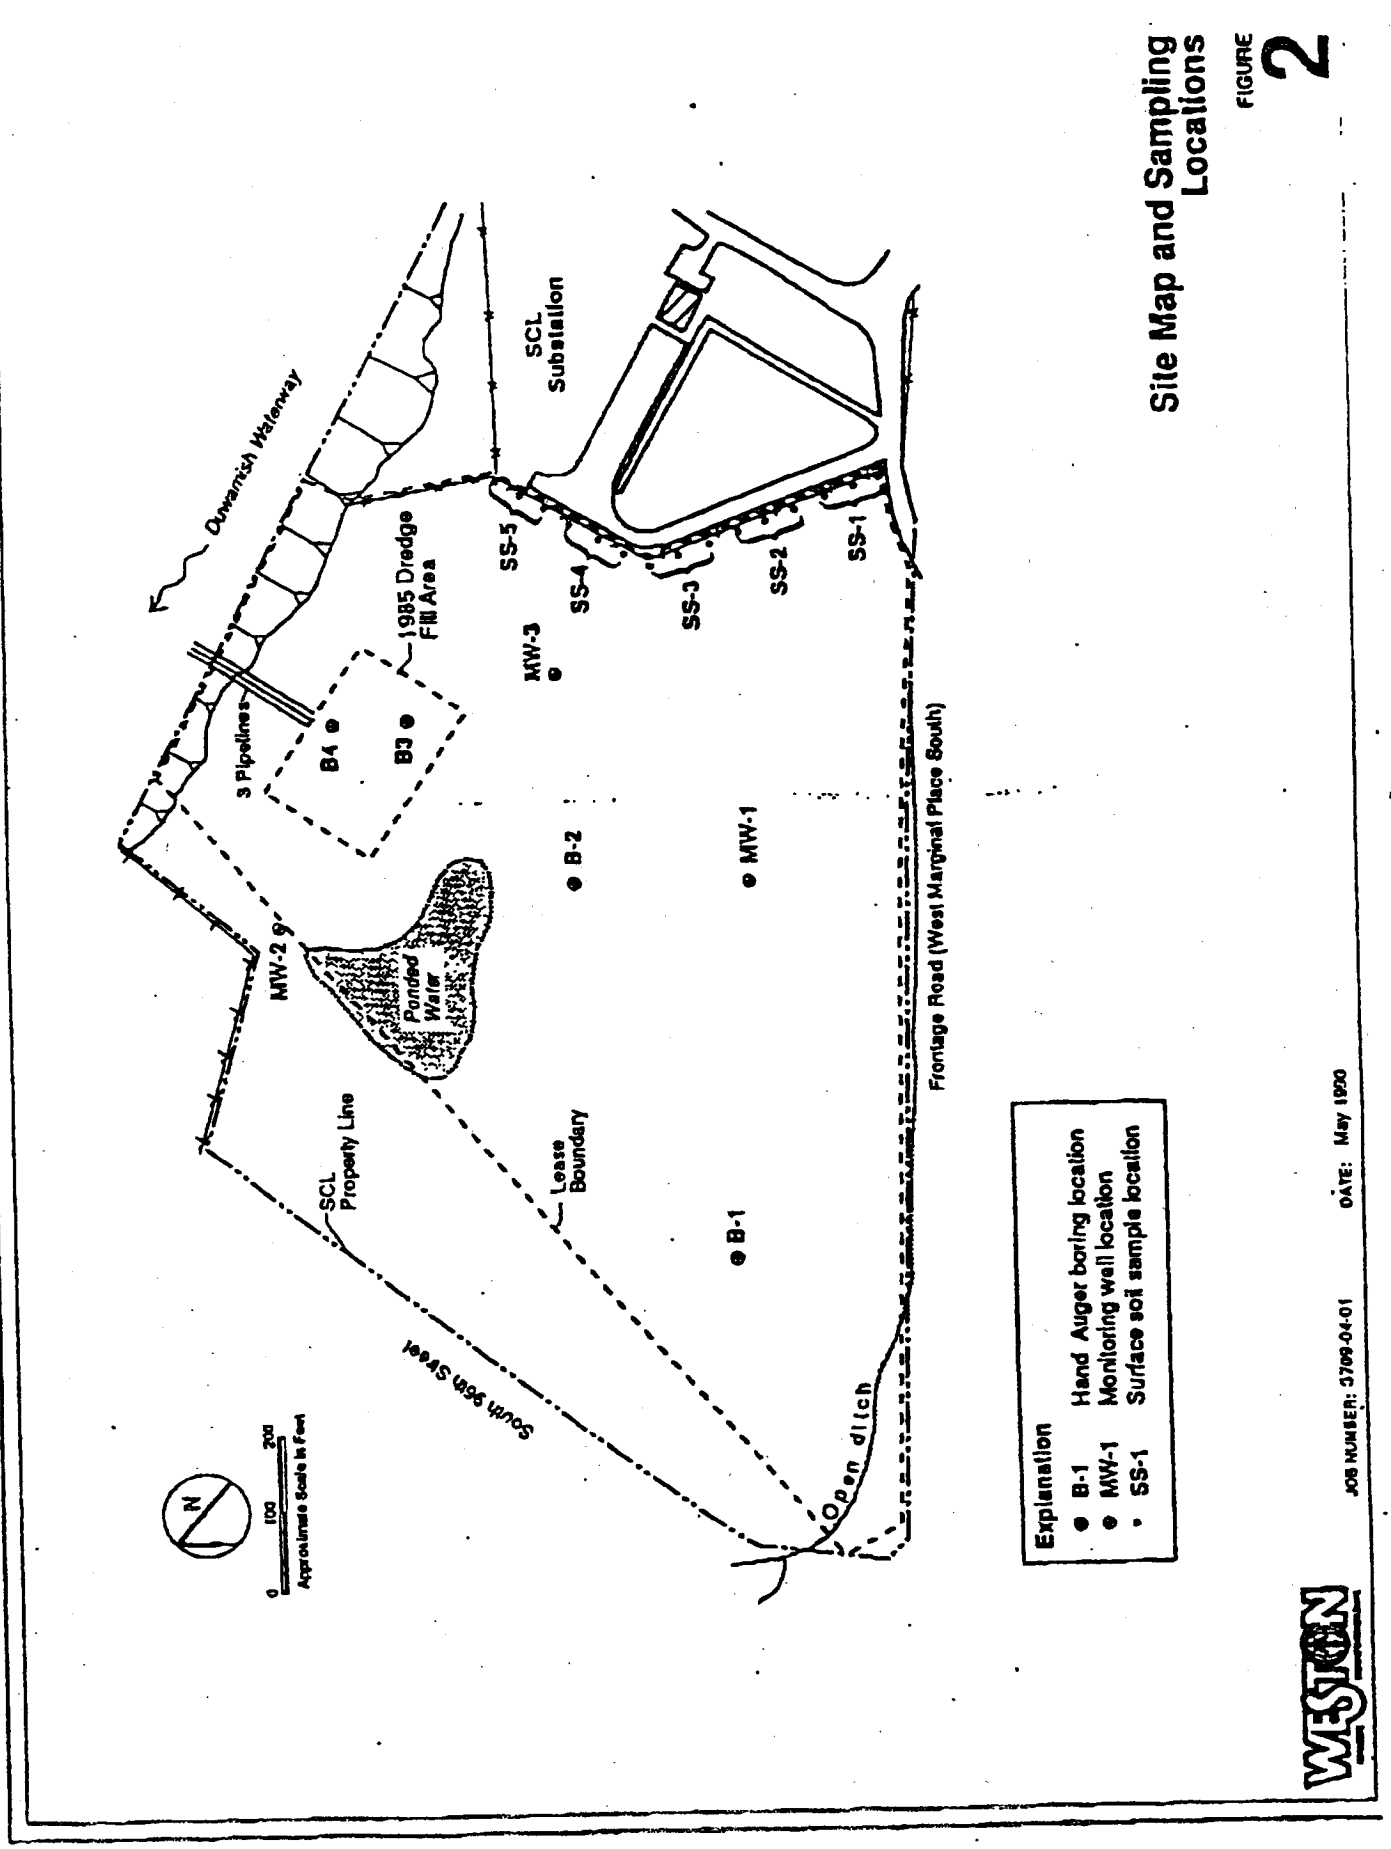
FIGURE 2

Site Map and Sampling Locations

Seven soil borings were drilled on the property (Figure 2). Three of the borings, designated MW-1 through MW-3, were drilled to a depth of approximately 20 feet using a mechanical drill rig and were completed as monitoring wells on 17 April 1990. Four of the borings, designated B-1 through B-4, were drilled to depths of 6 to 10 feet using hand-auger techniques. Borings B-3 and B-4 were located in the 1985 dredge fill area. All of the other borings were completed in the 1968 dredge fill area. A discussion of drilling, sampling, and decontamination procedures used at the site are provided in Appendix A. Exploration logs of the borings are also presented in Appendix A.

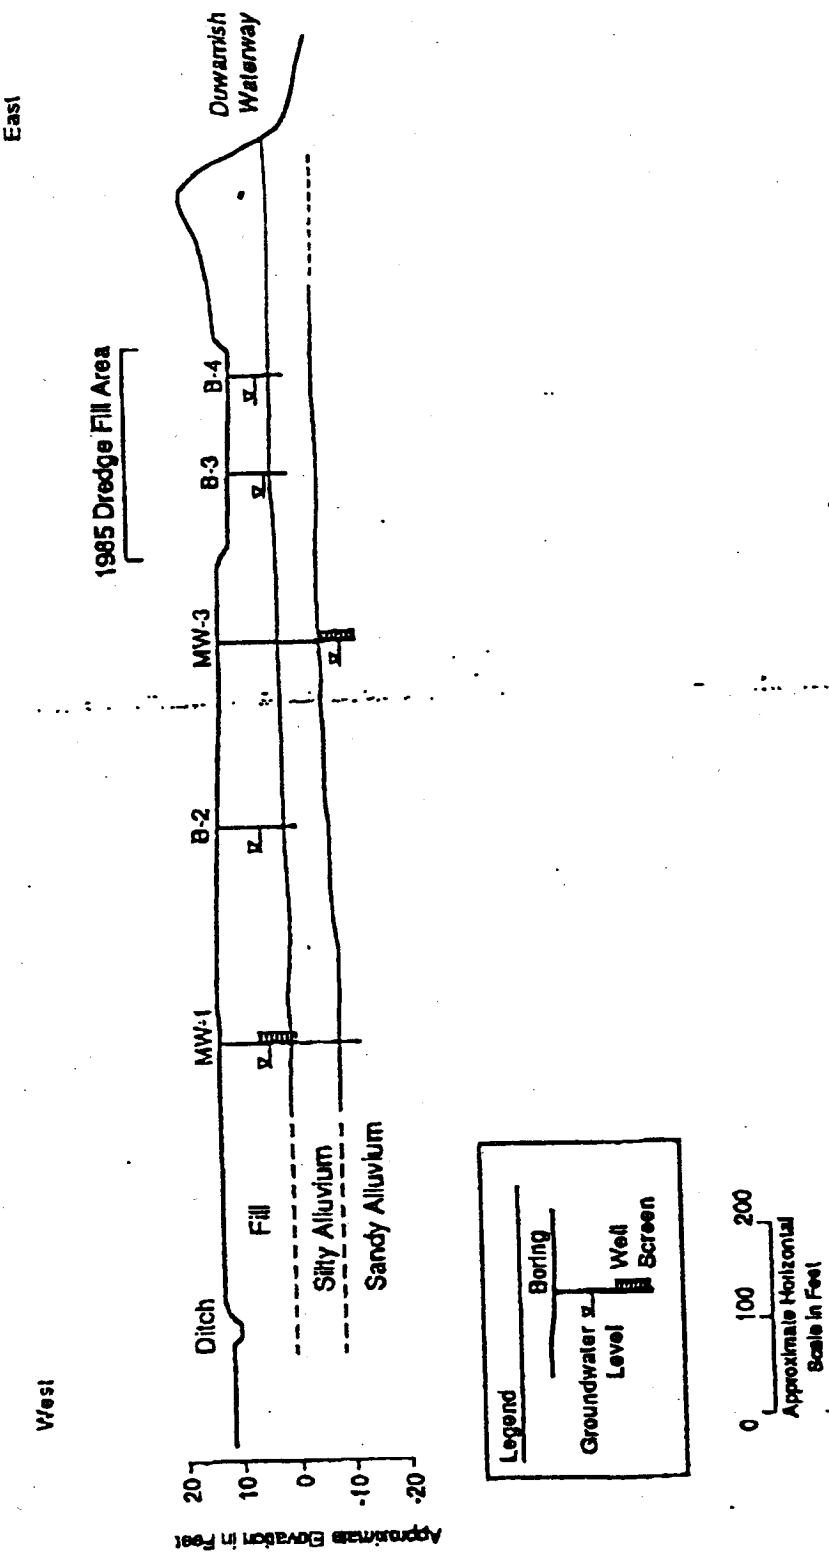
The subsurface investigation indicates that the property is underlain by approximately 5 to 10 feet of stratified, heterogeneous fill that, in turn, overlies alluvium of the Duwamish River floodplain (Figure 3). Apart from the man-made levee along the present bank of the Duwamish Waterway, the fill appears to thicken progressively westward across the property. The fill is thinnest (5.5 to 6.2 feet) in the topographic depression in the east portion of the property that apparently coincides with the limits of the 1985 dredge fill.

Relatively little lithologic or textural difference was noted between the 1968 and 1985 fills. The fill is composed predominantly of crudely layered silty sand and clayey silt. The upper 1 to 4 feet of the fill is typically a loose to medium-dense, moist, brown, silty sand. Dense, black, carbonaceous, fine sand and stiff, black, clayey silt typically occur beneath the surface layer. The black sand and silt often contain abundant wood fragments. In some borings, a saturated, gray, well-graded sand layer 0 to 4 feet thick occurs at or near the base of the fill.
