Some Observations of Geotechnical Aspects of the February 28,
2001,
Nisqually Earthquake in Olympia, South Seattle, and Tacoma,
Washington

Performance of Earth Structures

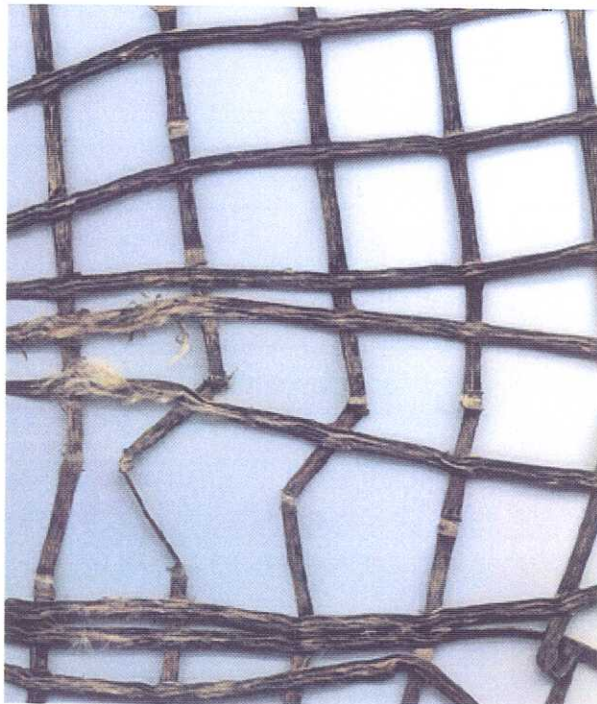
This wall had a segmental masonry facing and two types of geogrid reinforcement. The first is an asphalt-impregnated polyester biaxial geogrid with a 20 mm x 20 mm aperture. The second is a polypropylene biaxial geogrid with a 30 mm x 40 mm aperture (GPS N47.02479 W122.92230; 02/28/01).

Scan of sample from 20 mm x 20 mm polyester geogrid reinforcement.

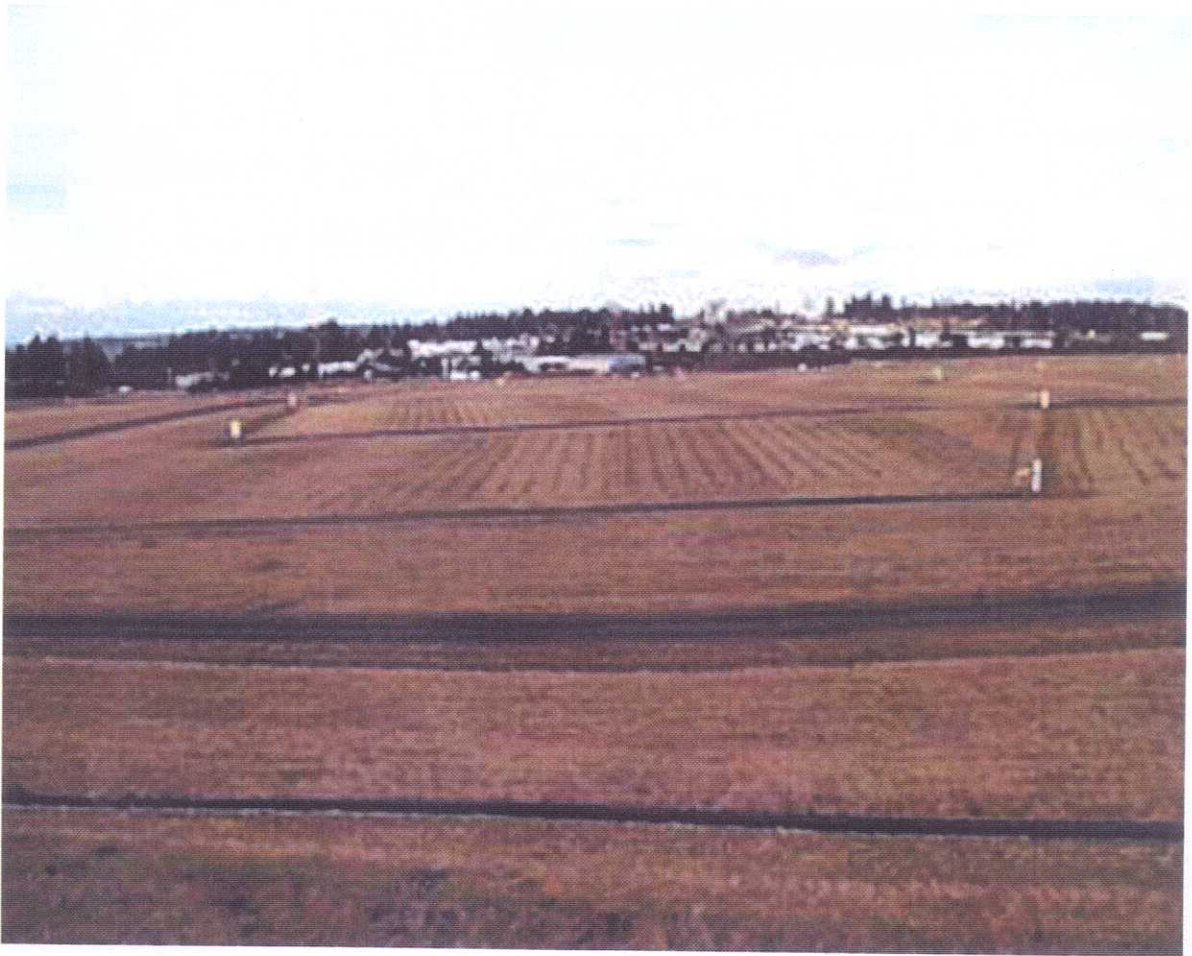
The Midway Landfill also has fairly flat slopes except on the north end (not shown). North-end slopes are on the order of 2H:1V (GPS N47.37583 W122.29367; 1157 03/03/01).
