## MEMORANDUM

**RE:** Post-Earthquake Reconnaissance and Photo Documentation  
STIA Third Runway Project  
J-4978-06

This memo and accompanying figures and photographs document observations by Hart Crowser on two occasions following the February 28, 2001, Nisqually earthquake.

**Third Runway Post-Earthquake  
3/2/01 Photo Documentation  
Photo Log Notes**

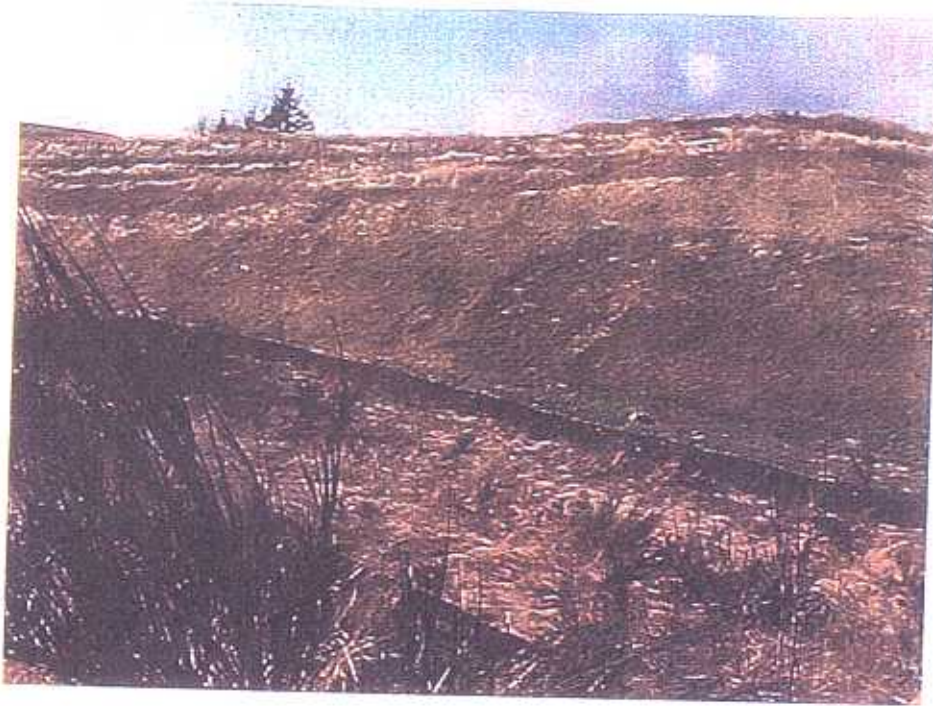
Photograph 1 -

- ① East end of 99 Fill
- ② From same location side view of N end of 99 fill
- ③ East end (southern half) of 99 Fill
- ④ ~~East~~ East end (northern 1/2) of 99 fill note: black spot is vine weevils
- ⑤ N. End of 99 fill (eastern portion)
- ⑥ N. end of 99 fill (central portion)
- ⑦ N end of 99 fill (western portion) note: recent stake pile @ top
- ⑧ N W corner of 99 fill
- ⑨ West end of 99 fill note contact w/ 2000 fill
- ⑩ N facing section of 00 fill from "pockets" wetland
- ⑪ adjacent to ⑩ same
- ⑫ East facing section of 00 fill from pocket wetland  
 note: minor sloughs on N. facing area all contain growing material and/or recent hydro seed i.e. pre-date earthquake
- ⑬ NE facing portion of 00 fill - note hydro seed on sloughed area
- ⑭ N extension - E face of 00 fill - minor sloughs
- ⑮ close up of slough area on E face of N extension of 00 fill  
 note: grass growing

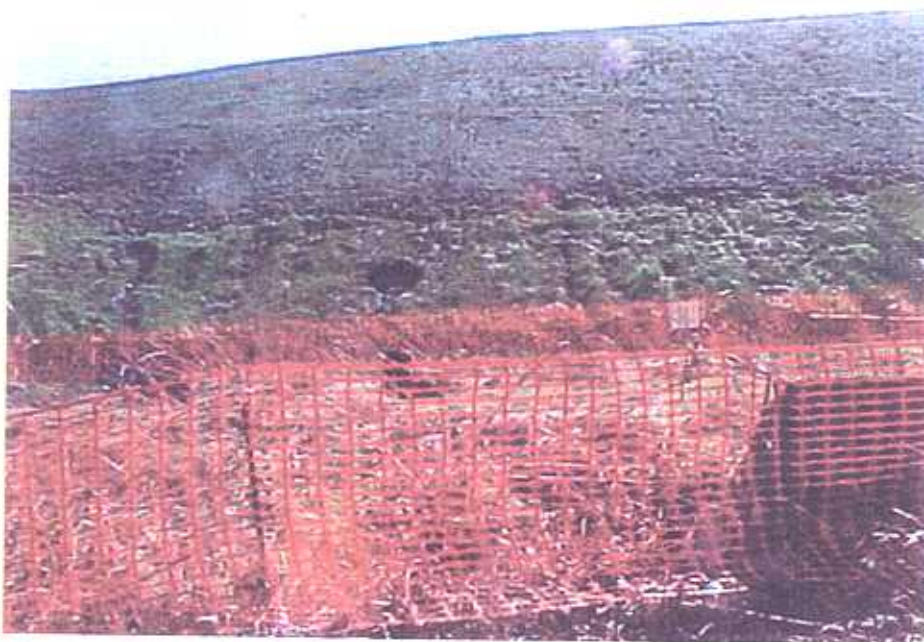
Photograph 10 -

10.	North facing section of 2000 fill from "pocket" wetland.
11.	Same, adjacent to photo 10.
12.	East facing section of 2000 fill from pocket wetland. Note: Minor sloughs on north facing area contain growing material and/or recent hydroseed (i.e., predate earthquake).

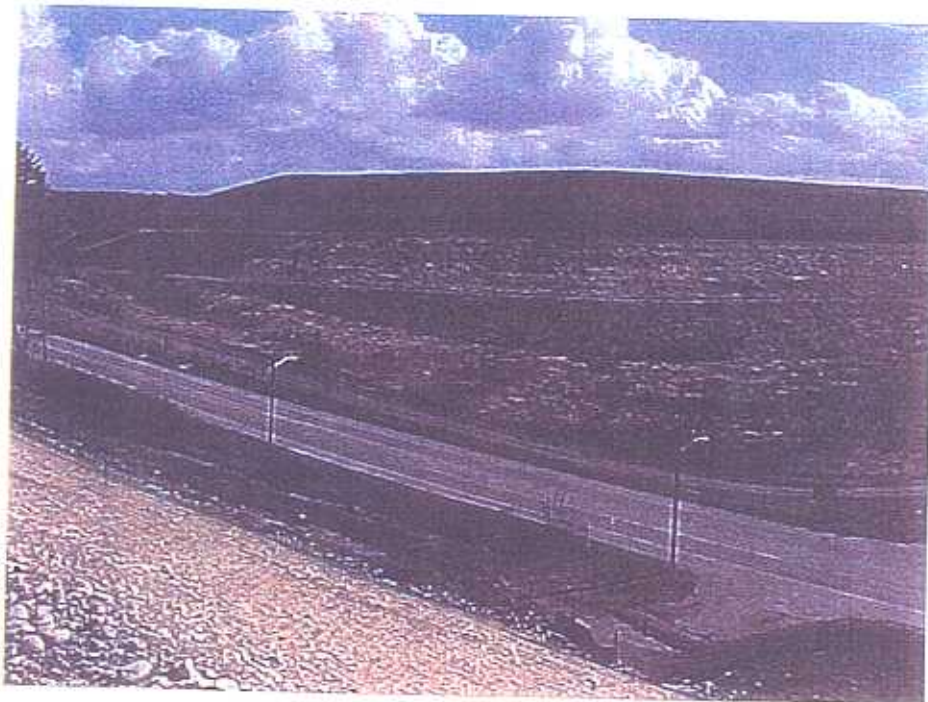
Photograph 26 -

25.	Surface of 2000 fill - no cracks observed.
26.	AOA fill - north face from 2000 fill.
27.	AOA fill - west face from 2000 fill.
28.	2001 fill - south side.

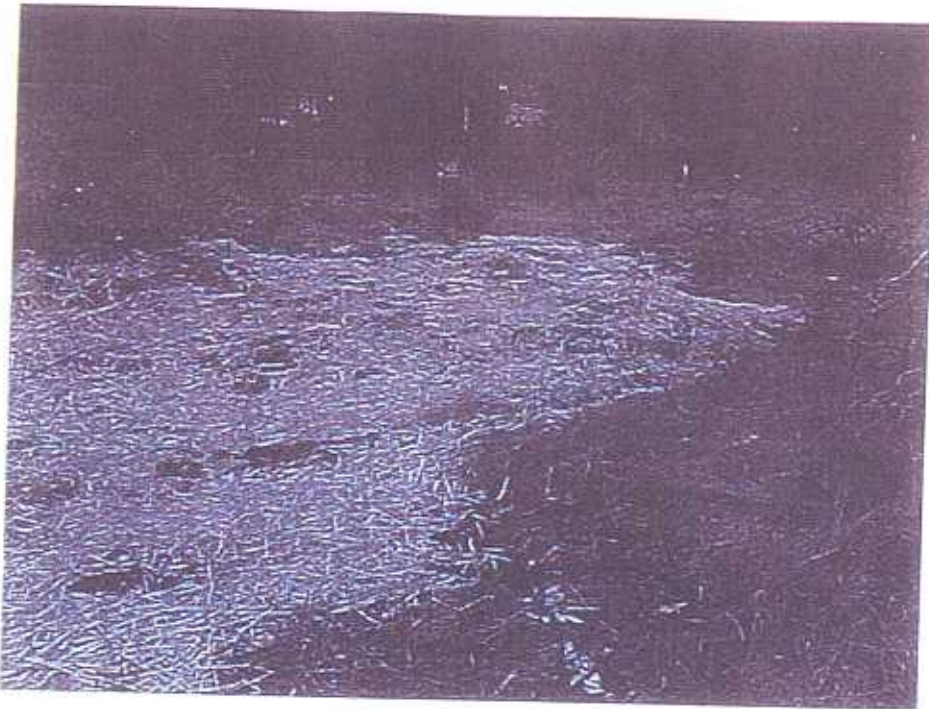
Photograph 37 -

- (36) West Wall area note PCS stain from recent dump activity
- (37) West Wall area same note
- (38) West Wall area same note and toe of wall stakes
- (39) West Wall area (lot 299) same note: wall cracks

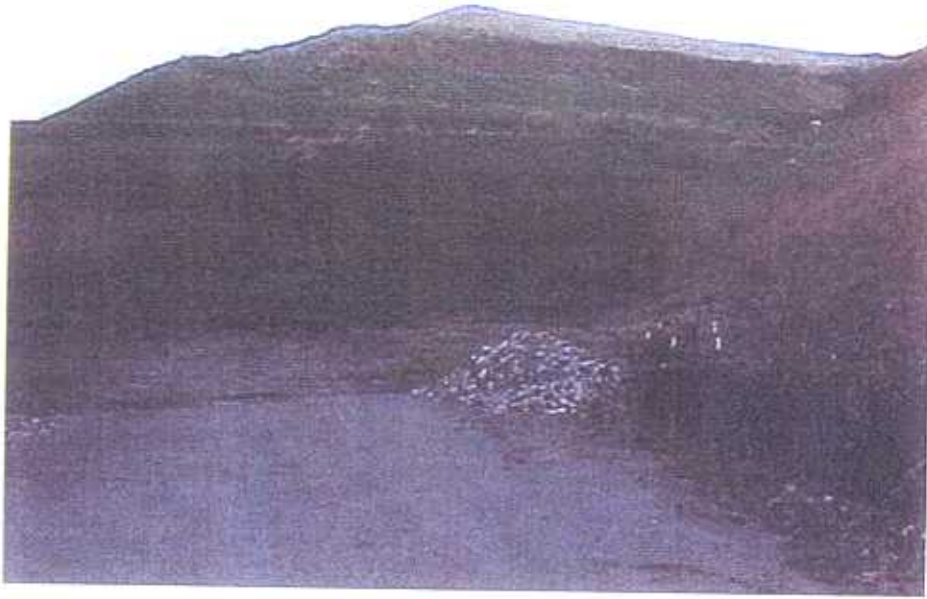
Photograph 47 -

- (47) S end of AOA Fill
- (48) SW Face of AOA fill - note few older clumps
- (49) SW Face of AOA Fill - southern portion, note drain pipe @ corner to W face
- (50) some just S of (49)
- end of  
series #3 (51) West Face of AOA fill looking N
- (52) Surface of SW Face of AOA Fill - no cracks
- (53) Surface of W Face of AOA Fill - no cracks
- (54) N Face of AOA fill
- end of  
series #2 (55) W. Face of AOA fill - N. end note corner to N face
- (56) W Face of AOA Fill - center
- (57) W Face of AOA Fill - S. end - note corner to SW face

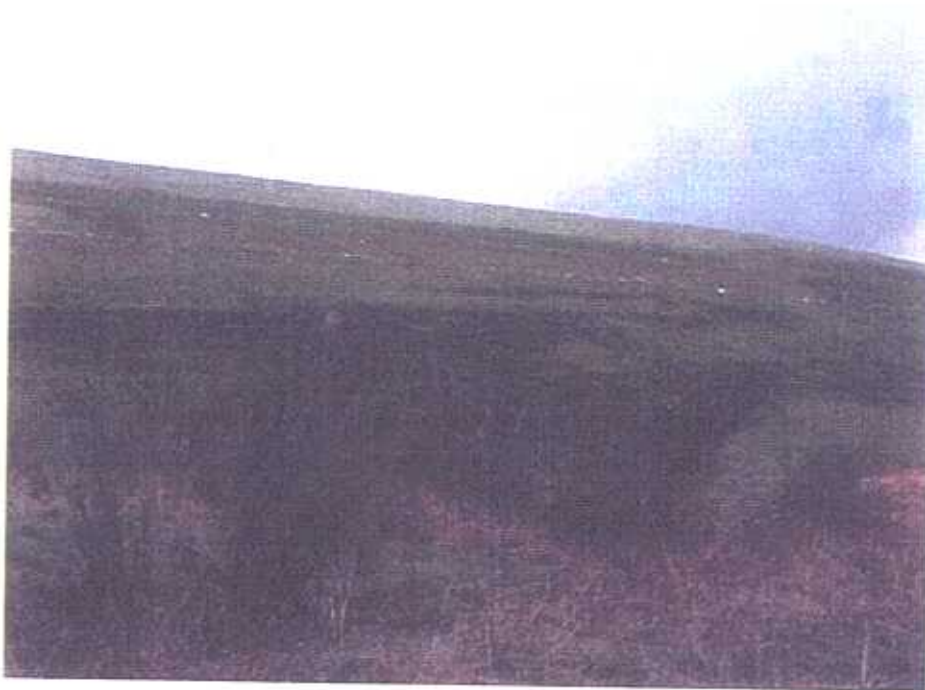
Photograph 50 -

50.	Same, just south of photo 49.
51.	West face of AOA fill looking north.
52.	Surface of southwest face of AOA fill - no cracks.
53.	Surface of west face of AOA fill - no cracks.
