Some Typical Examples Of Port Package Problems

These are examples which attempt to capture the various *types* of Port Package issues that cannot be attributed to normal wear and tear or 'user-error'. The distribution of problems is roughly equal throughout the geographic area where Port Packages have been installed, although the *types* of problems occasionally vary due to a particular product and contractor.

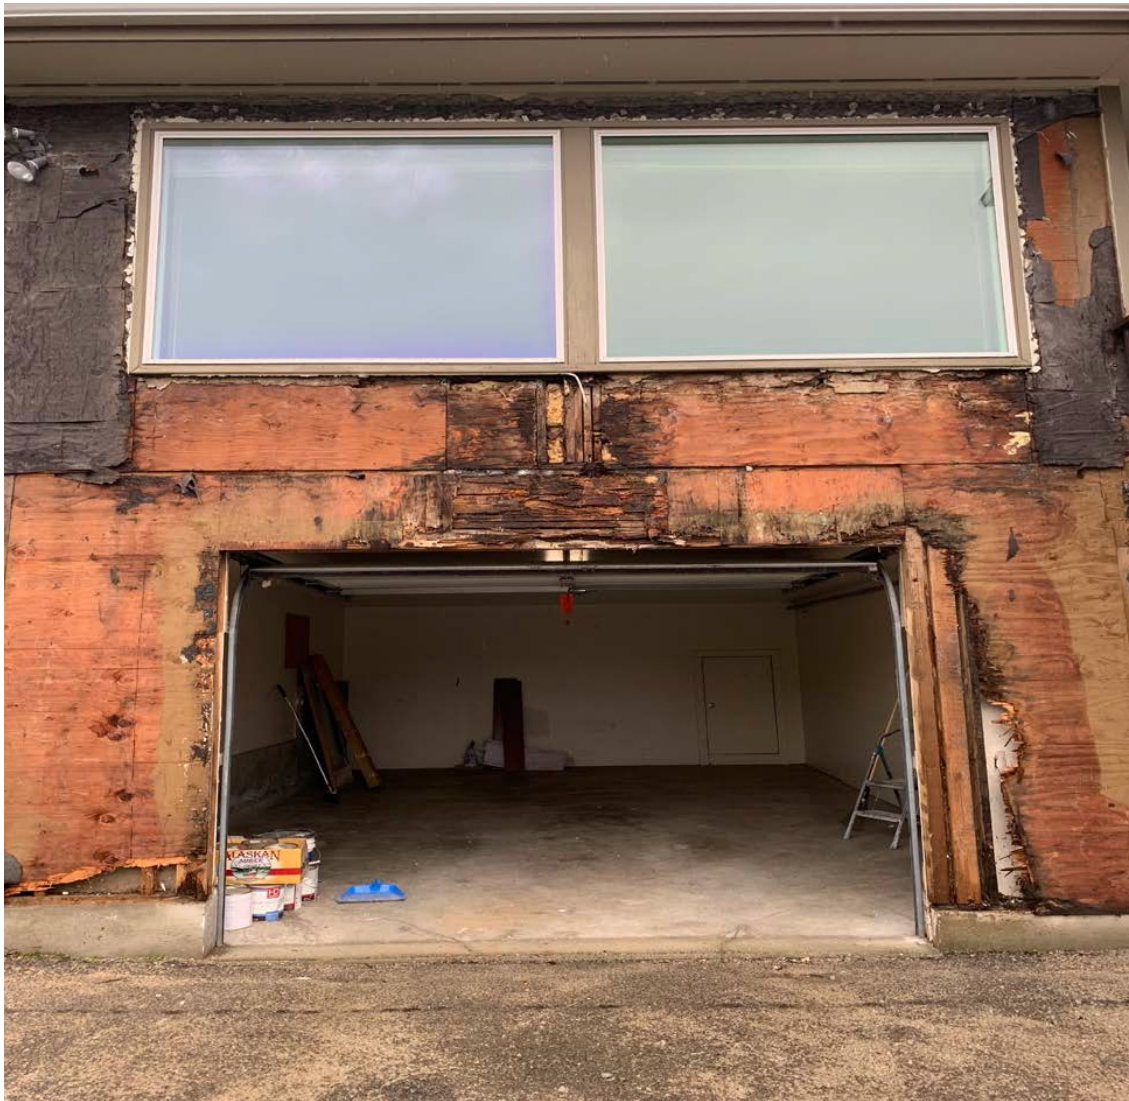
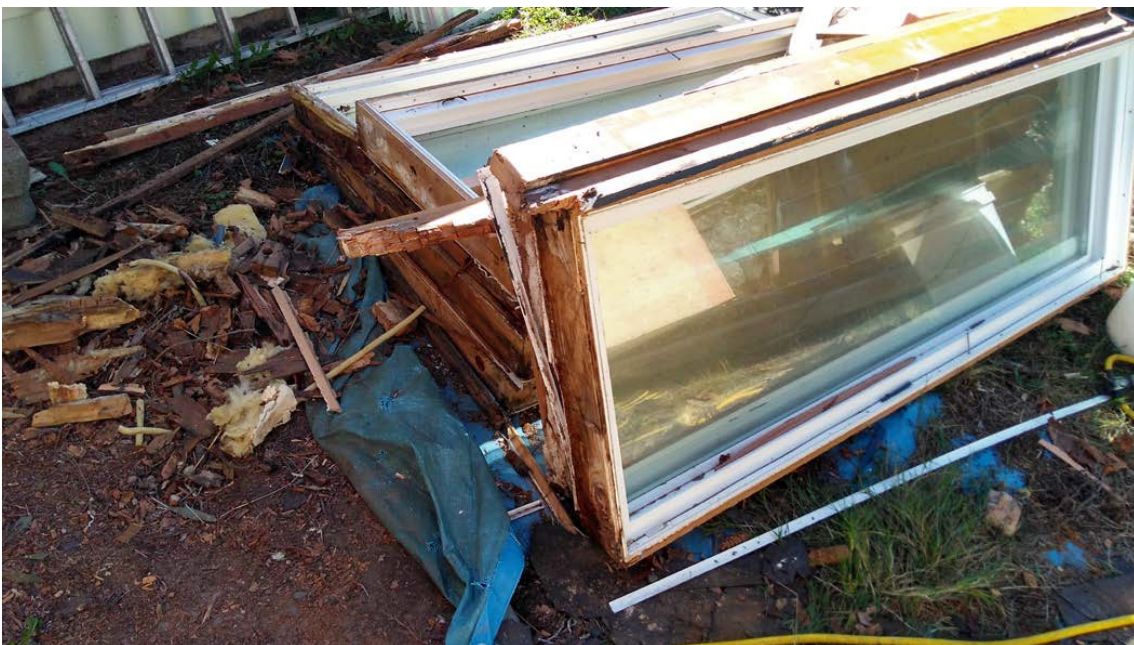
Two common types of structural damage. These are both *not* 'Alpine Windows'. The top example is a split-level home (the living room is the two windows above the garage). In both cases, water gets in behind the framing and rots the underlying structure holding up the wall. **This requires the entire wall to be replaced. In the top case at \$100,000.**
