**ANALYSIS OF PREFERENTIAL GROUND WATER  
FLOW PATHS RELATIVE TO  
PROPOSED THIRD RUNWAY**

**SEATTLE-TACOMA INTERNATIONAL AIRPORT**

**PREPARED FOR:  
PORT OF SEATTLE**

**AESI PROJECT No. BV99122C  
JUNE 19, 2001**

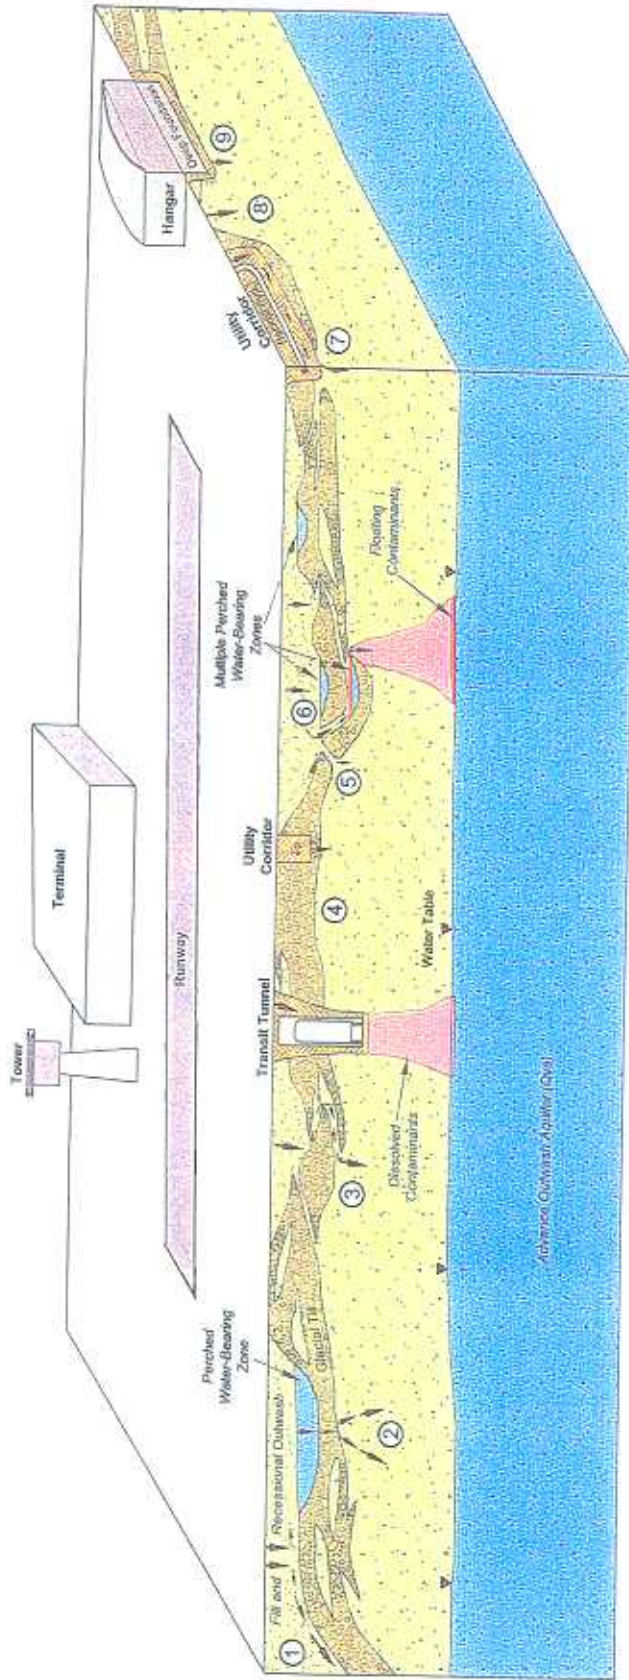
# Conceptual Model of Potential Perched Ground Water Flow Paths Seattle-Tacoma International Airport

## POSSIBLE PERCHED GROUND WATER FLOW PATHS ON AND THROUGH GLACIAL TILL

- ① Lateral migration on till surface - slow where slope is gentle, faster where slope is steep
- ② Slow seepage through till where perched
- ③ Flow where till is discontinuous or through sand and gravel lenses
- ④ Vertical flow through backfill for transit tunnels or utility corridors
- ⑤ Vertical flow where till was not deposited
- ⑥ Flow between multiple perched zones
- ⑦ Lateral flow along utility corridors
- ⑧ Vertical flow where till has been removed by grading
- ⑨ Flow where till has been pervialitized by deep foundations

Within the AOMA, areas of contaminated ground water exist in both shallow perched zones and in the Qva. The perched zones are isolated and discontinuous, while the Qva is continuous. Figure 1 is a conceptual diagram illustrating the typical hydrogeologic properties and relationships below the AOMA. Figure 1 significantly simplifies typical conditions, but identifies key features:

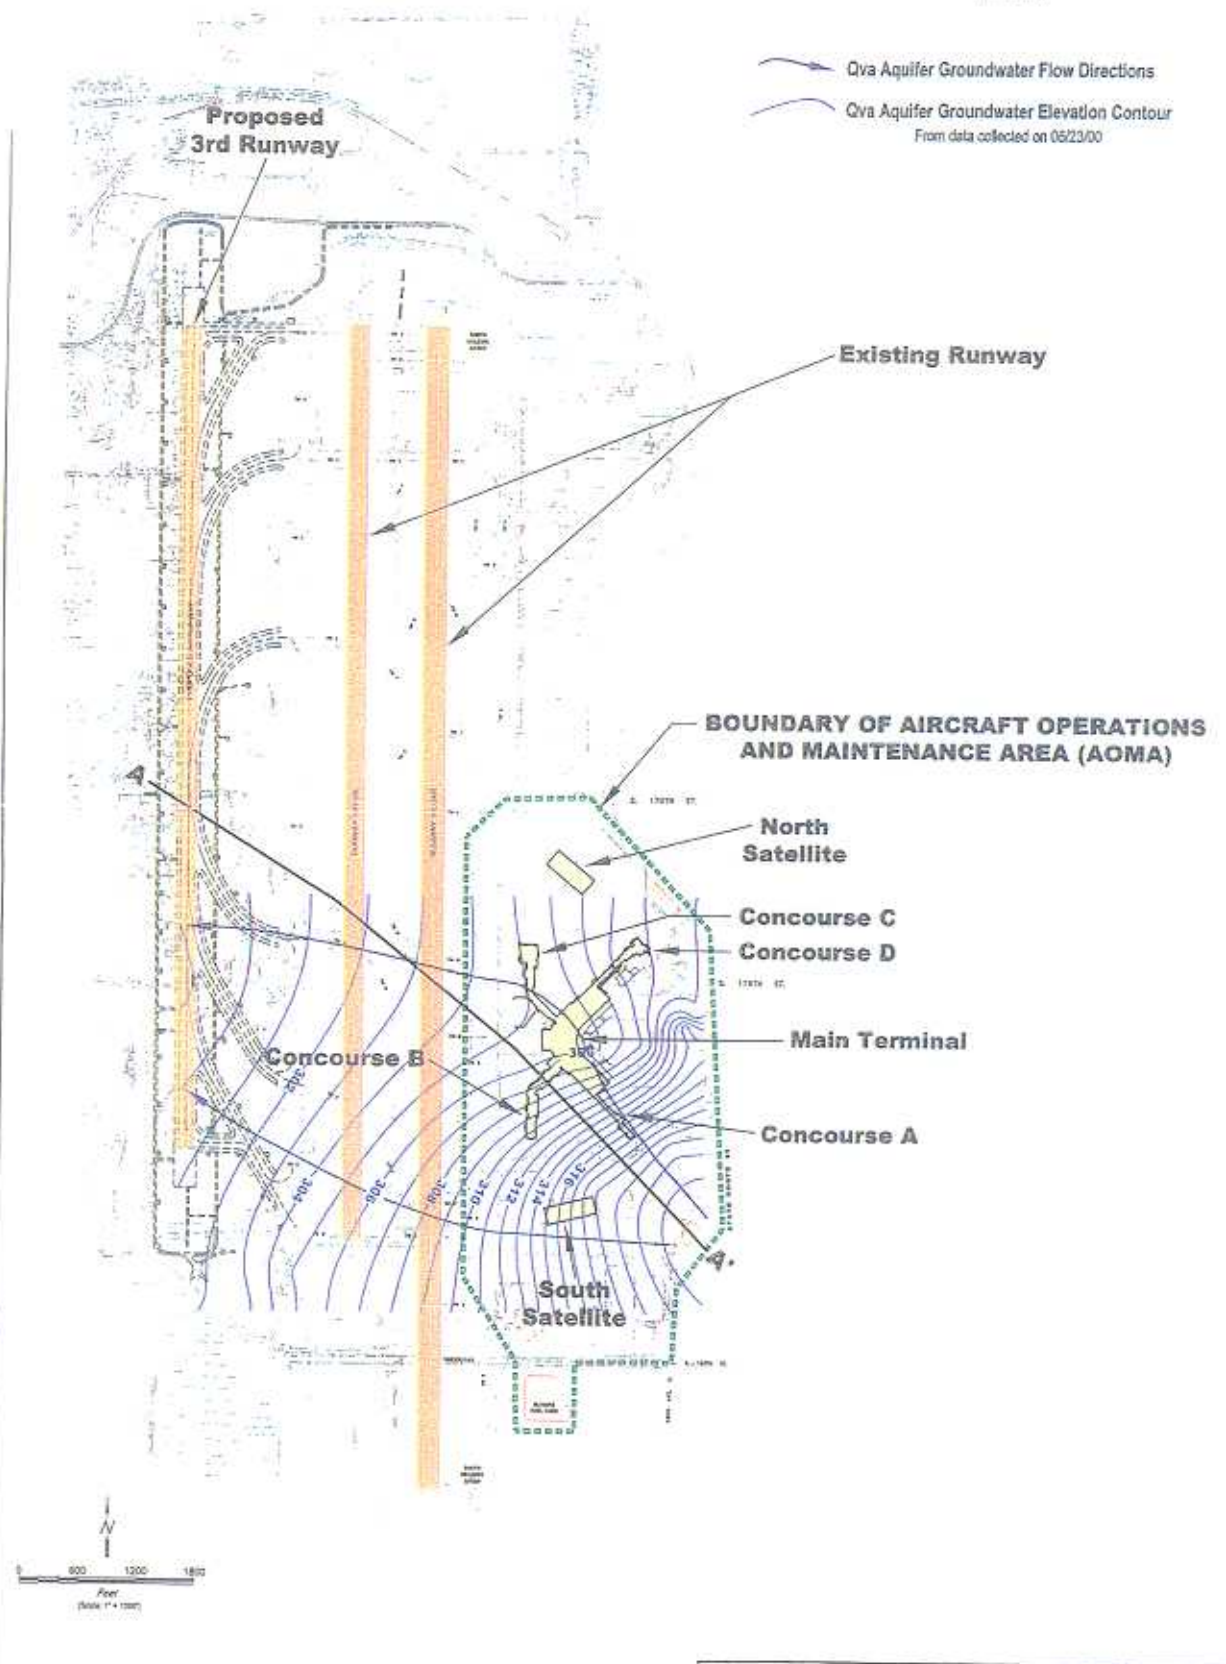
<b>Seattle Tacoma International Airport</b> Site Reference Map	DATE 06/14/01
	PLANNED BY PWS&S/ALM/
	NO. 2

Qva Aquifer Groundwater Elevation Contour  
From data collected on 05/23/00

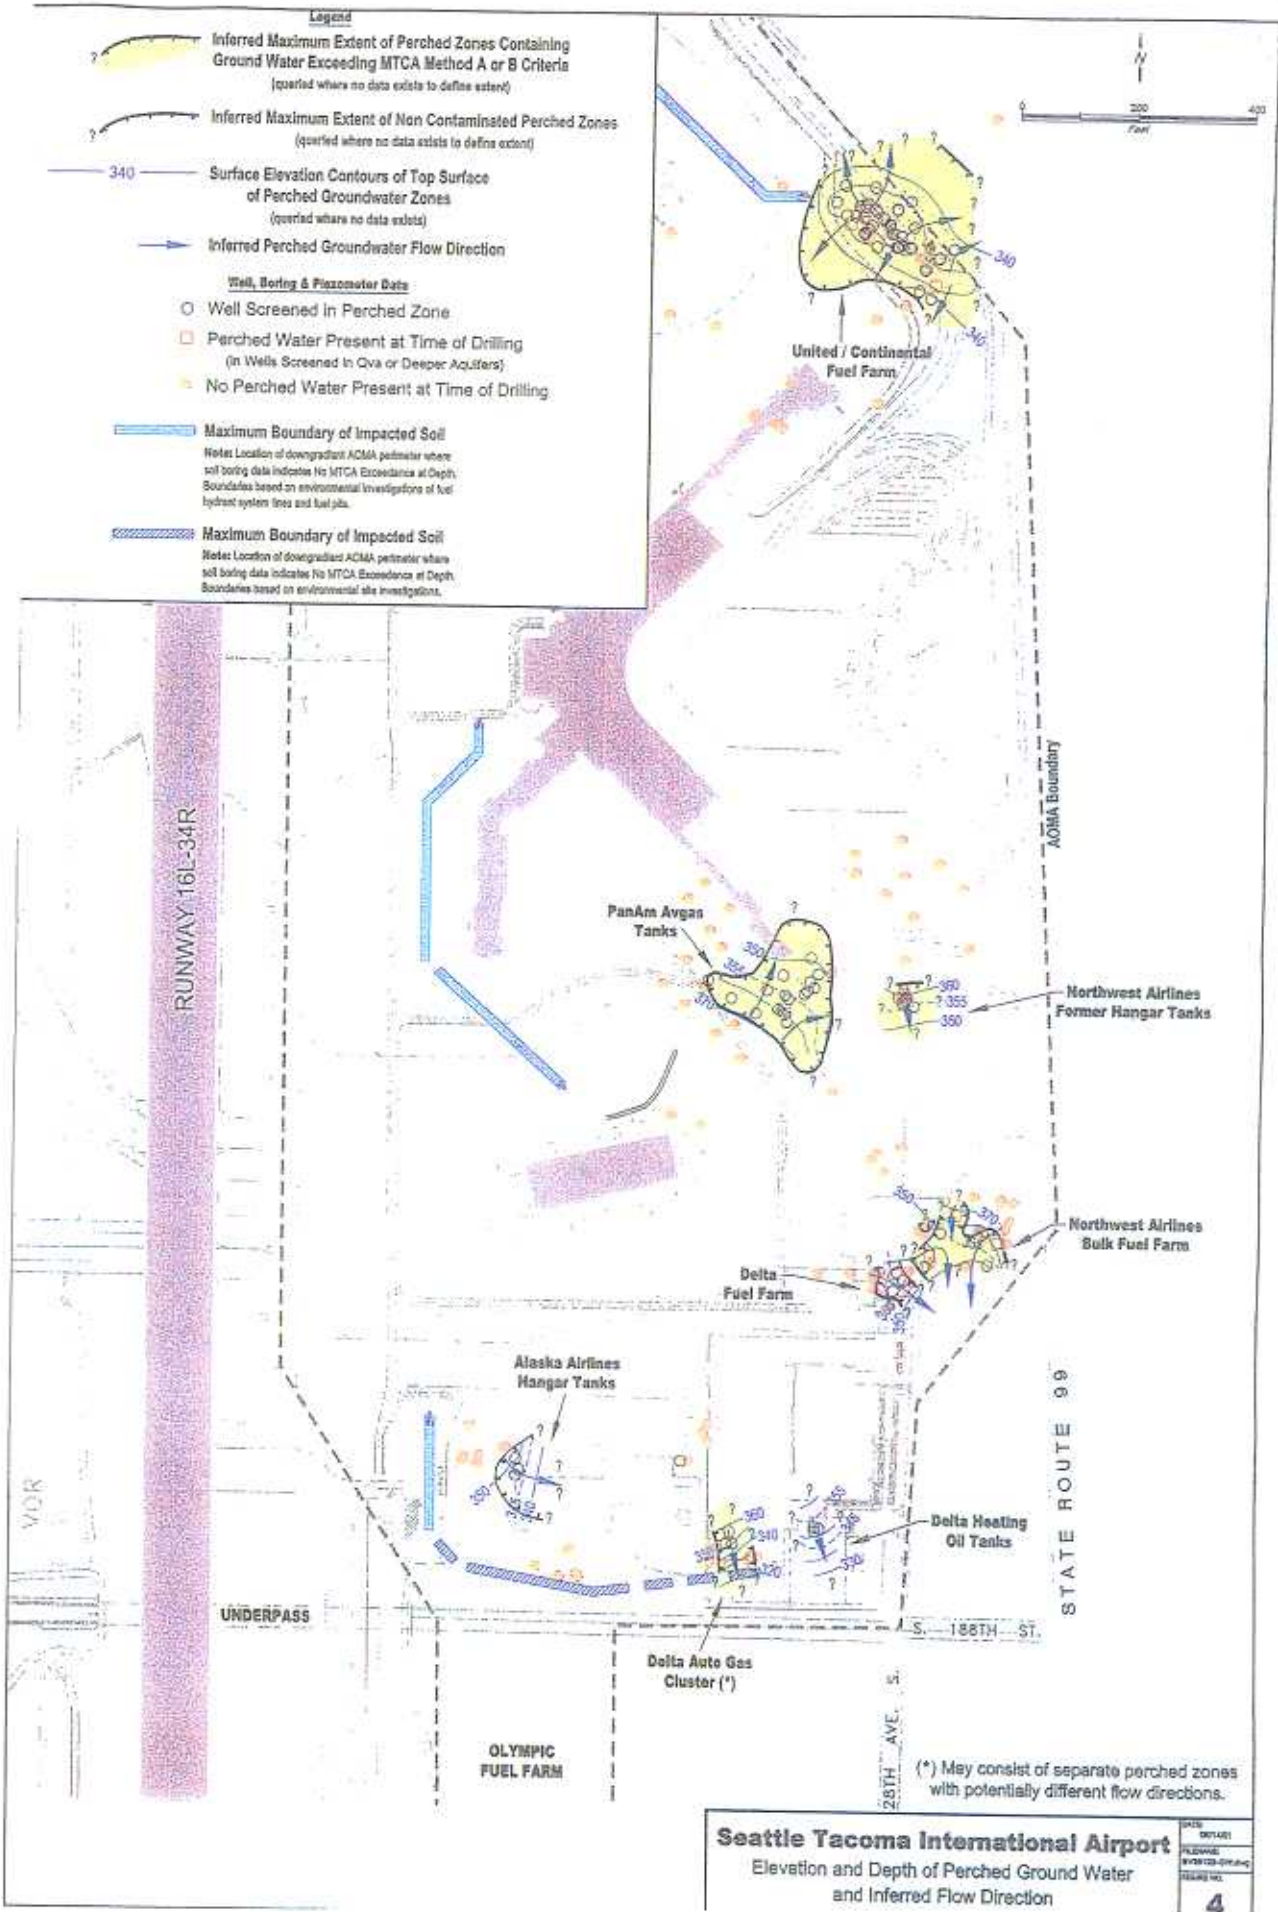
**Seattle Tacoma International Airport**  
 Elevation and Depth of Perched Ground Water  
 and Inferred Flow Direction

The United/Continental Fuel Farms Area site is located in an area where three discontinuous perching zones between the surface and about 40 feet below ground surface have been mapped (Figure 4). Area utilities are located from the near surface to a depth of about 20 feet below ground surface. Local perched water contours suggest radial flow, although the multiple perching layer stratigraphy also suggests a strong vertical component of flow. In addition, it appears that localized mounding of perched ground water is occurring at this site as a result of infiltration resulting from precipitation collecting in the tank farm backfill and surrounding unpaved areas. This mounding has resulting in a radial direction of perched ground water flow. However based on soil data collected to the west of this area, it appears that the perched water condition is limited to the tank farm area. Boring logs for adjacent site wells on the west suggest no perched water is present. Remediation is ongoing, including planned installation of additional perched wells to the southeast.

The Northwest Hangar Tanks site is located in an area where perched ground water occurs at about 18 feet to about 32 feet below ground surface in the immediate vicinity of the tanks excavation area (Figure 4). Area utilities are located from the near surface to a depth of about 12 feet below ground surface. Frequent observation of unsaturated well conditions just outside the tank excavation area, and the absence of perched water in the boring for the nearest down gradient (west) well indicate the perching zone is localized to the tank area. The inferred direction of perched ground water flow in this area appears to the south towards the Northwest Airlines Hanger building. It appears that perched ground water is at a lower elevation than the depth of utilities, however, the deep foundation structure at the Northwest Airlines Hanger could provide a vertical pathway for perched ground water migration through the glacial till zone. Data from ground water monitoring wells indicated solvent-impacted perched ground water at this site. It appears that solvents in the perched ground water have migrated vertically and caused an impact to the Qva. Remediation continues through current construction; monitoring will be reinitiated following construction.

The former Delta tank installation was located in an area where multiple perching zones were identified, with zones between about 9 to 22 feet, and about 33 to 45 feet below ground surface (Figure 4). Area utilities are located from the near surface to a depth of about 10 feet below ground surface. Shallow perched ground water was observed to occur within the vicinity of the tank excavation but has not been observed beyond the tank excavation. The perched ground water flow direction appears to be towards the south. Dissolved contamination is bound on the west side by the presence of unsaturated soil conditions, suggesting the perched zones are restricted to the backfill areas of the tank excavations. Planned remediation was completed in conjunction with construction in 2000; additional evaluation of current conditions is pending.

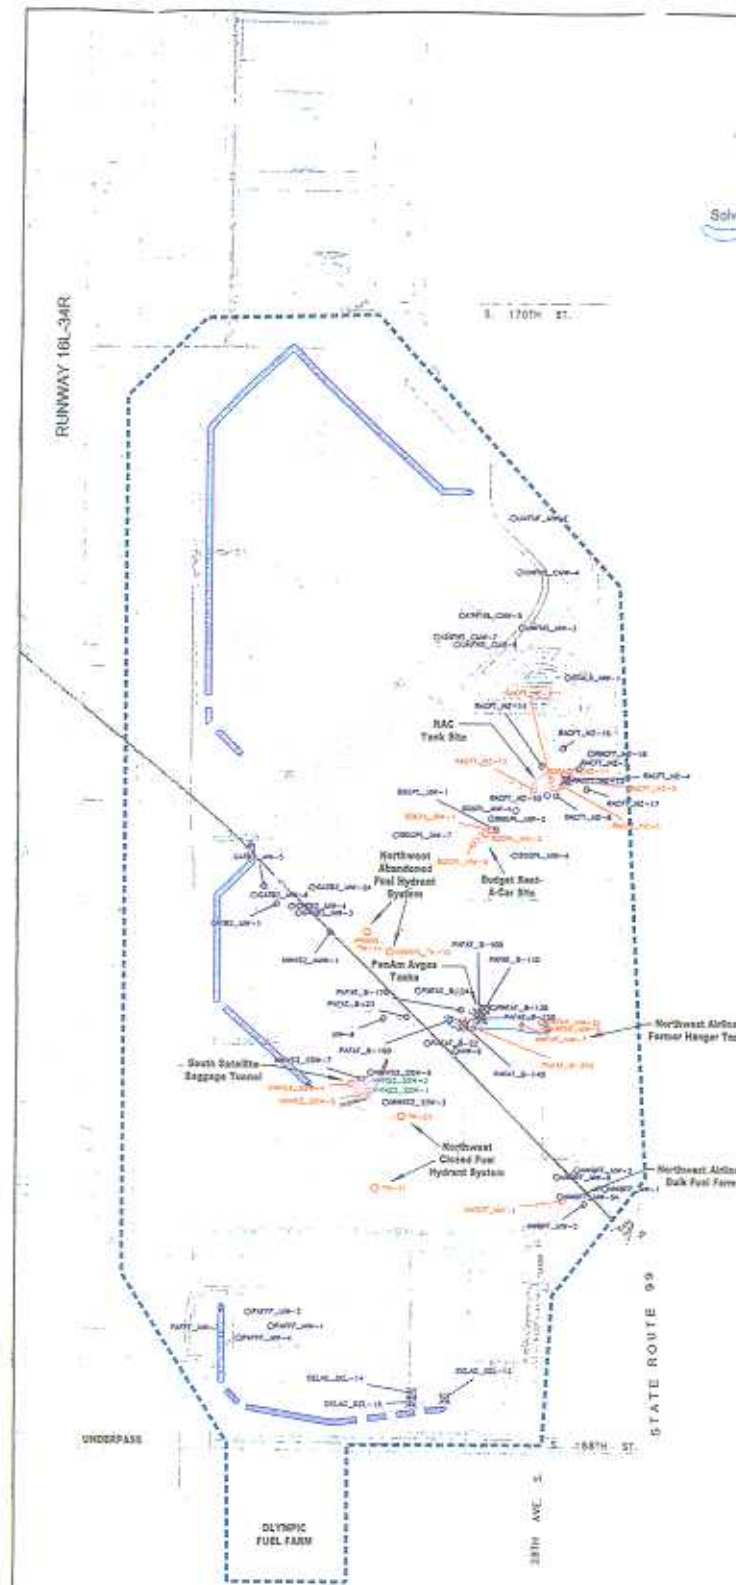
**Seattle Tacoma International Airport**  
AOMA Wells in Qva Aquifer W/ MTCA Ground Water Standard Exceedances

Fueling operations at the Northwest "Closed" hydrant system were discontinued in about 1996. This facility caused Qva impacts in three locations (shown on Figure 5), a fuel release at the South Satellite Baggage Tunnel Site, and indications of ground water impact near two fuel hydrant pits.

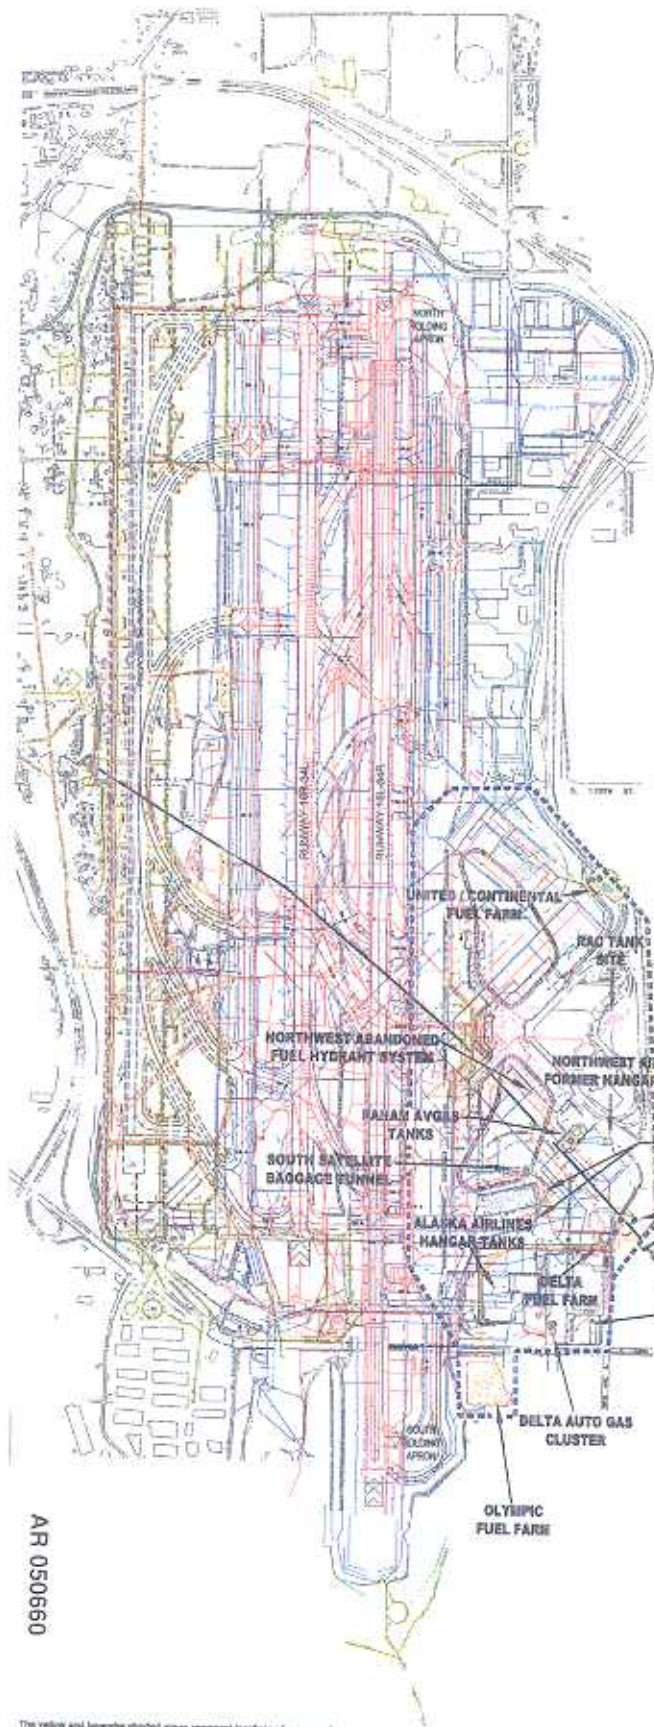
Utilities with a shaded background represent New Utilities Constructed in 2001 (near Main Terminal) and All New Utilities and Electric for the New Runway.

*Notes: Typical depth of 3rd Runway utilities, including water, sewer, IWS lines, electrical and communications ductbanks, etc. are 5 - 10 feet below ground surface, with a maximum depth of 15 feet. Proposed stormwater detention vaults and outlet piping may be located as deep as 40 - 45 feet below ground surface.*

The yellow and lavender shaded areas represent locations where ground water quality has exceeded MTCA Method A or Method B Cleanup Levels in perched water bearing zones and in the Qvs aquifer. These areas are illustrated using the most recent chemical analysis data entered in the Point of Discharge Environmental Interagency Information System database, and may not represent present day conditions. The shaded areas are not compound specific, but were chosen based on an exceedance value for any one of the suite of constituents analyzed.

- Figure 7 – Figure 7 presents an enlargement of the Figure 6 cross-section through the AOMA area. The enlarged cross section is developed through the Northwest Bulk Fuel Farm and the Pan Am Avgas Tanksites, areas where impacted perched ground water has been characterized. The perched ground water observed at the Pan Am Avgas Tank site represents the western-most area within the AOMA that contains impacted perched ground water exceeding MTCA standards. The cross section shows wells completed in the perched horizons at both the Northwest Bulk Fuel Farm and Pan Am Avgas Tank sites and indicates the perched water level elevation as shown by the blue triangle. Utility lines are shown on the cross section, which are positioned at a typical construction depth of 10 feet.
