Des Moines Creek Basin Plan

DES MOINES CREEK BASIN PLAN

November 1997

Des Moines Creek Basin Committee

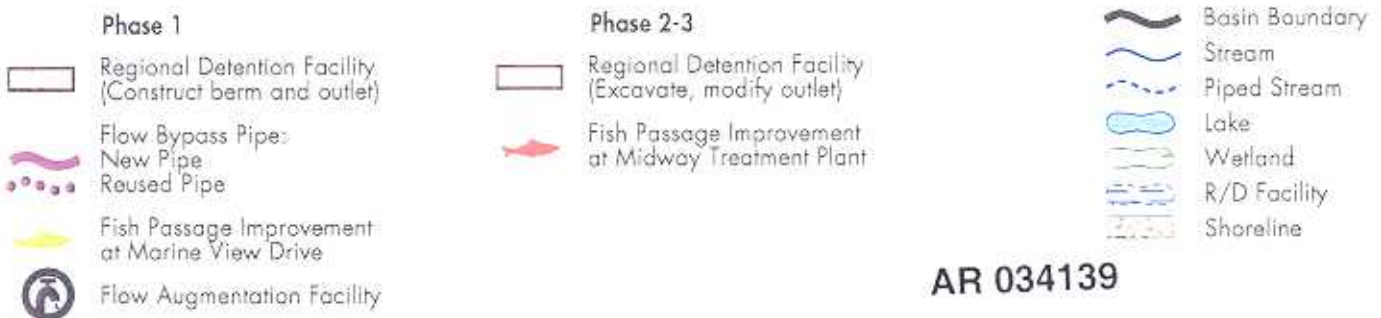
Figure 6-1

DES MOINES CREEK BASIN Capital Improvement Projects

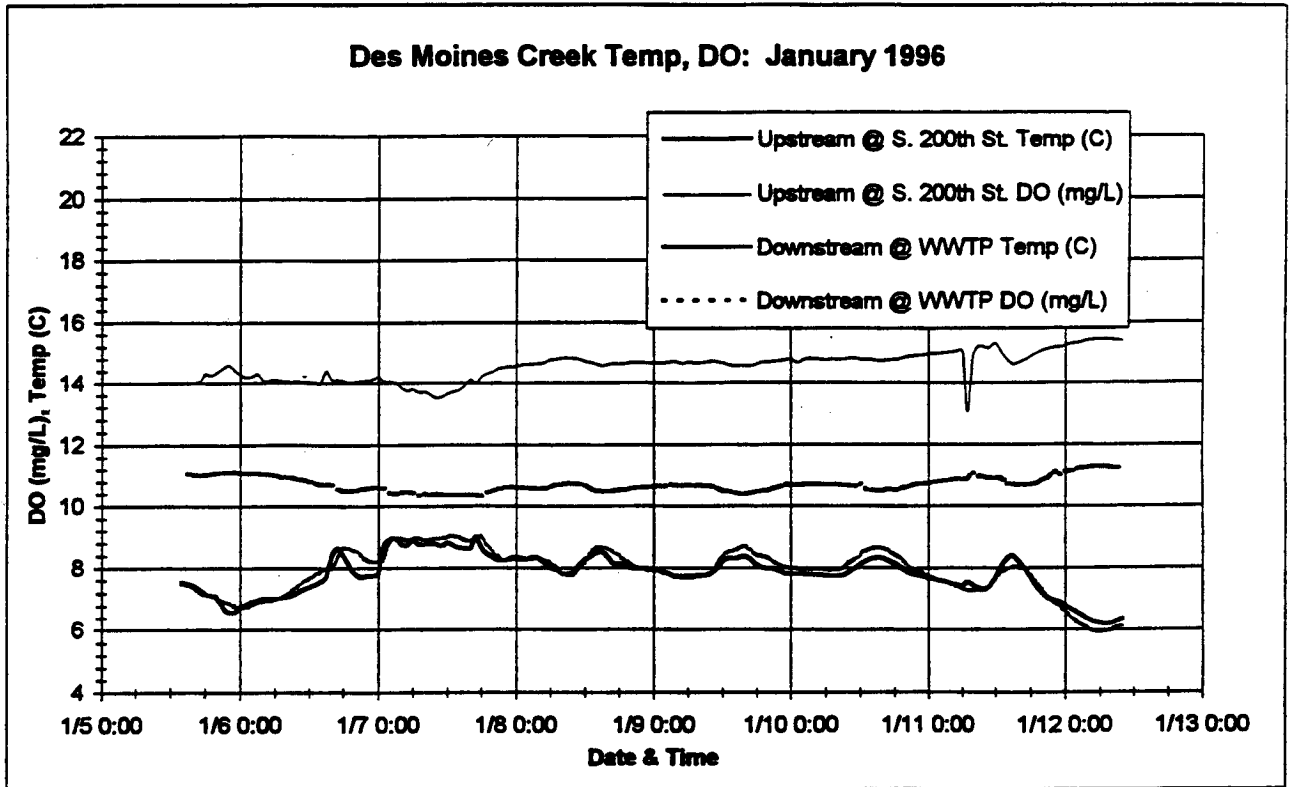
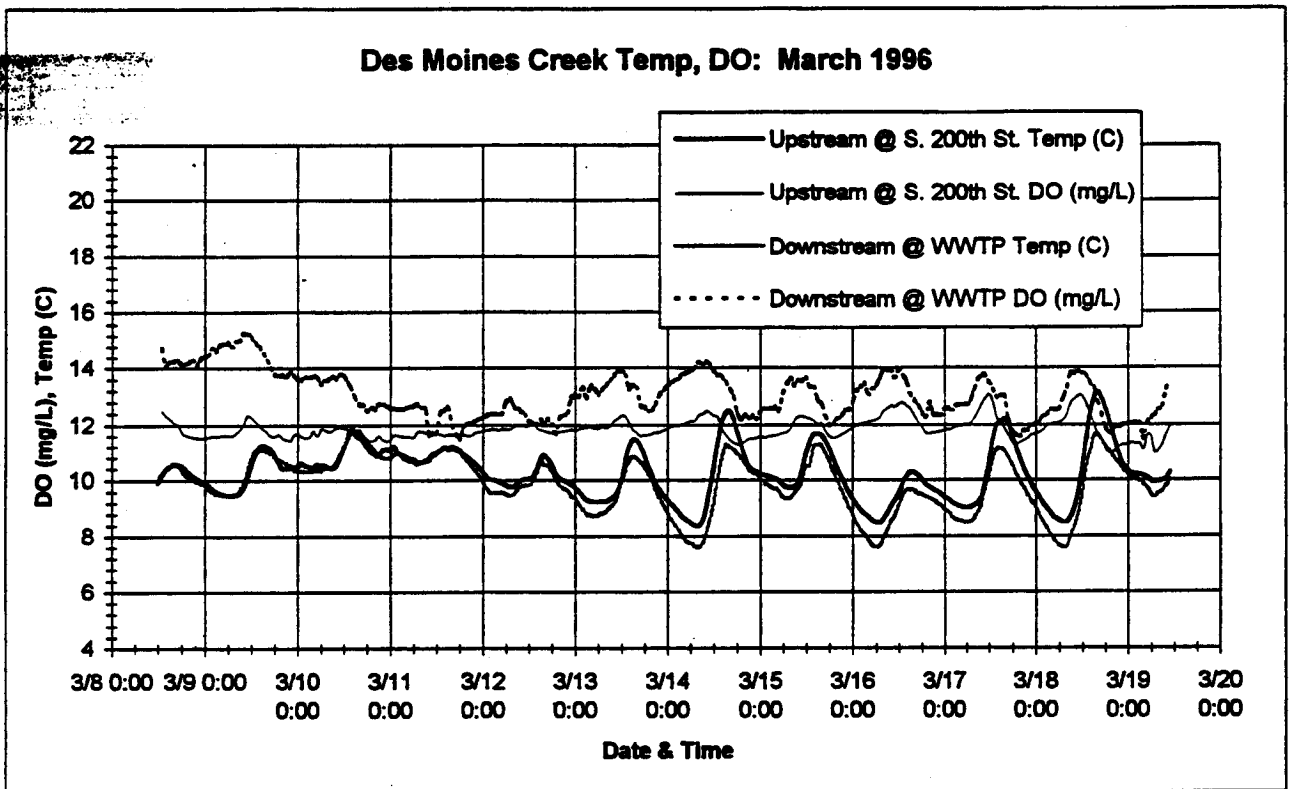
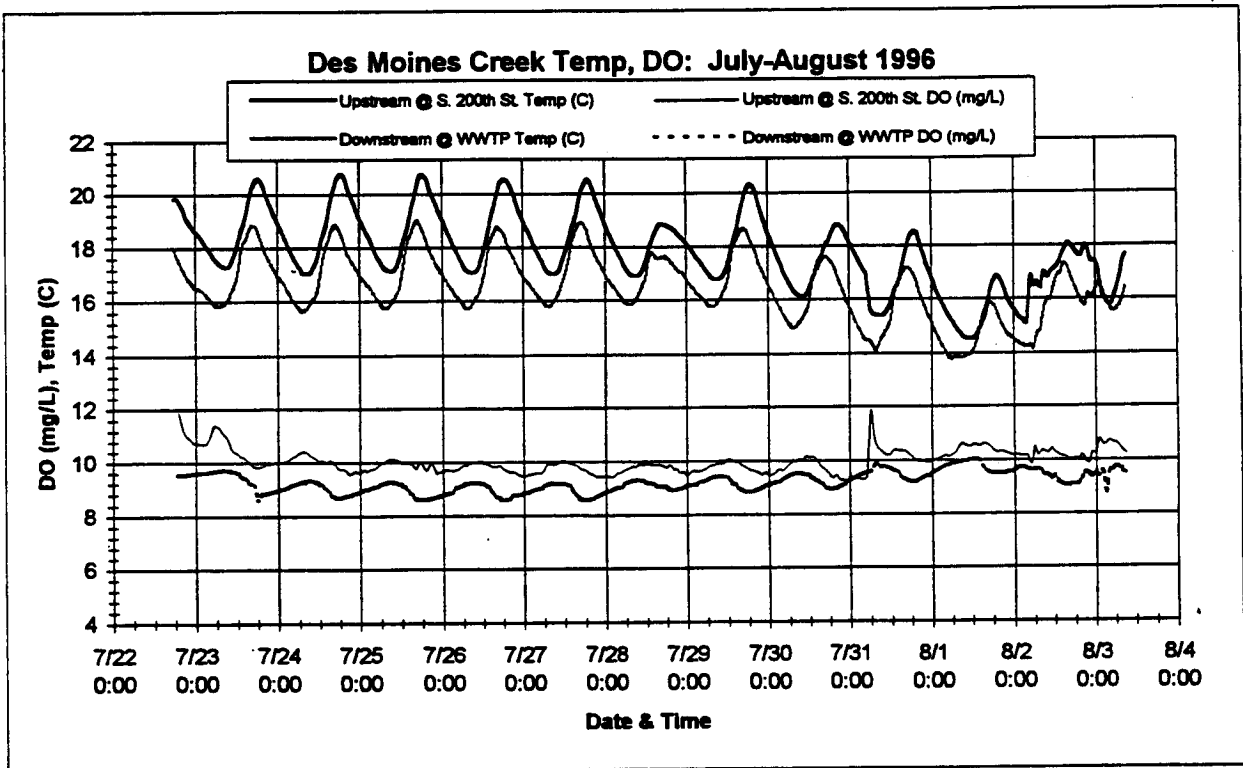
Figure B.3. Des Moines Creek dissolved oxygen at Upstream (S. 200th St.) and Downstream (WWTP) baseflow monitoring stations.

Figure B.3 (continued). Des Moines Creek dissolved oxygen at Upstream (S. 200th St.) and Downstream (WWTP) baseflow monitoring stations.

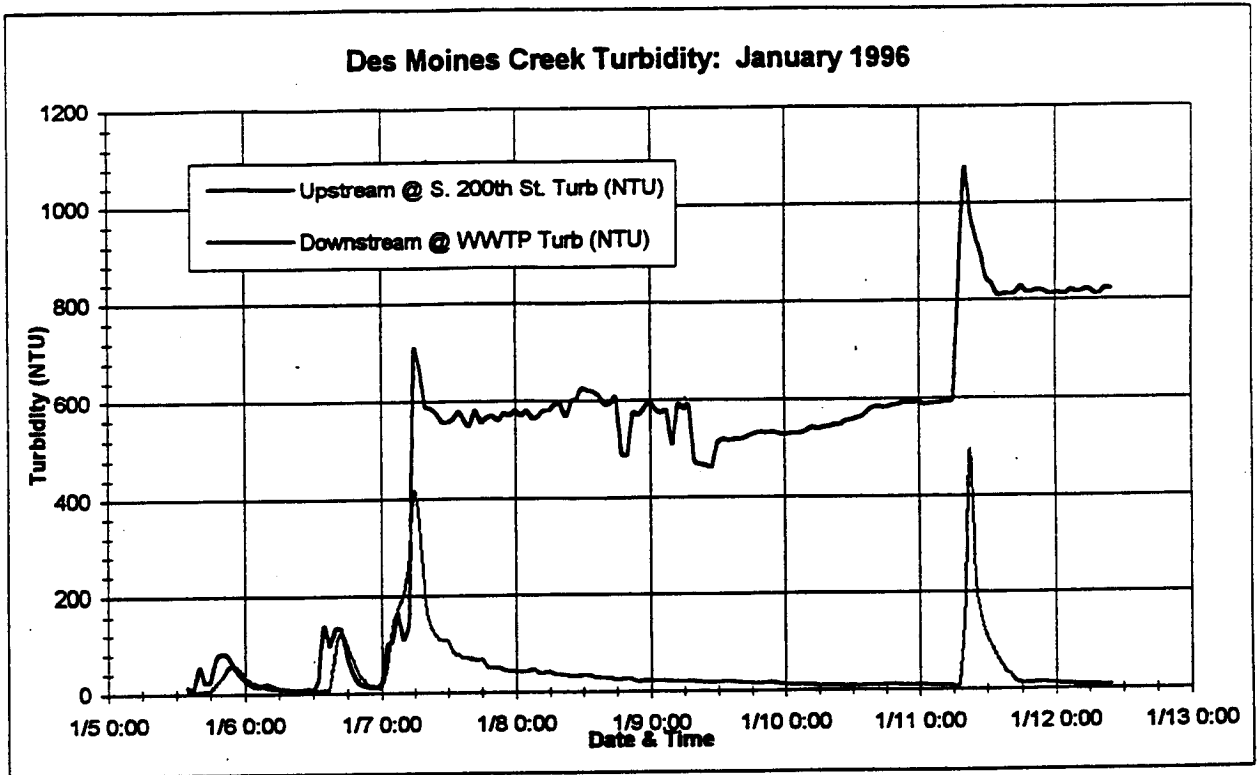
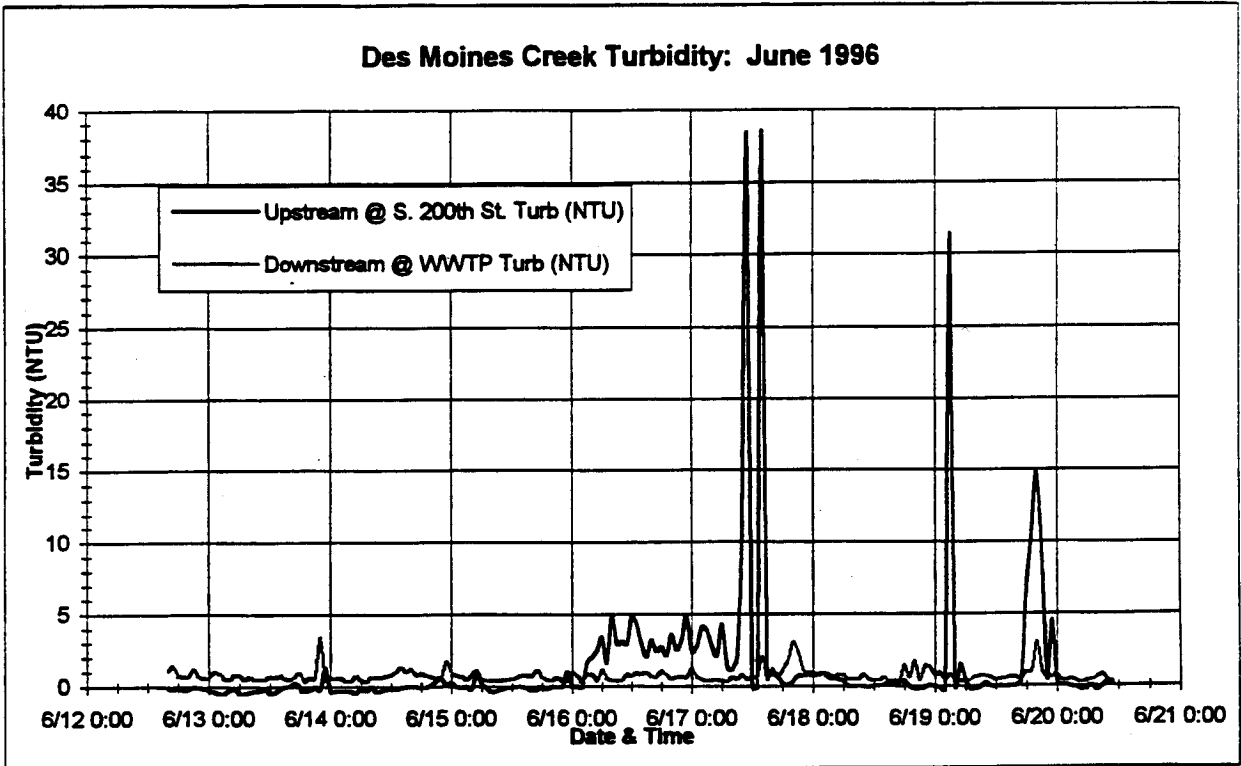
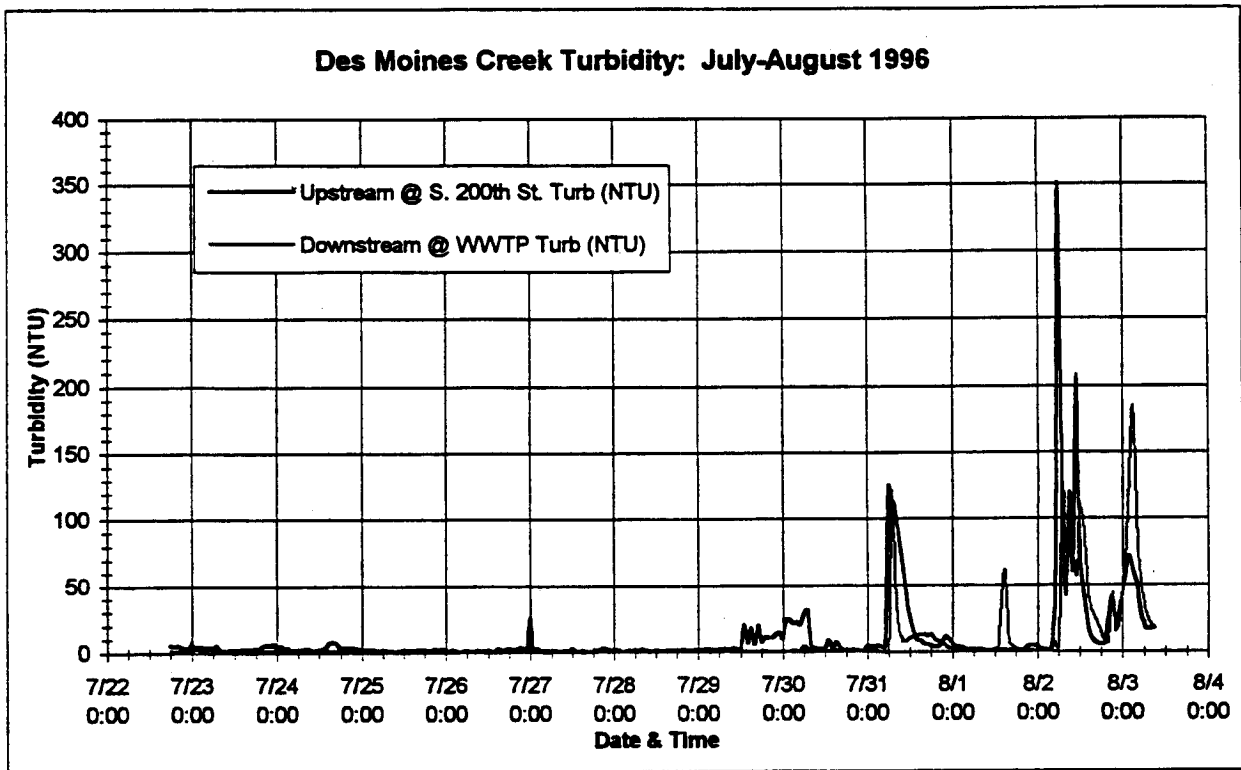
Figure B.4. Des Moines Creek turbidity at Upstream (S. 200th St.) and Downstream (WWTP) baseflow monitoring stations. No turbidity data available for March.

Figure B.4 (continued). Des Moines Creek turbidity at Upstream (S. 200th St.) and Downstream (WWTP) baseflow monitoring stations.

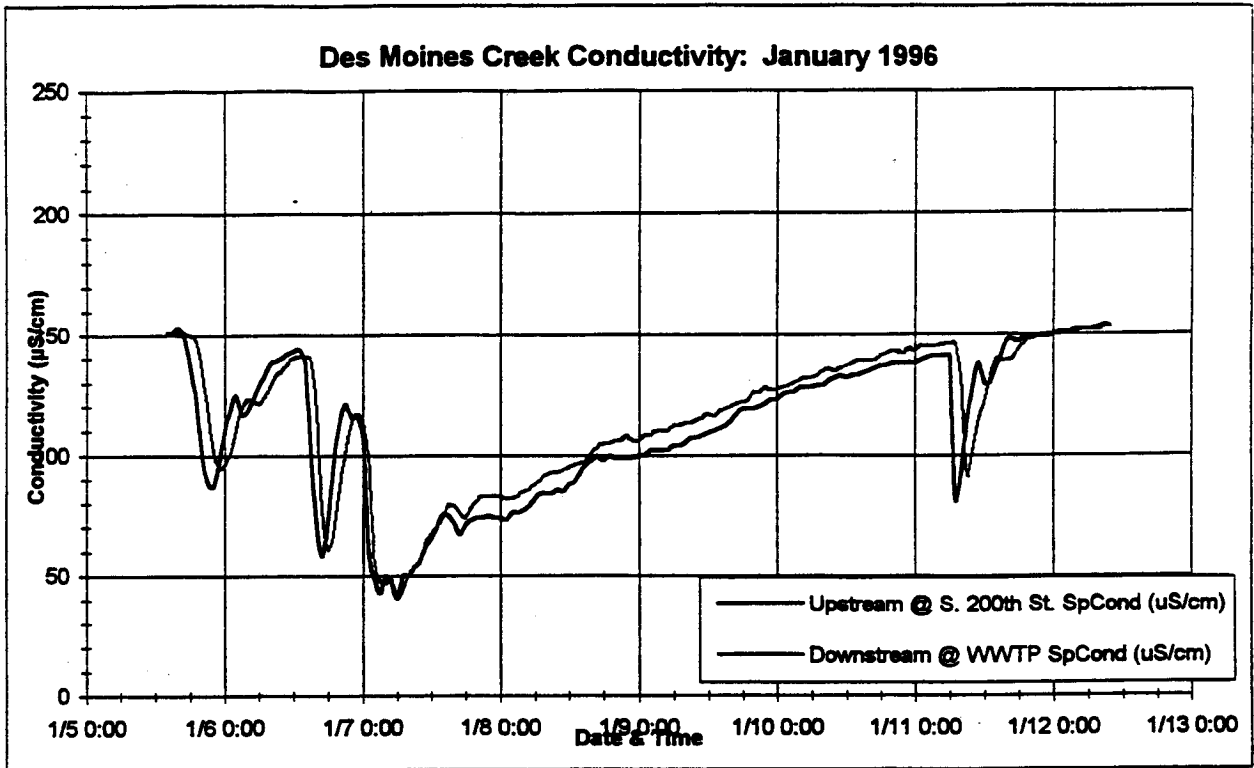
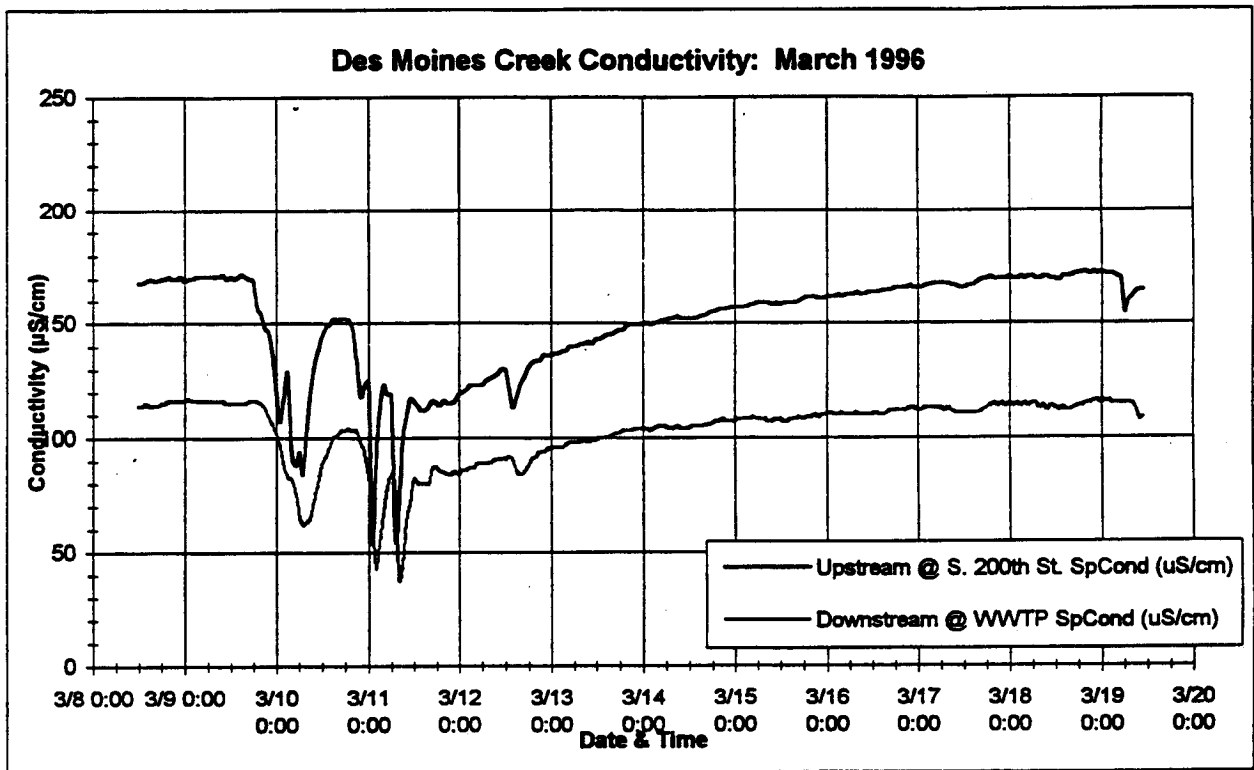
Figure B.5. Des Moines Creek conductivity at Upstream (S. 200th St.) and Downstream (WWTP) baseflow monitoring stations.

Figure B.5 (continued). Des Moines Creek conductivity at Upstream (S. 200th St.) and Downstream (WWTP) baseflow monitoring stations.
